Subject: Oconee Nuclear Station
Docket Nos. 50-269, -270, -287
Special Report Concerning Pressurizer
Relief Valve Setpoint Inaccuracies

TITLE (4) **Pressurizer Safety Relief Valve Actuation Setpoint Drift Occurs Due to Unknown Causes, Possible Test Procedure Deficiency**

Oconee Nuclear Station, Unit 3 Special Report PIR# 3-091-0024

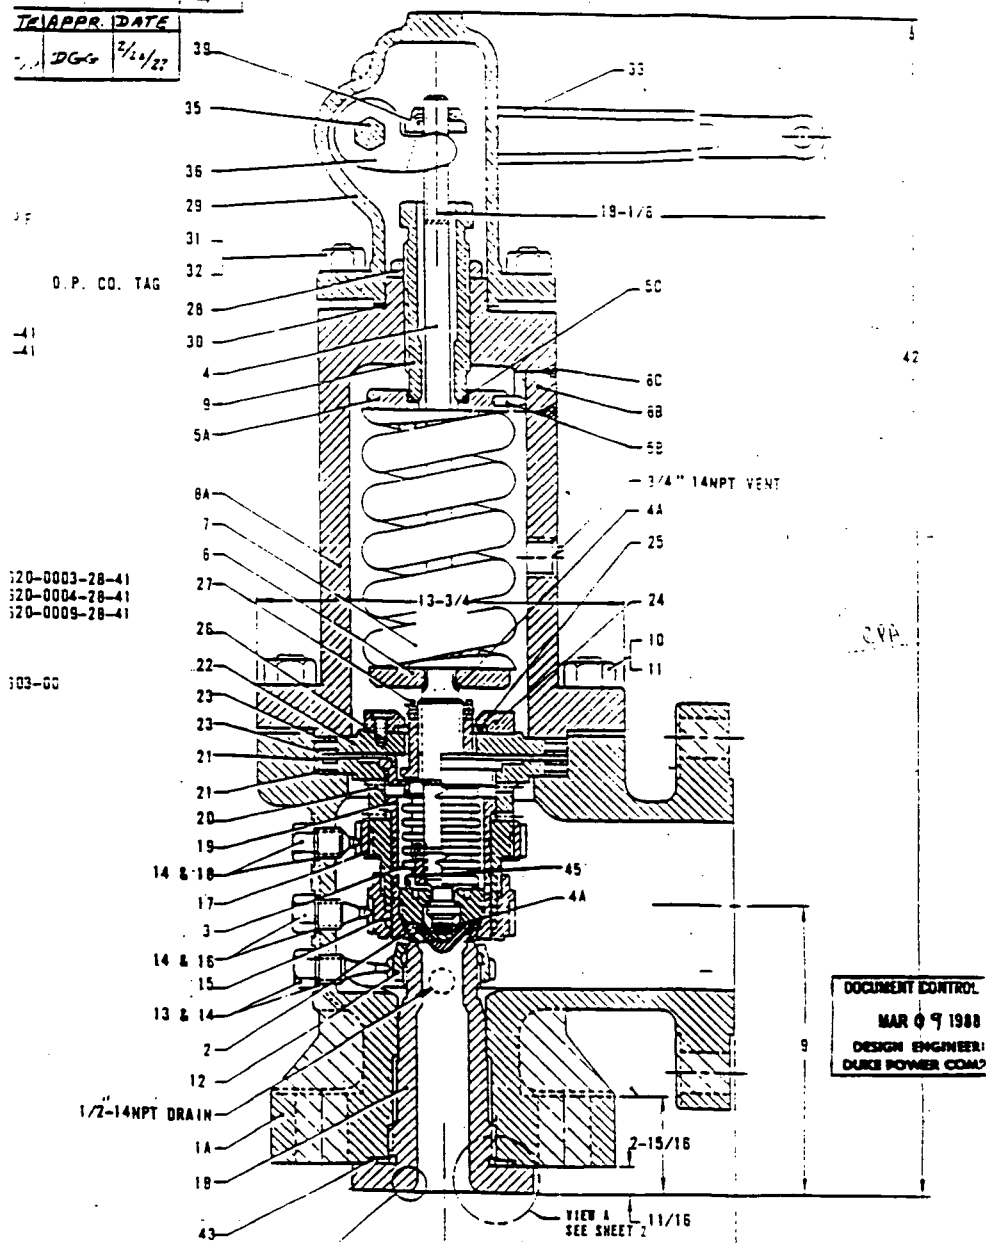
Attachment-1

A drawing of the safety relief valve internals is presented in Attachment 1. The valve disc is forced against its seat by a spring whose compression can be adjusted using an adjustable compression screw. The valve disc area exposed to RCS pressure increases when the valve lifts. Consequently, the valve will reseat at a lower pressure than its actuation setpoint. Middle and lower adjusting rings can also be set to affect the opening and closing setpoints of the valve.

Pressurizer Safety Relief Valve Internals
(from Dresser Drawing 3CP-10800)
