REGULATORY INFORMATION DISTRIBUTION SYSTEM (RIDS)

SUBJECT: LER 91-008-00: on 911123, operators observed symptoms of excessive RCS leakage. Caused by mgt deficiencies & equipment failure. Operators controlled unit shutdown. W/911223 ltr.

FACILITY NAME (1) **Oconee Nuclear Station, Unit 3** DOCKET NUMBER (2) **0 5 0 0 0 2 8 7 1** PAGE (3) **1 OF 2 4**

TITLE (4) **Excessive Reactor Coolant Leak, Reactor Trip, And Inadvertent Protective System Actuation Result From Management Deficiencies and Equipment Failure**

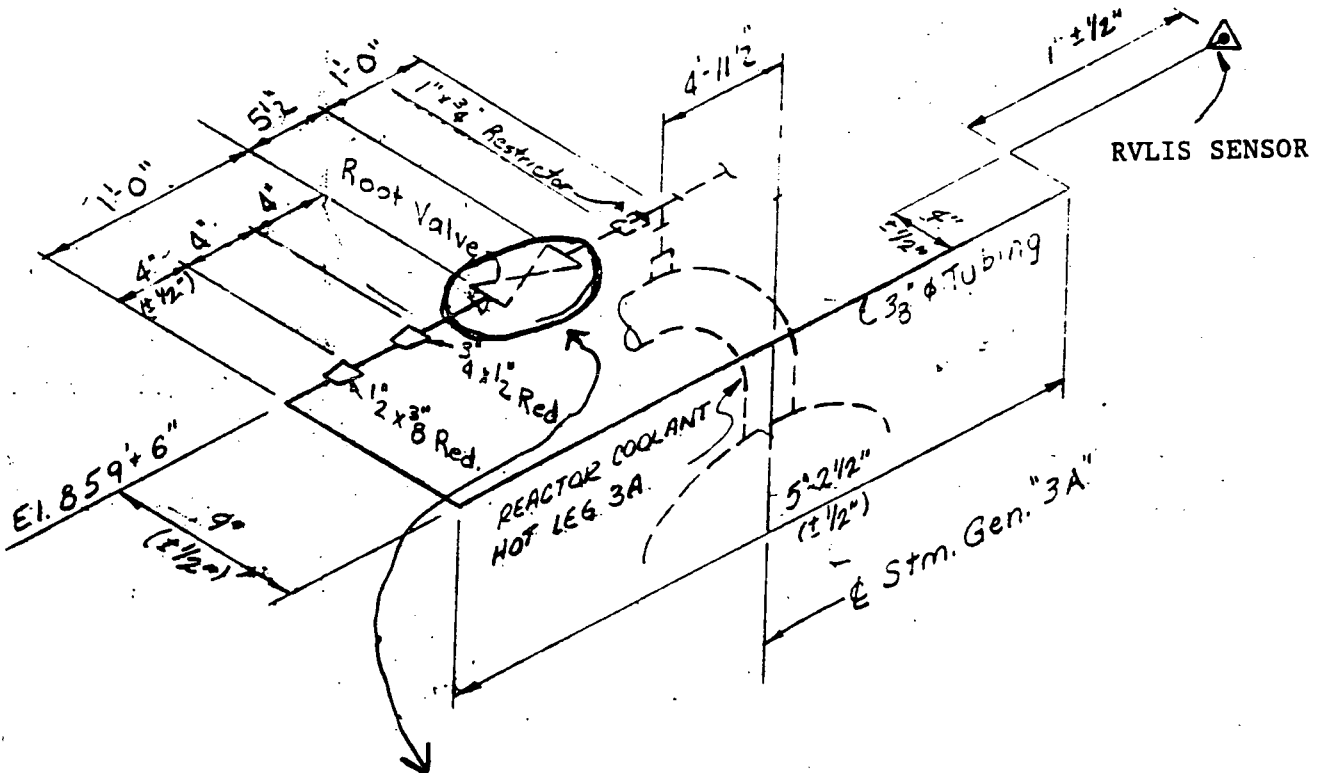
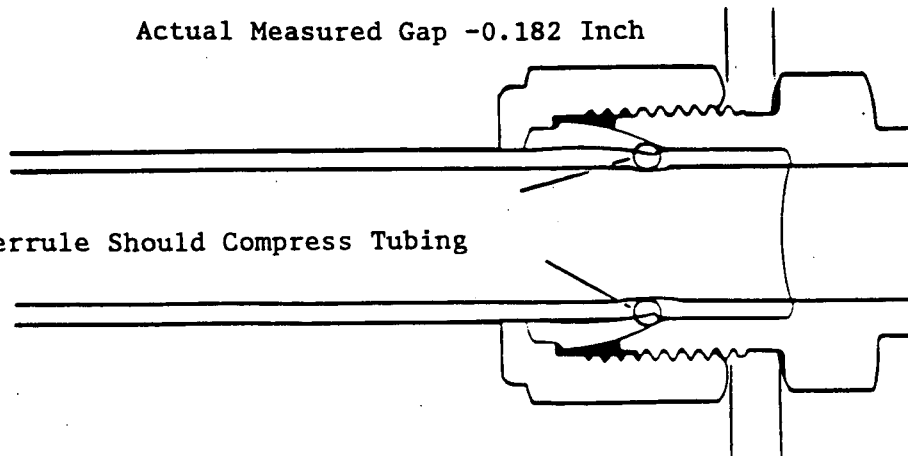
"A" STEAM GENERATOR TAP

At 1300 hours, airborne iodine activity was 27 MPC. An inspection team entered the RB and located the source of the leak. It was found to be due to a 3/4 inch diameter instrument line which had pulled out of a compression fitting downstream of a root valve. The line was located at the top of the RCS hot leg pipe where it entered the "A" Steam Generator (SG A).

Parker Hannifin Company (Parker), manufacturer of the fitting, was contacted and provided a range of "nominal" values for the makeup gap between the hex on the fitting and the end of the nut. The Parker spokesperson stated that these nominal values did not constitute acceptance tolerances or specifications. The inspections showed that the gap was 0.182 inch versus a nominal 0.153 inch. The degree of crimping of the tube was determined by comparing the internal diameter (ID) reduction of the failed fitting to the reduction due to the fitting at the other end of the tube, which did not fail. The ID reduction at the failed end was only 0.002 inch compared to 0.007 inch at the "good" end.

It is concluded, based on the investigation performed by Oconee Engineering and Babcock and Wilcox, that the initiating cause of the leak in this event was improper installation of the fitting. Specifically, the fitting nut was not fully tightened. Therefore, a contributing cause of Inappropriate Action, (Improper Action, Action chosen was proper but execution failed because an action was performed with insufficient precision), is assigned. However, the root cause of this event is determined to be Management Deficiency, for less than adequate policy, directive, or task specific procedure, as explained below.

"Nominal" Gap Expected - 0.153 to 0.165 Inch

Actual Measured Gap - 0.182 Inch

Ferrule Should Compress Tubing

1. The root valve, tubing, and associated fittings on both the "A" and "B" Steam Generator RVLIS impulse lines were replaced with new components.
2. All compression fittings on tubing connected to the Reactor Coolant System and related high pressure systems (High Pressure Injection and Core Flood) were inspected, and tightened if necessary.
3. An operability evaluation was performed to document the engineering justification for returning Unit 3 to service with the gap on several fittings remaining outside the manufacturer's nominal range. This also documented the justification for continuing operation of Units 1 and 2 without shutting down to inspect for similar defects.
4. Appropriate calibration procedures were revised to change the tuning of the Integrated Control System with the intent to minimize the control oscillation which caused the unit trip.
