**UNITED STATES
NUCLEAR REGULATORY COMMISSION**
REGION II
245 PEACHTREE CENTER AVENUE NE, SUITE 1200
ATLANTA, GEORGIA 30303-1257

EN 52090

**SUBJECT: NUCLEAR REGULATORY COMMISSION AUGMENTED INSPECTION TEAM
REPORT NO. 70-1151/2016-007**

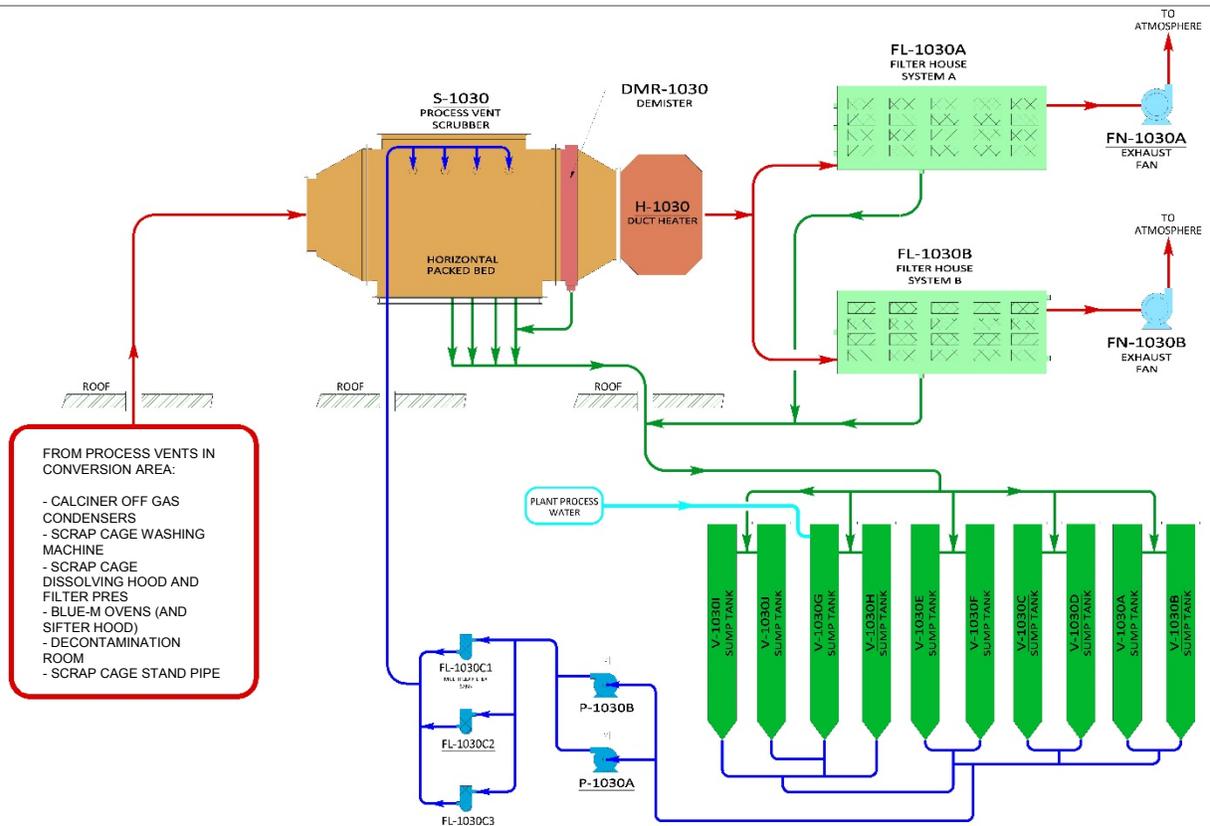
The feed streams all tie together through a network of duct work of various diameters to a large diameter section before entering the transition into the S-1030 scrubber. The large surface area reduces the linear velocity of the incoming stream as it enters the scrubber body. This speed reduction allows for greater reaction time between the scrubber solution and the incoming streams. The scrubber body contains a specialized packing to increase the surface area of the scrubber liquid. The increase in surface area allows for more absorption of gaseous contaminants into the scrubber liquid. The following diagram provides a visual representation of the S-1030 scrubber and related feed streams; this diagram does not show the inlet spray nozzles.

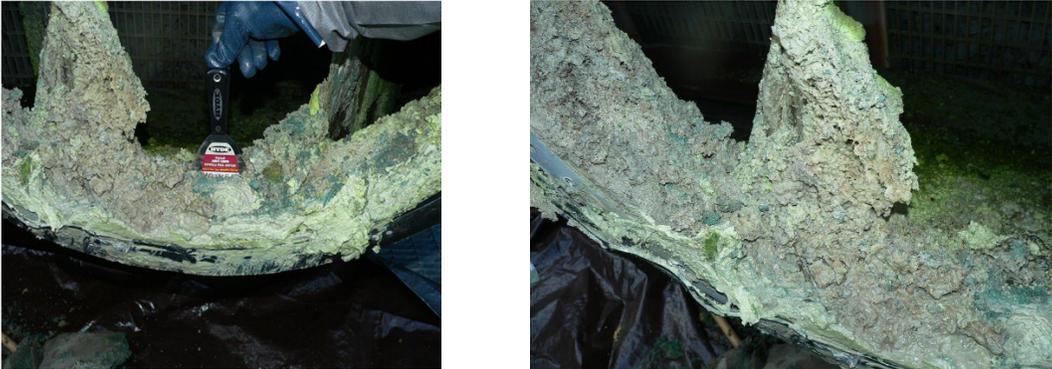
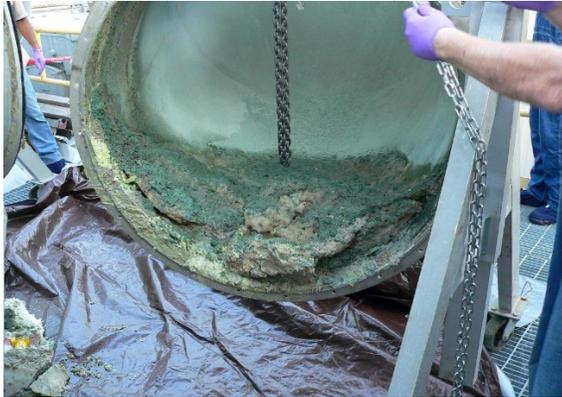
<u>DATE</u>	<u>ACTIVITY</u>
2001-2002 (5/28/02)	<ul style="list-style-type: none"> Removal of S-1056, 3A, and 3B scrubbers Installation of S-1030 to replace above scrubbers (CCF 01-152)
6/2005	<ul style="list-style-type: none"> Removed and replace Blue M filter box with straight 6" duct
5/30/06-6/7/06	<ul style="list-style-type: none"> S-1030 Transition Piece, inlet elbow and tellerettes Cleaned-out High U material was removed (WO 390126) 23kg of U removed from scrubber packing area. Transition section had significantly U accumulation >29kg.

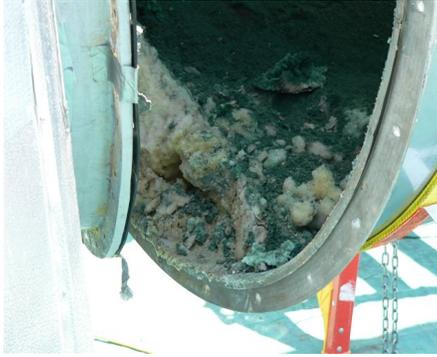
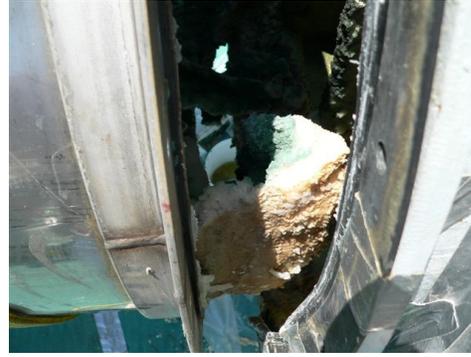
2007	<ul style="list-style-type: none"> S-1030 Transition Piece and elbow removal Clean-out indicate significant build up

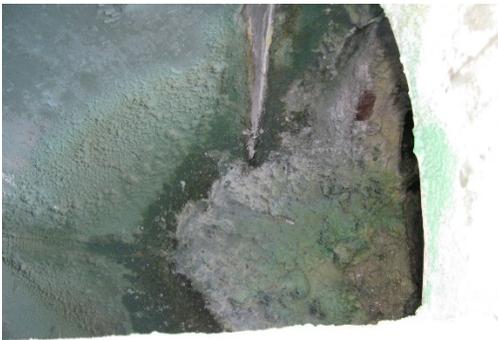
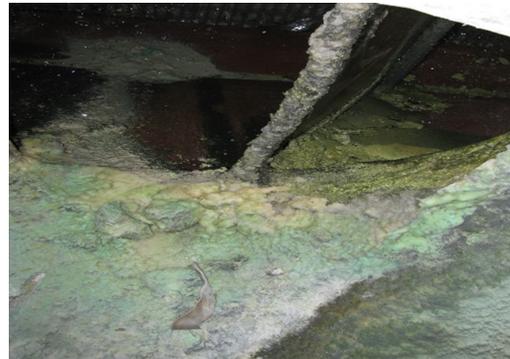
- *S-1030 Transition and inlet elbow cleanout*
- 5/5/09**
- *High U material was removed (but less than the 1956 kg U limit at the time)
(WO 479924)*

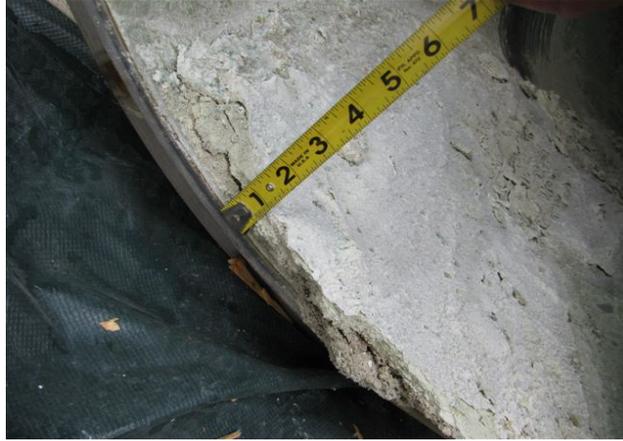
May 27, 2016 Inlet Transition Elbow

-
- Annual outage (Shutdown); planned annual scrubber clean-out;
 - Removed 6-7 polypacks of material from the right and left side of the transition section. Removed 2.5 additional 55 gallon bags of contaminated packing (tellerettes). Pressure washed the transition sections and some of the bottom of the packing. Identified a buildup of material in the center section of the transition that will need to be cleaned out – appears to be 5-7 polypaks worth of material. Recommend dropping the elbow to gain access to the center.
 - Red Book Item 71195 indicating 5-7 popcorn buckets; Criticality safety evaluated this accumulation and stated it did not challenge the safety basis.

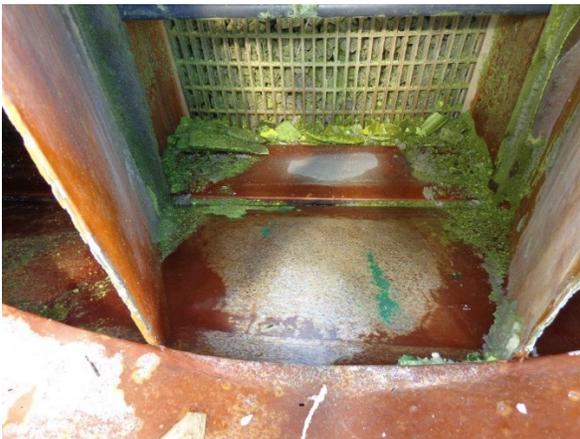
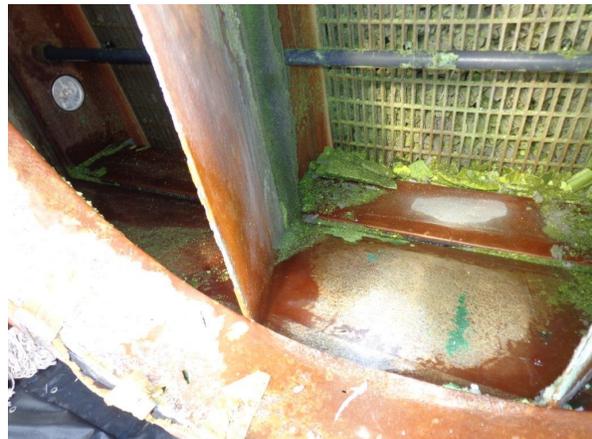
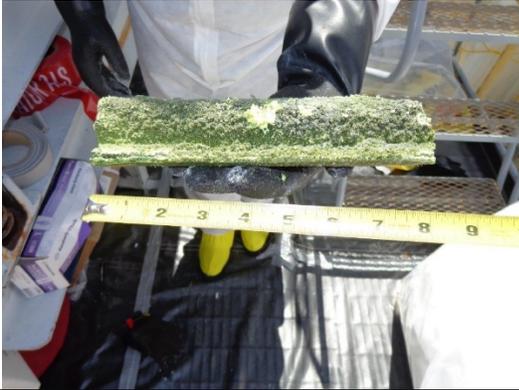
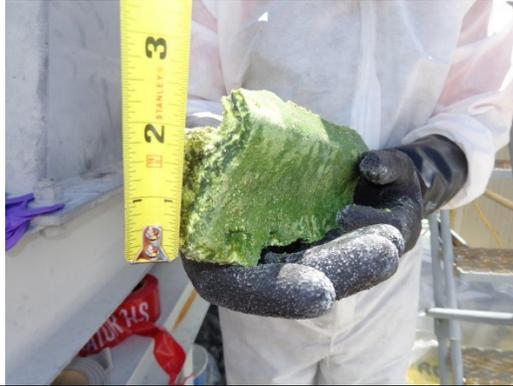
- Process engineer provided weights and uranium concentration results of the first 7 samples to NCS Engineer and NCS Manager.
-
- 5/31/16**
- Westinghouse removed inlet elbow and began removing material from center section of inlet transition.

6/1/16	<ul style="list-style-type: none"> • A total of 36 popcorn buckets of material were removed from inlet transition for a total of 197 kgs (net weight) of wet, green sludge, and solid green chunks and 1 popcorn bucket of material removed from inlet elbow. • Process engineer received additional uranium concentration sample results.
6/2/16	<ul style="list-style-type: none"> • Process Engineer received the remaining uranium concentration sample results. • Discovery that “popcorn” buckets not dimensionally verified (failed IROFS) which resulted on NRC Event Notification (EN) 51974 • S-1030 scrubber was restarted.
6/20/16	<ul style="list-style-type: none"> • Red Book 71195 was updated stating that the total accumulation removed weighed approximately 463 lbs (gross weight) • Material from 37 buckets placed in 22 cream cans to be dissolved for isotopic analysis
6/21/16	<ul style="list-style-type: none"> • Personnel changes (New acting NCS manager)
