Technical Basis for Optimization or Elimination of Liquid Penetrant Exams  
for the Embedded Flaw Repair, Beaver Valley, Unit 2,  
Letter LTR-PSDR-16-008-NP, Revision 0, dated October 2016  
(Nonproprietary Version)

LTR-PSDR-16-008-NP  
Revision 0

**TECHNICAL BASIS FOR OPTIMIZATION OR  
ELIMINATION OF LIQUID PENETRANT EXAMS FOR  
THE EMBEDDED FLAW REPAIR  
BEAVER VALLEY UNIT 2**

October 2016

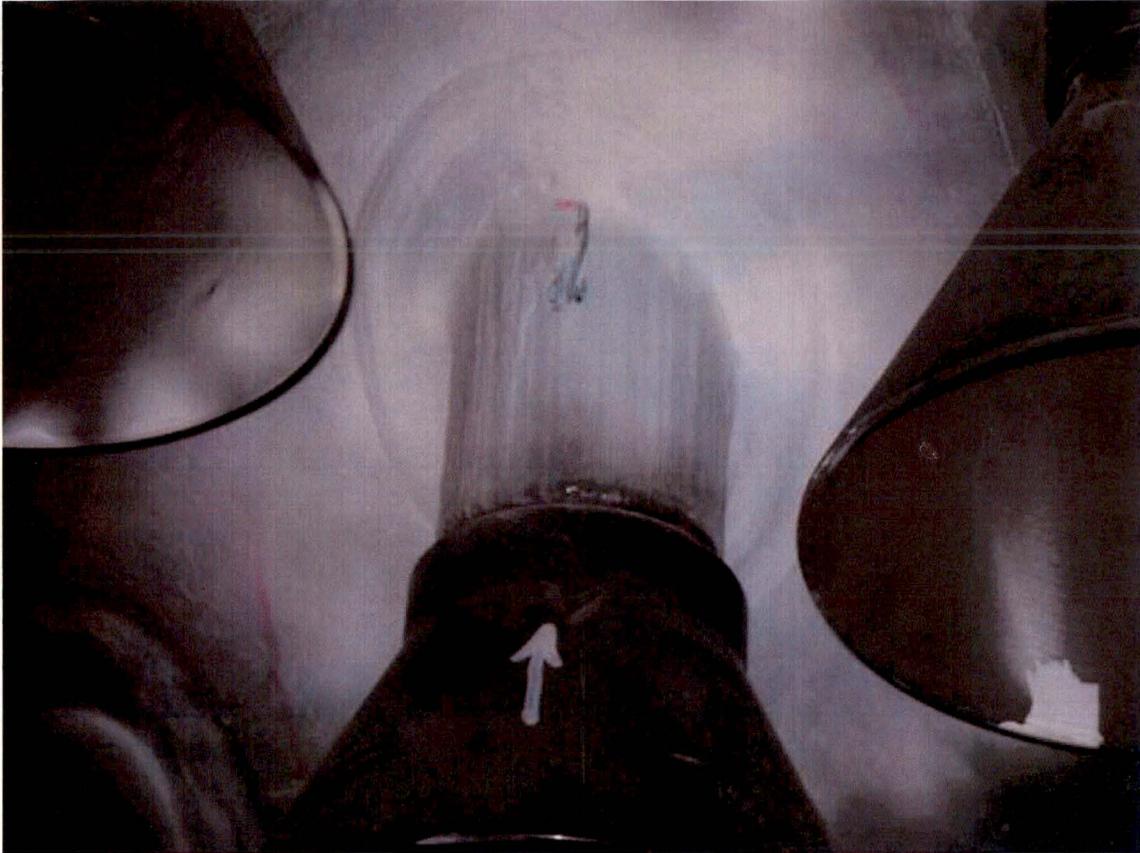
A similar situation may occur in areas where separate weld passes/beads join together. These areas often constitute geometric discontinuities, and (as explained previously) can cause penetrant to become entrapped. Operating conditions may cause minor additional changes in the surface geometry in these locations, and these slight changes can increase the risk of penetrant entrapment. An example is shown in Figures 1 and 2. These changes may then preclude effective cleaning during subsequent PT examinations. When these situations occur, metal removal is typically required to smooth the area, and restore a configuration suitable for PT acceptance. Again, these minor configuration changes do not constitute weld failure of the EFR; they constitute only a condition warranting surface conditioning to facilitate the PT process, thus confirming the integrity of the weld. This situation is the most common source of indications which are found in subsequent PT inspections. Since the OD of the head penetrations near the J-groove weld is located in a very high dose region, subsequent surface preparation by grinding has a significant impact on personnel radiation exposure, and is only performed when absolutely necessary to facilitate the PT process.

**Figure 1: Example of an indication at the boundary of the vertical weld passes on the penetration tube, and the elliptical weld passes on the head**

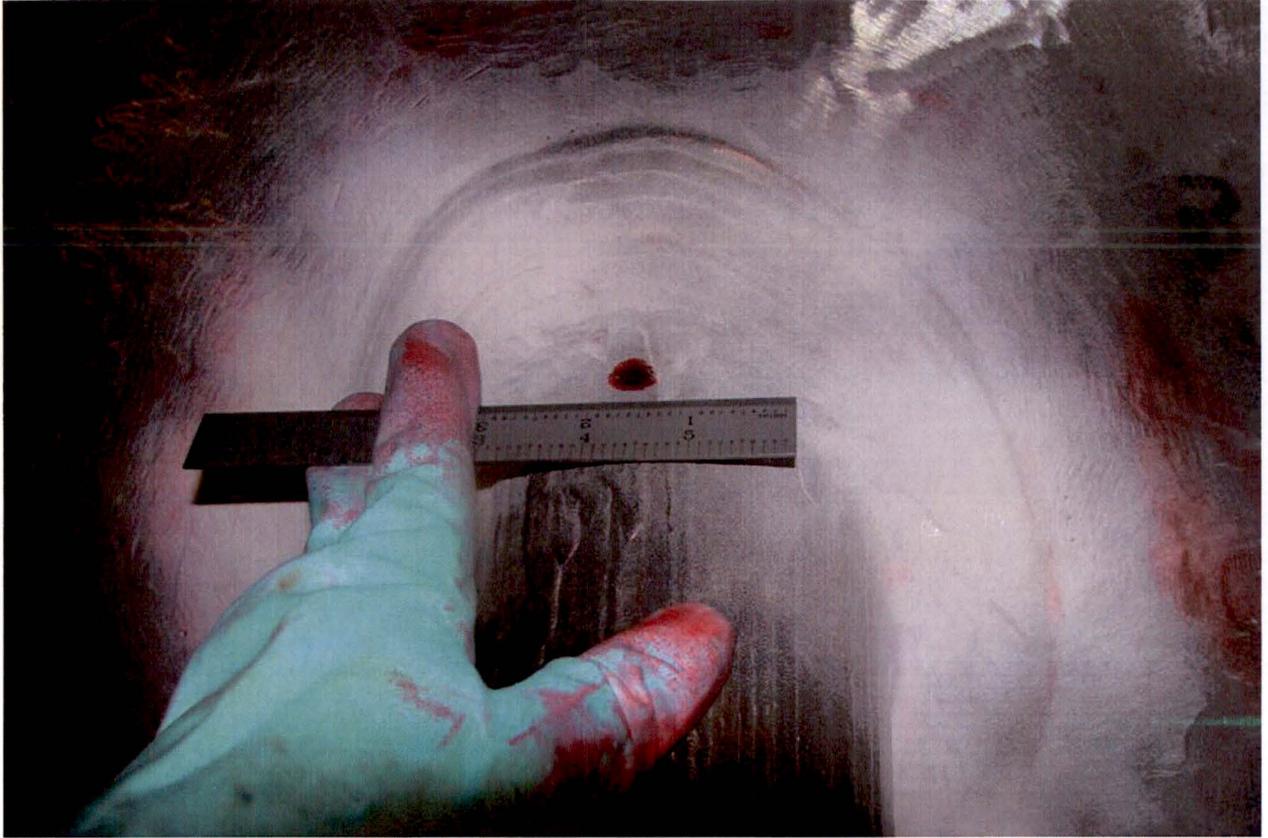
**Figure 2: Closer View of the indication of Figure 1**

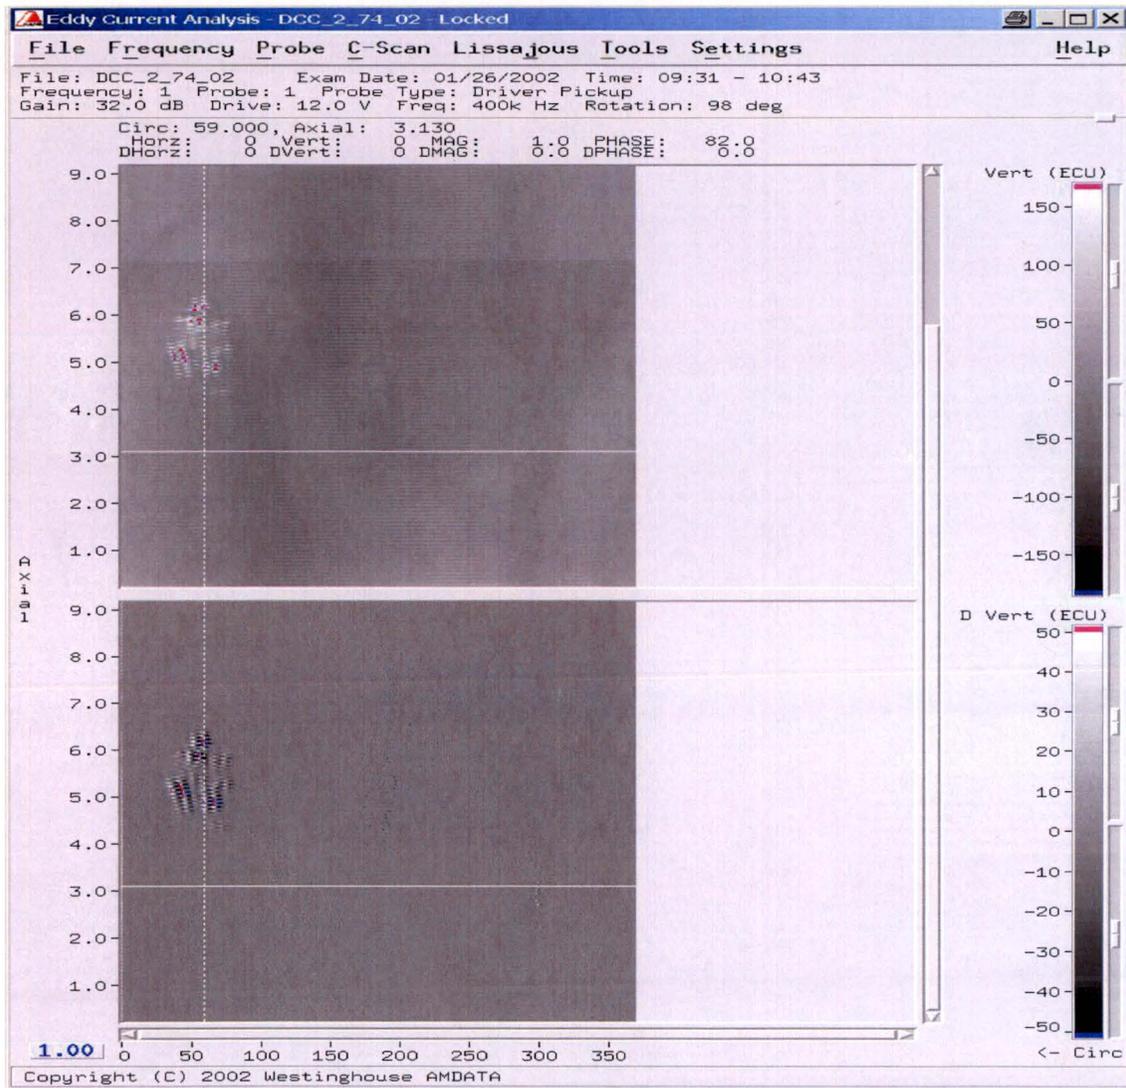
**Figure 1**  
**ECT View of Craze Cracking**

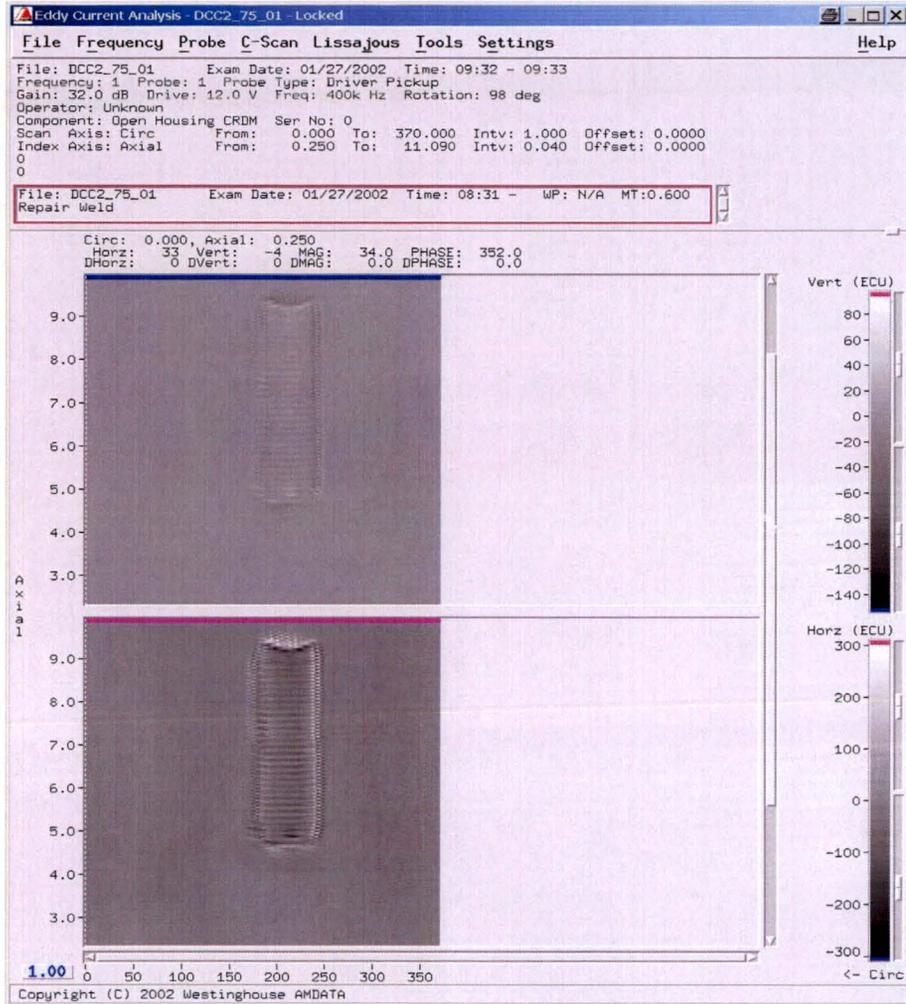
This eddy current testing and display process was applied to the D.C. Cook penetration 75 in January 2002, and the results are shown in Figure 2. The results show no evidence of cracking after six years of service. Further inspections conducted up until the head was replaced in 2006 also showed no evidence of cracking. Therefore, the ID embedded flaw repair was confirmed to last at least 10 years with no deterioration.

**Figure 2**  
**ECT View of 1996 Repair, Taken in 2002**
