UNITED STATES  
NUCLEAR REGULATORY COMMISSION  
OFFICE OF INSPECTION AND ENFORCEMENT  
WASHINGTON, D.C. 20555

IE Bulletin No. 79-13  
Revision 2

CRACKING IN FEEDWATER SYSTEM PIPING

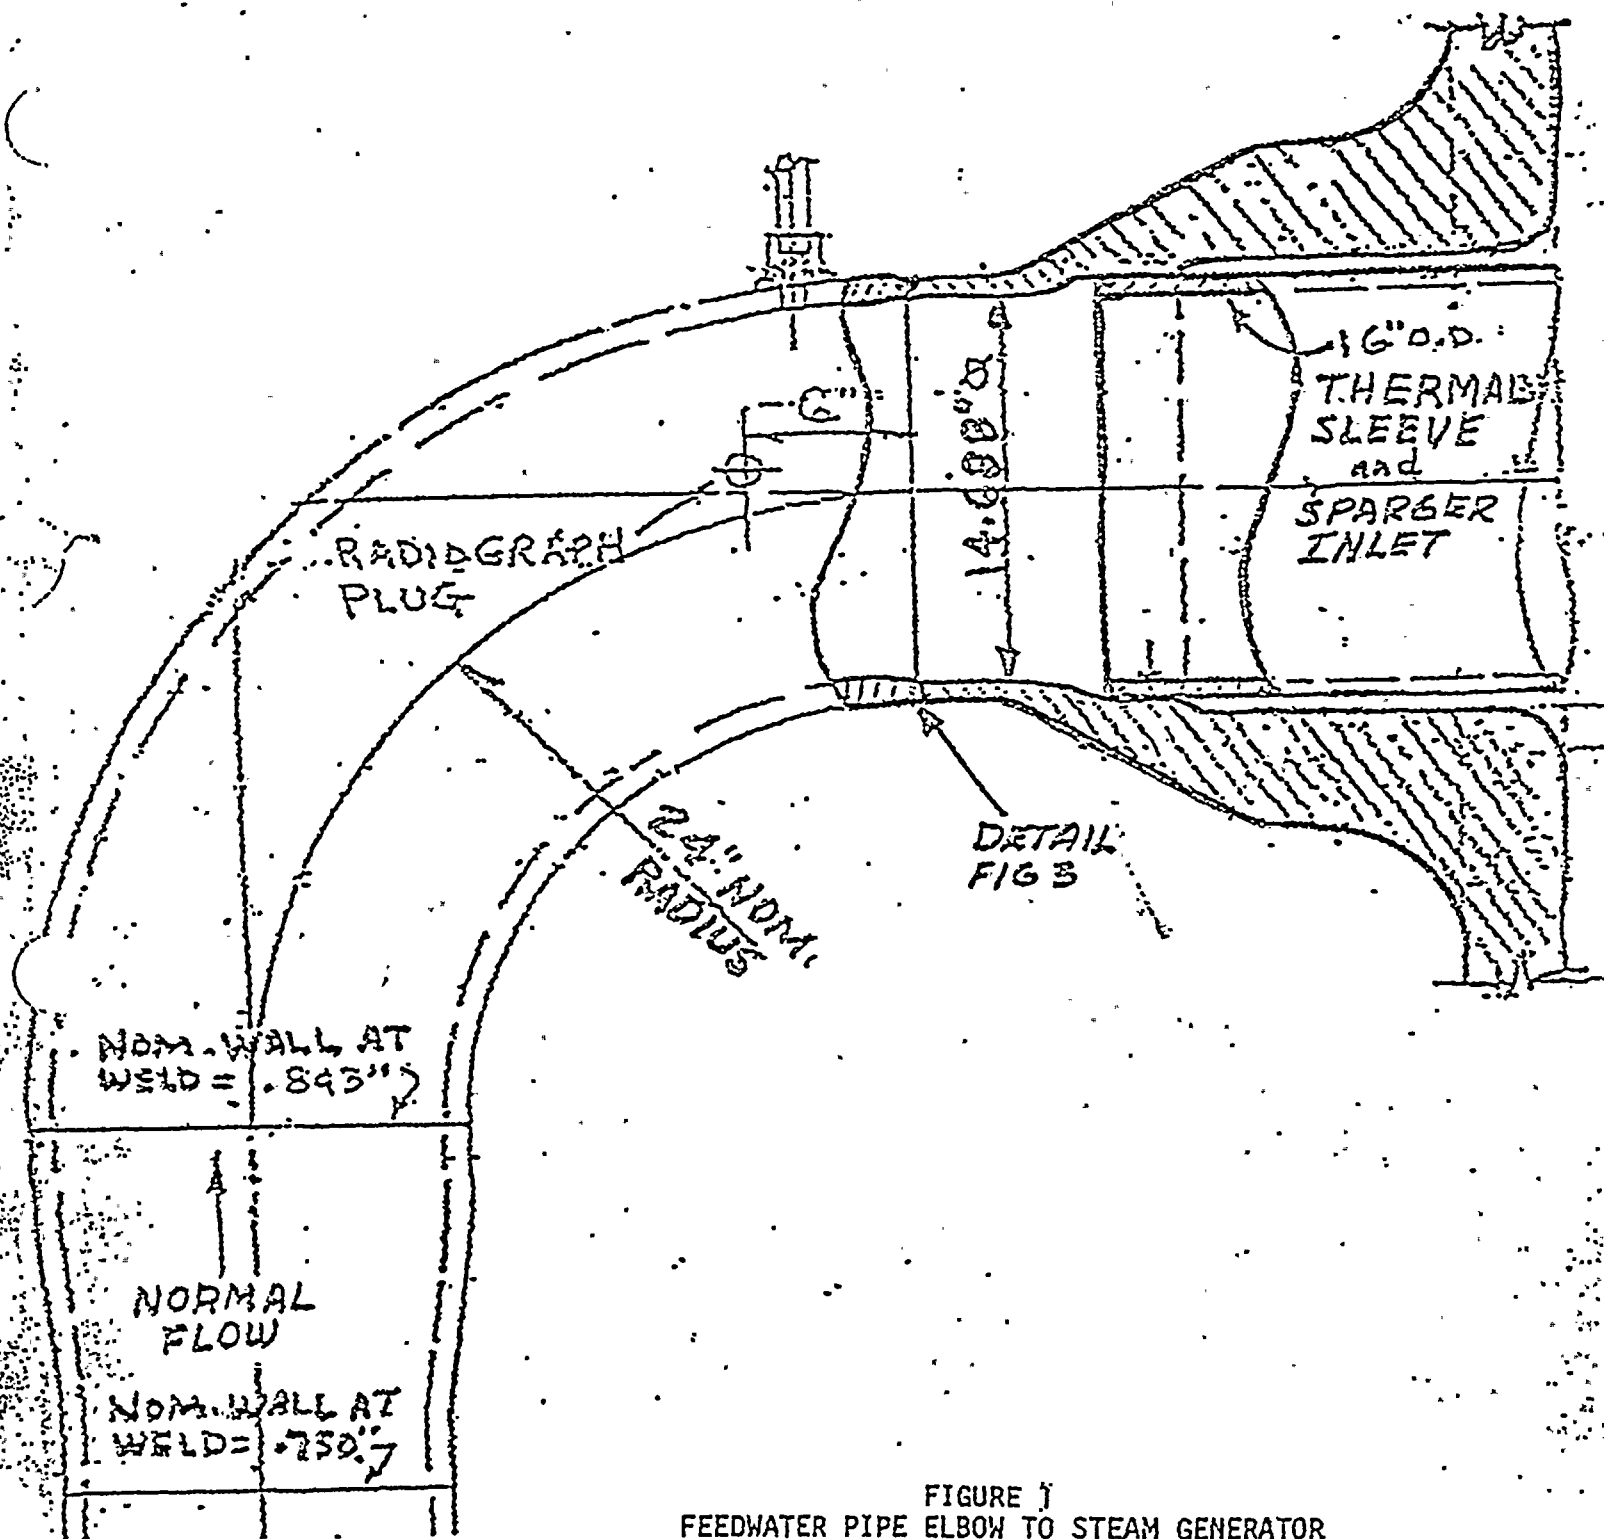
FIGURE 1  
FEEDWATER PIPE ELBOW TO STEAM GENERATOR  
NOZZLE INSTALLATION (DC COOK)

On May 20, 1979, Indiana and Michigan Power Company notified the NRC of cracking in two feedwater lines at their D. C. Cook Unit 2 facility. The cracking was discovered following a shutdown on May 19 to investigate leakage inside containment. Leaking circumferential cracks were identified in the 16-inch feedwater elbows adjacent to two steam generator nozzle elbow welds. Subsequent radiographic examination revealed crack indications in all eight steam generator feedwater lines at this location on both Units 1 and 2.

The feedwater nozzle-to-pipe configurations for D. C. Cook and for San Onofre are shown on the attached figures 1 and 2. A typical feedwater nozzle-to-pipe weld joint detail showing the principal crack locations for D. C. Cook and San Onofre are shown on the attached figure 3.

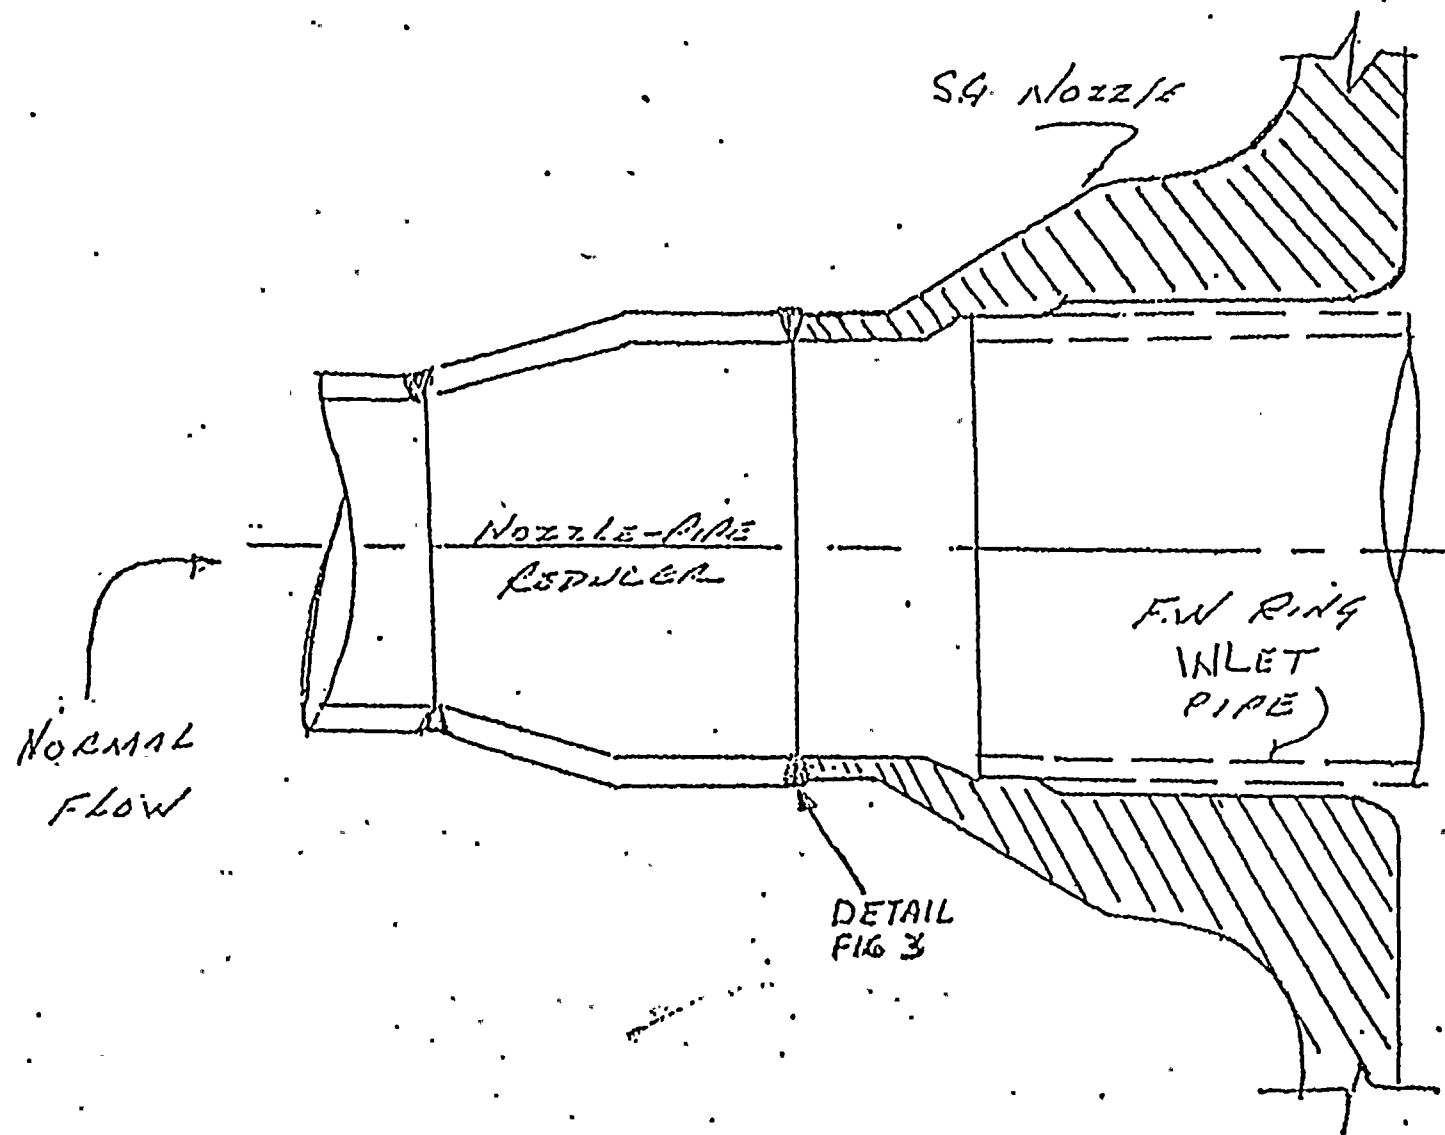
FIGURE 2  
FEEDWATER PIPE REDUCER TO STEAM GENERATOR  
NOZZLE INSTALLATION (SAN ONOFRE).

As a result of these actions, several other licensees with Westinghouse steam generators reported crack indications. Southern California Edison reported on June 5, 1979, that radiographic examination revealed indications of cracking in feedwater nozzle-to-pipe welds on two of three steam generators of San Onofre Unit 1. On June 15, 1979, Carolina Power and Light reported that radiography showed crack indications in similar locations at their H. B. Robinson Unit 2. Duquesne Power and Light confirmed on June 18, 1979, that radiography has shown cracking in their Beaver Valley Unit 1 feedwater piping-to-vessel nozzle weld. Public Service Electric and Gas Company reported on June 20, 1979 that Salem Unit 1 also has crack indications. Wisconsin Public Service company decided on June 20, 1979 to cut out a feedwater nozzle-to-pipe weld which contained questionable indication, for metallurgical examination. As of June 22, 1979 and since May 25, 1979 seven other PWR facilities have inspected the feedwater nozzle-to-pipe welds without finding cracking indications.

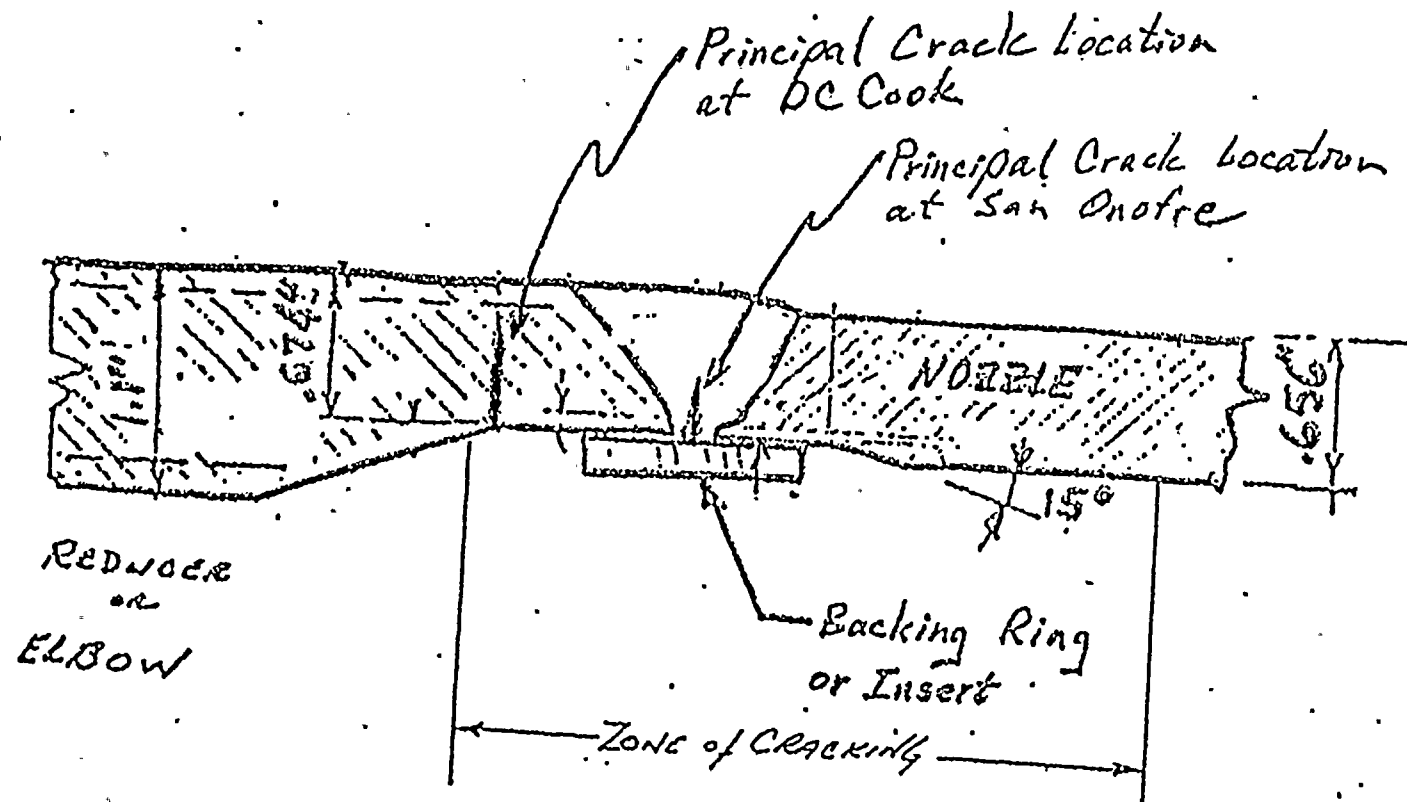
FIGURE 3  
TYPICAL FEEDWATER PIPE TO NOZZLE  
WELD JOINT DETAIL  
( V , CE )

An extensive metallurgical investigation has been conducted by Westinghouse on a substantial number of cracked weldments removed from the above plants. Results of the metallurgical analysis lead to the conclusion that a corrosion fatigue phenomenon is the probable failure mechanism, except for the San Onofre piping which has been characterized as stress assisted corrosion.

- a. Perform radiographic examination, supplemented by ultrasonic examination as necessary to evaluate indications, of all feedwater nozzle-to-pipe welds and of adjacent pipe and nozzle areas (a distance equal to at least two wall thicknesses). Evaluation shall be in accordance with ASME Section III, Subsection NC, Article NC-5000. Radiography shall be performed to the 2T penetrameter sensitivity level, in lieu of Table NC-5111-1, with systems void of water.
