SSINS No.: 6835
Accession No.:
8011040265
IN 81-04

IE Information Notice No. 81-04: CRACKING IN MAIN STEAM LINES

PLANT: SURRY 1
NSSS: (W)
A/E: S&W

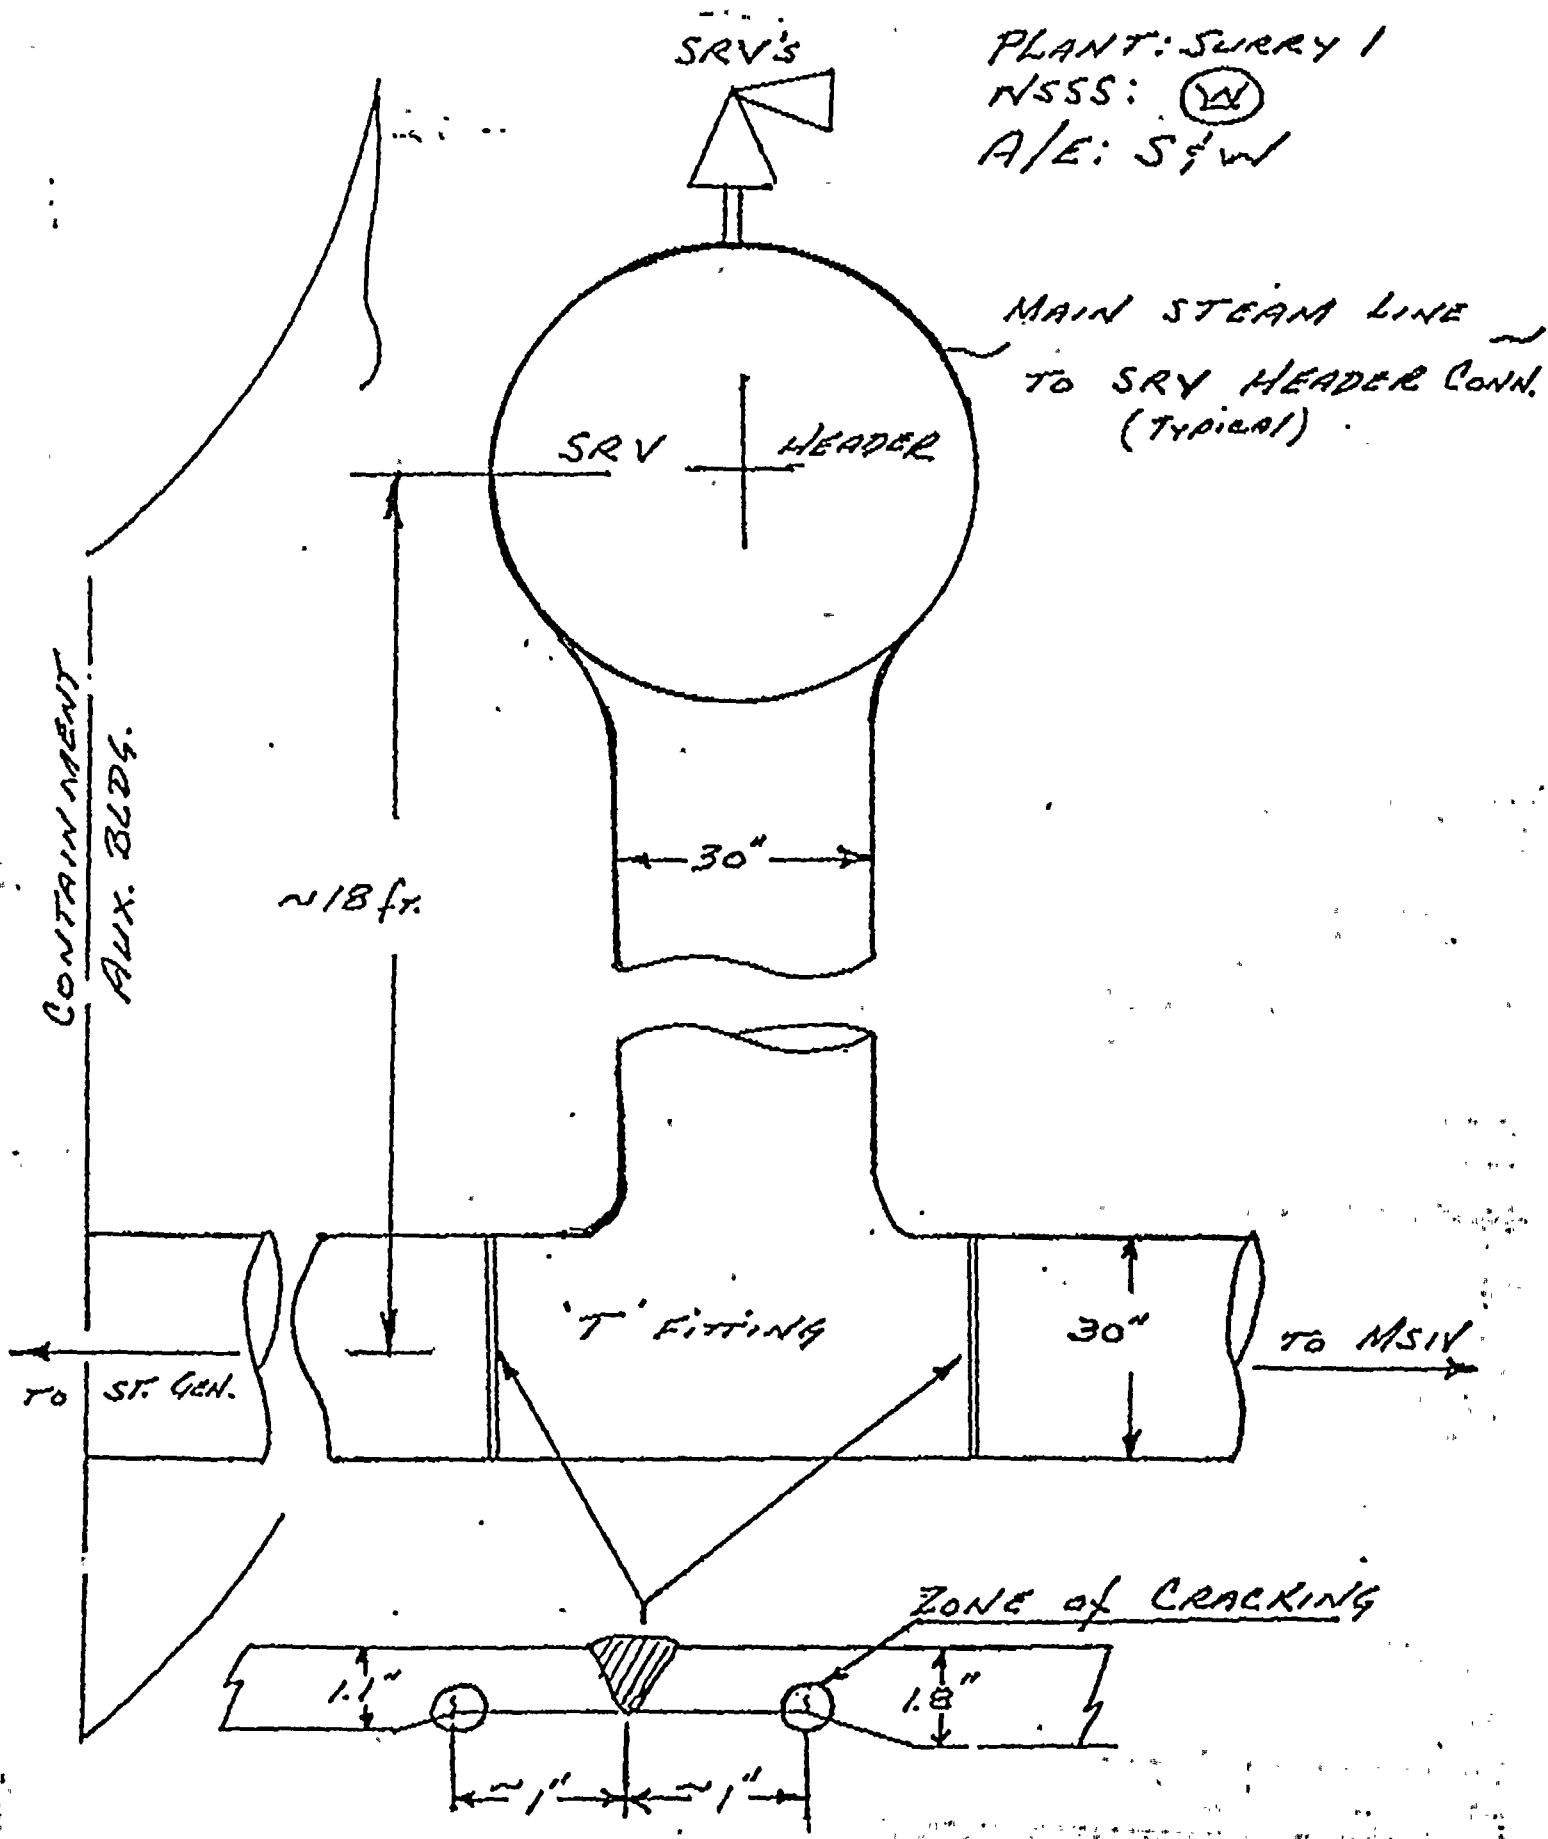
The Virginia Electric Power Company promptly notified the NRC on February 23, 1981 that a radiography examination, during the ongoing steam generator replacement outage at Surry Unit 1, had revealed a lengthy crack indication in the I.D. counterbore area of a weldment on the in-line "T" fitting which connects the vertical run of 30-inch piping to the safety relief valve header and 30-inch main steam line of Steam Generator "A". This piping connection is located outside the containment penetration immediately upstream of the main steam isolation valve as shown in the attached sketch.

A visual and dye penetrant examination on the pipe I.D. surface of the weldment nearest the containment penetration established that the cracking extended about 120° around the fitting counterbore between the 4 o'clock to 8 o'clock position. Cracking was also observed in the weld counterbore at the opposite end of the T-fitting during visual examination of the piping interior. Radiographic examination of "B" and "C" main steam line T-fitting welds disclosed crack indications at similar locations.

Metallurgical specimens of the cracking were trepanned from the T-fitting of the "A" main steam line for analysis. Controlled excavation and depth measurements of the crack at its mid-length indicated a crack depth of about 0.090" in this location. The cause of cracking has not yet been established.

ZONE of CRACKING

This information is provided as an early notification of a significant safety matter that is still under review by the NRC staff. It is expected that recipients will review the information for possible applicability to their plants. For those plants having similar main steam line configurations which are currently in a refueling or extended repair outage, it is recommended that a ultrasonic and/or radiographic examination of the three welds and counterbore areas of the T-fittings be performed before resumption of operations, unless some current basis for assurance of piping integrity is available.
