BREAKWATER DAMAGE BY SEVERE  
STORM WAVES AND TSUNAMI WAVES

Robert L. Wiegel

5 March 1982

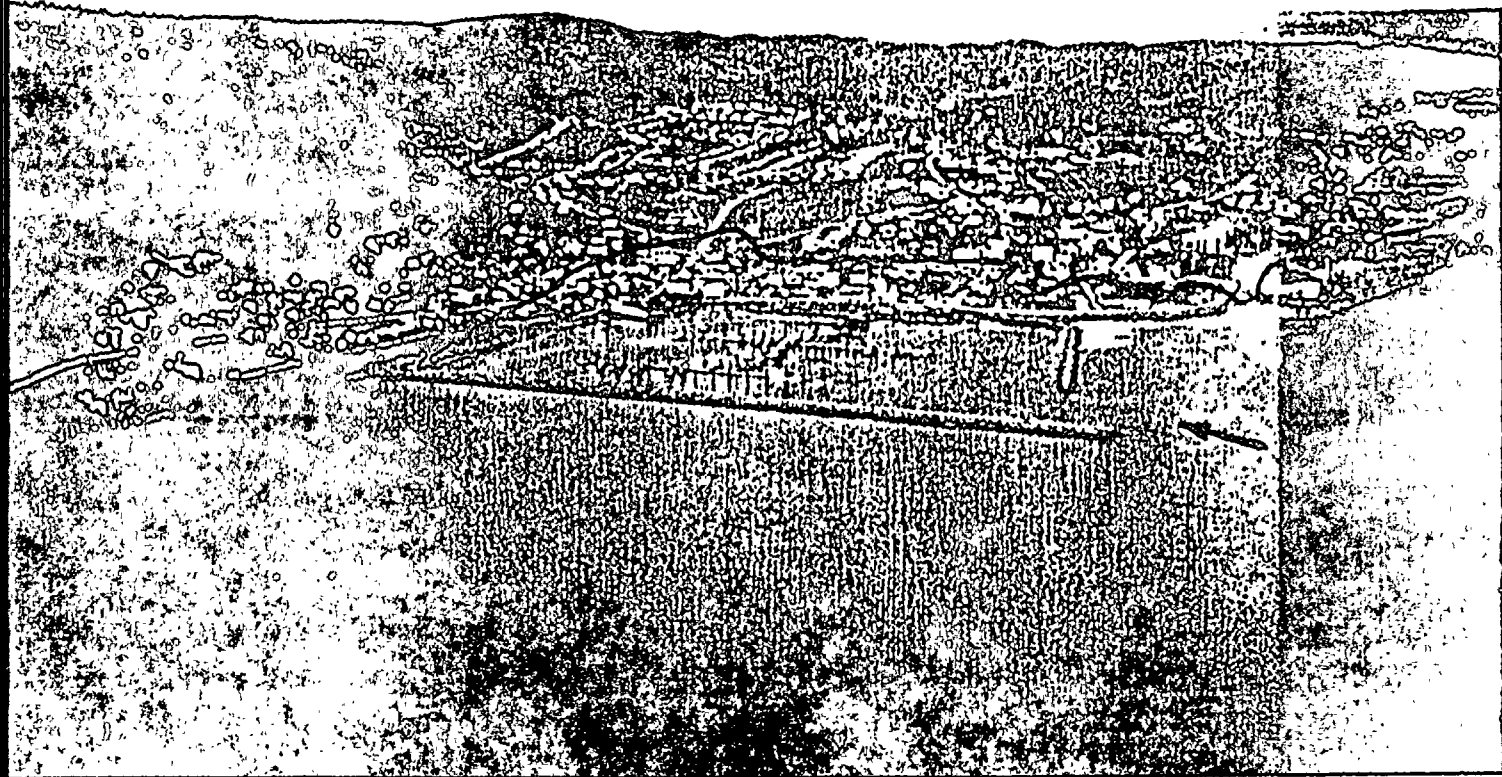
Figure 4a Aerial photo of City of Kodiak, center of one of the largest fishing fleets in Alaska. Solid line shows highest level reached by waves. (Photo by Alf Madsen)  
(From Tudor, 1964)

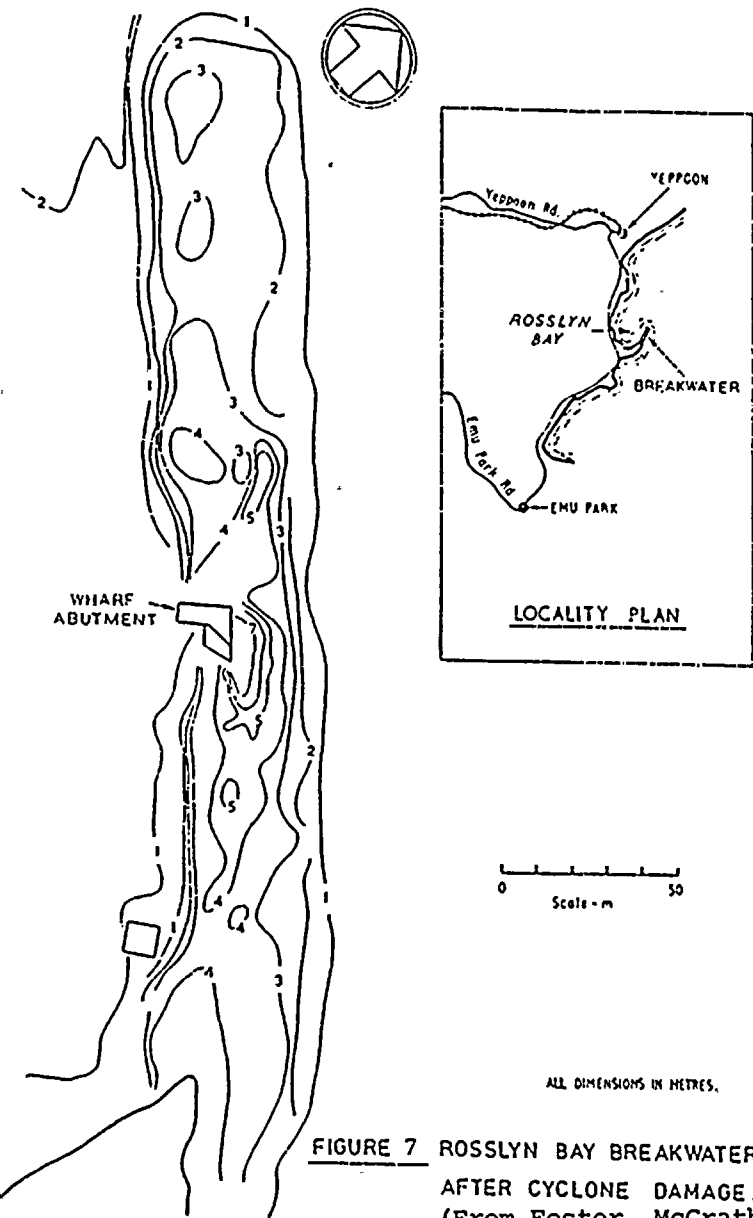
**FIGURE 7** ROSSLYN BAY BREAKWATER AFTER CYCLONE DAMAGE. (From Foster, McGrath and Bremner, 1978)

"A survey of damage to the breakwater was undertaken 20 days following the failure as shown in Figure [7].

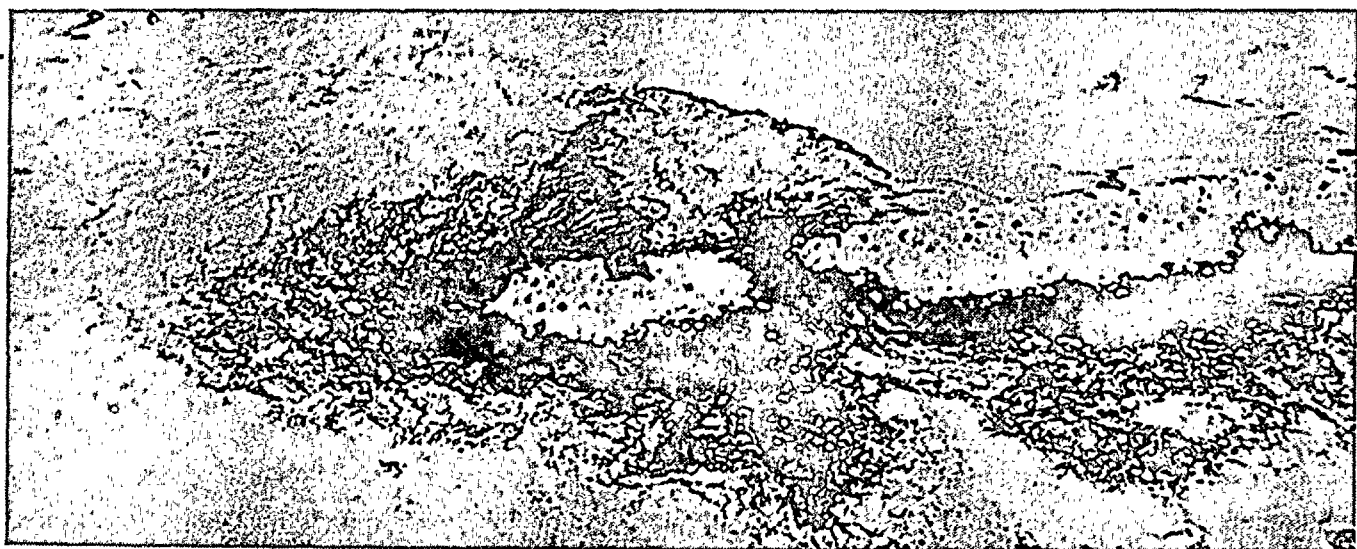
Figure 14. Views of the Damages  
(From Reis de Carvalho, 1964)

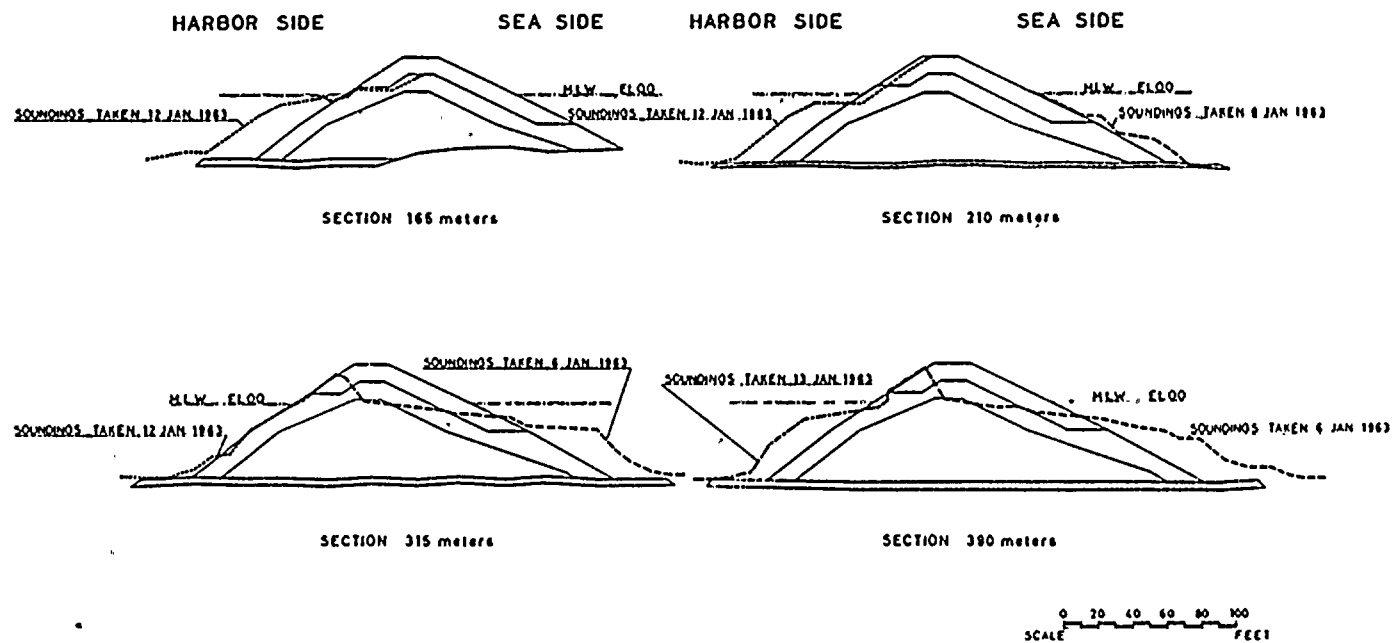
Figure 15. Breakwater sections after storm  
(From Reis de Carvalho, 1964)

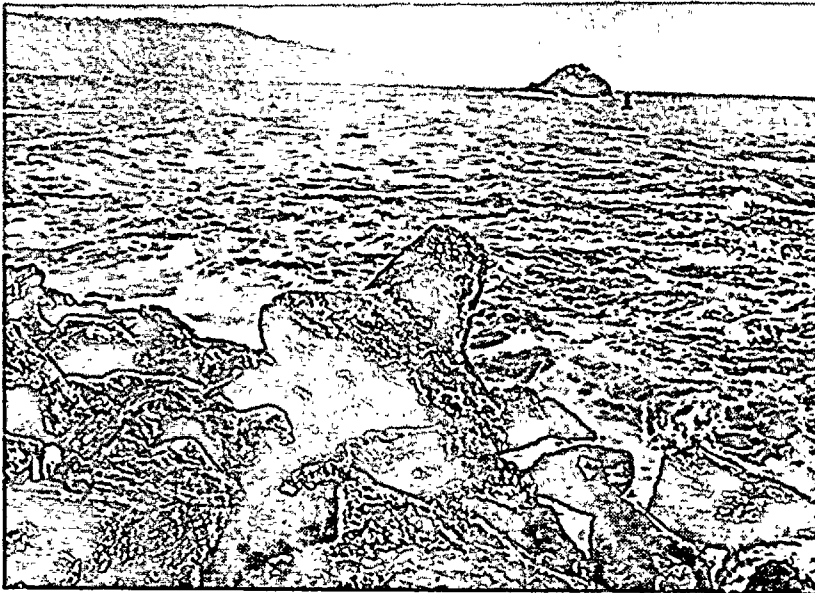
Figure 34. Storm wave displacement of originally submerged tetrapod from repaired area shown on Fig. 6.\*  
(From Magoon, Sloan and Foote, 1974)

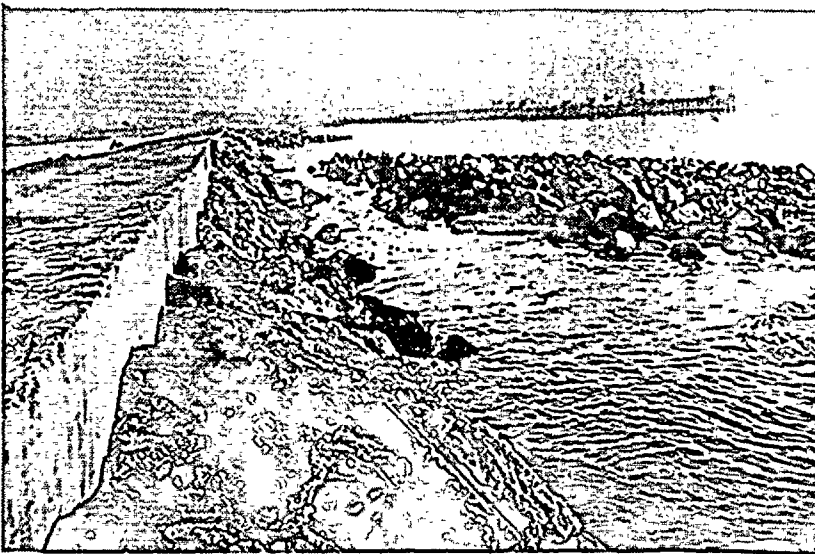
Figure 35. Wave trench resulting from the overtopping shown on Fig. 9--\* Crescent City Outer Breakwater.  
\*Original figure (From Magoon, Sloan and Foote, 1974)

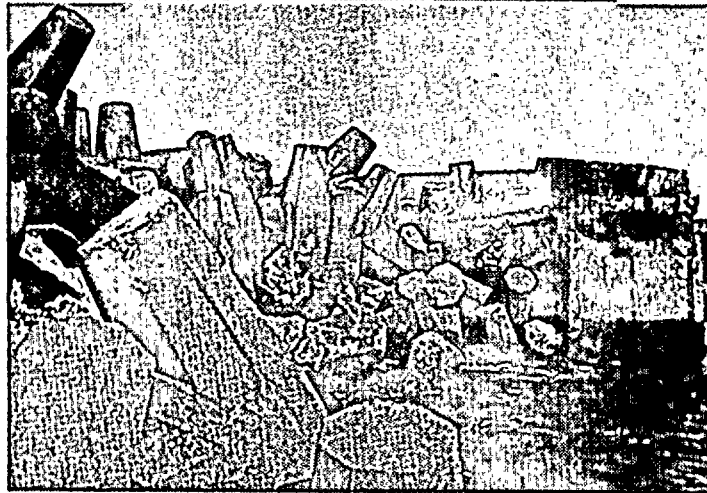
Figure 45. Photo of damage at Gansbaai breakwater after storm of December 1977 (From Edge and Magoon, 1979)

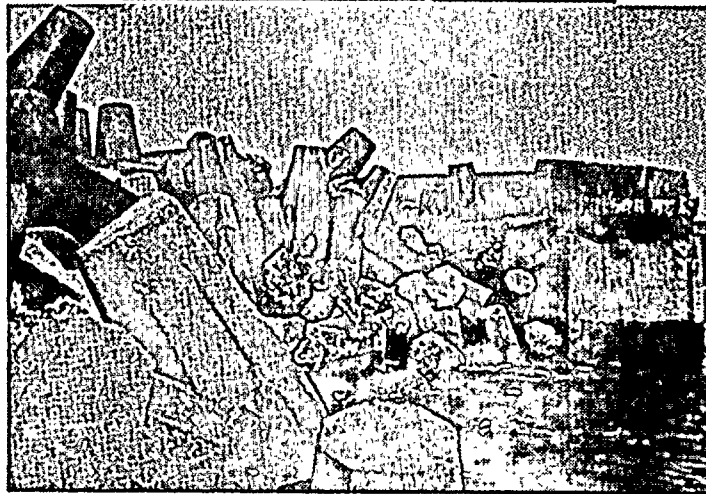
Figure 45. Photo of damage at Gansbaai breakwater after storm of December 1977 (From Edge and Magoon, 1979)

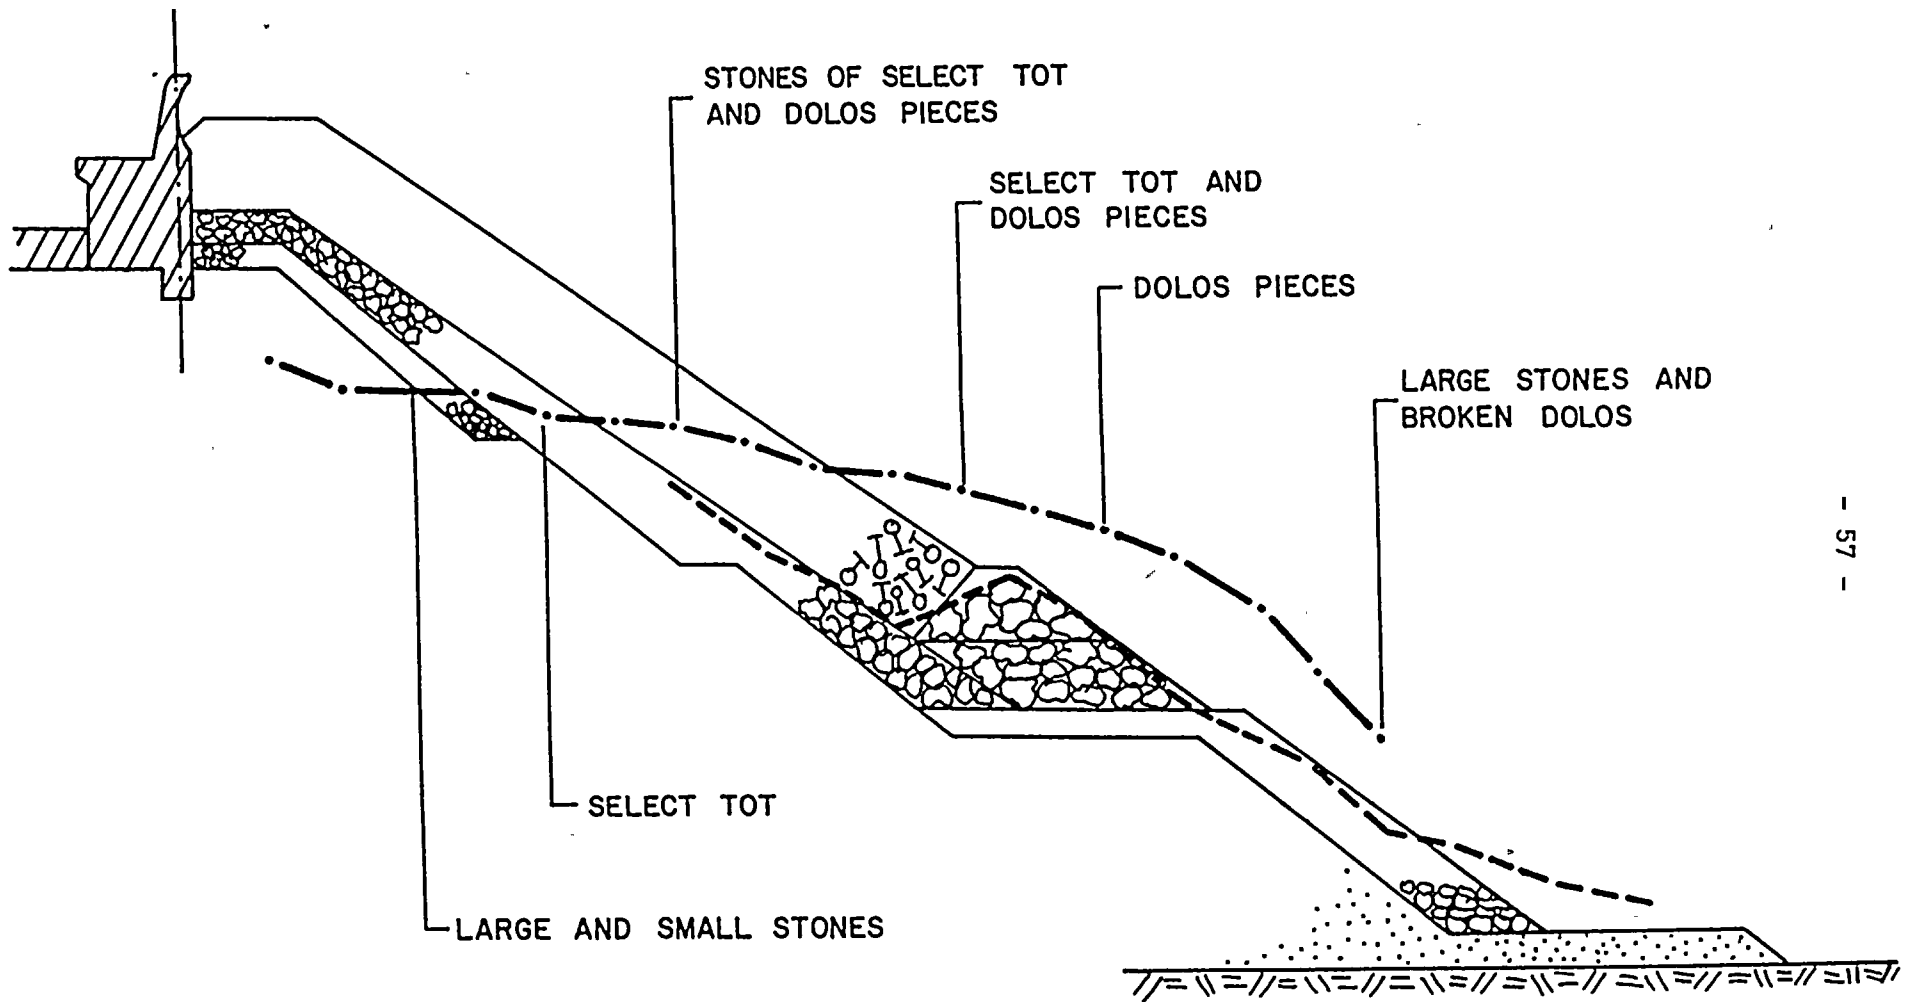
FIGURE 50. A TYPICAL CROSS-SECTION AS OBSERVED BY DIVERS  
 (From Port Sines Investigating Panel, 1981)

divers that virtually all of the underwater units were broken, irrespective of the state of the dolos above the water level. It also revealed recent movement of the broken dolos parts."
