SUBJECT: Provides updated info re damage sustained by west breakwater at facility. Damage is limited to length of breakwater, w/no significant displacement at toe of slope in damaged segment. No safety issue involved. Diagrams encl.

Diablo Canyon Units 1 and 2

This letter provides updated information regarding the damage sustained by the west breakwater at Diablo Canyon.

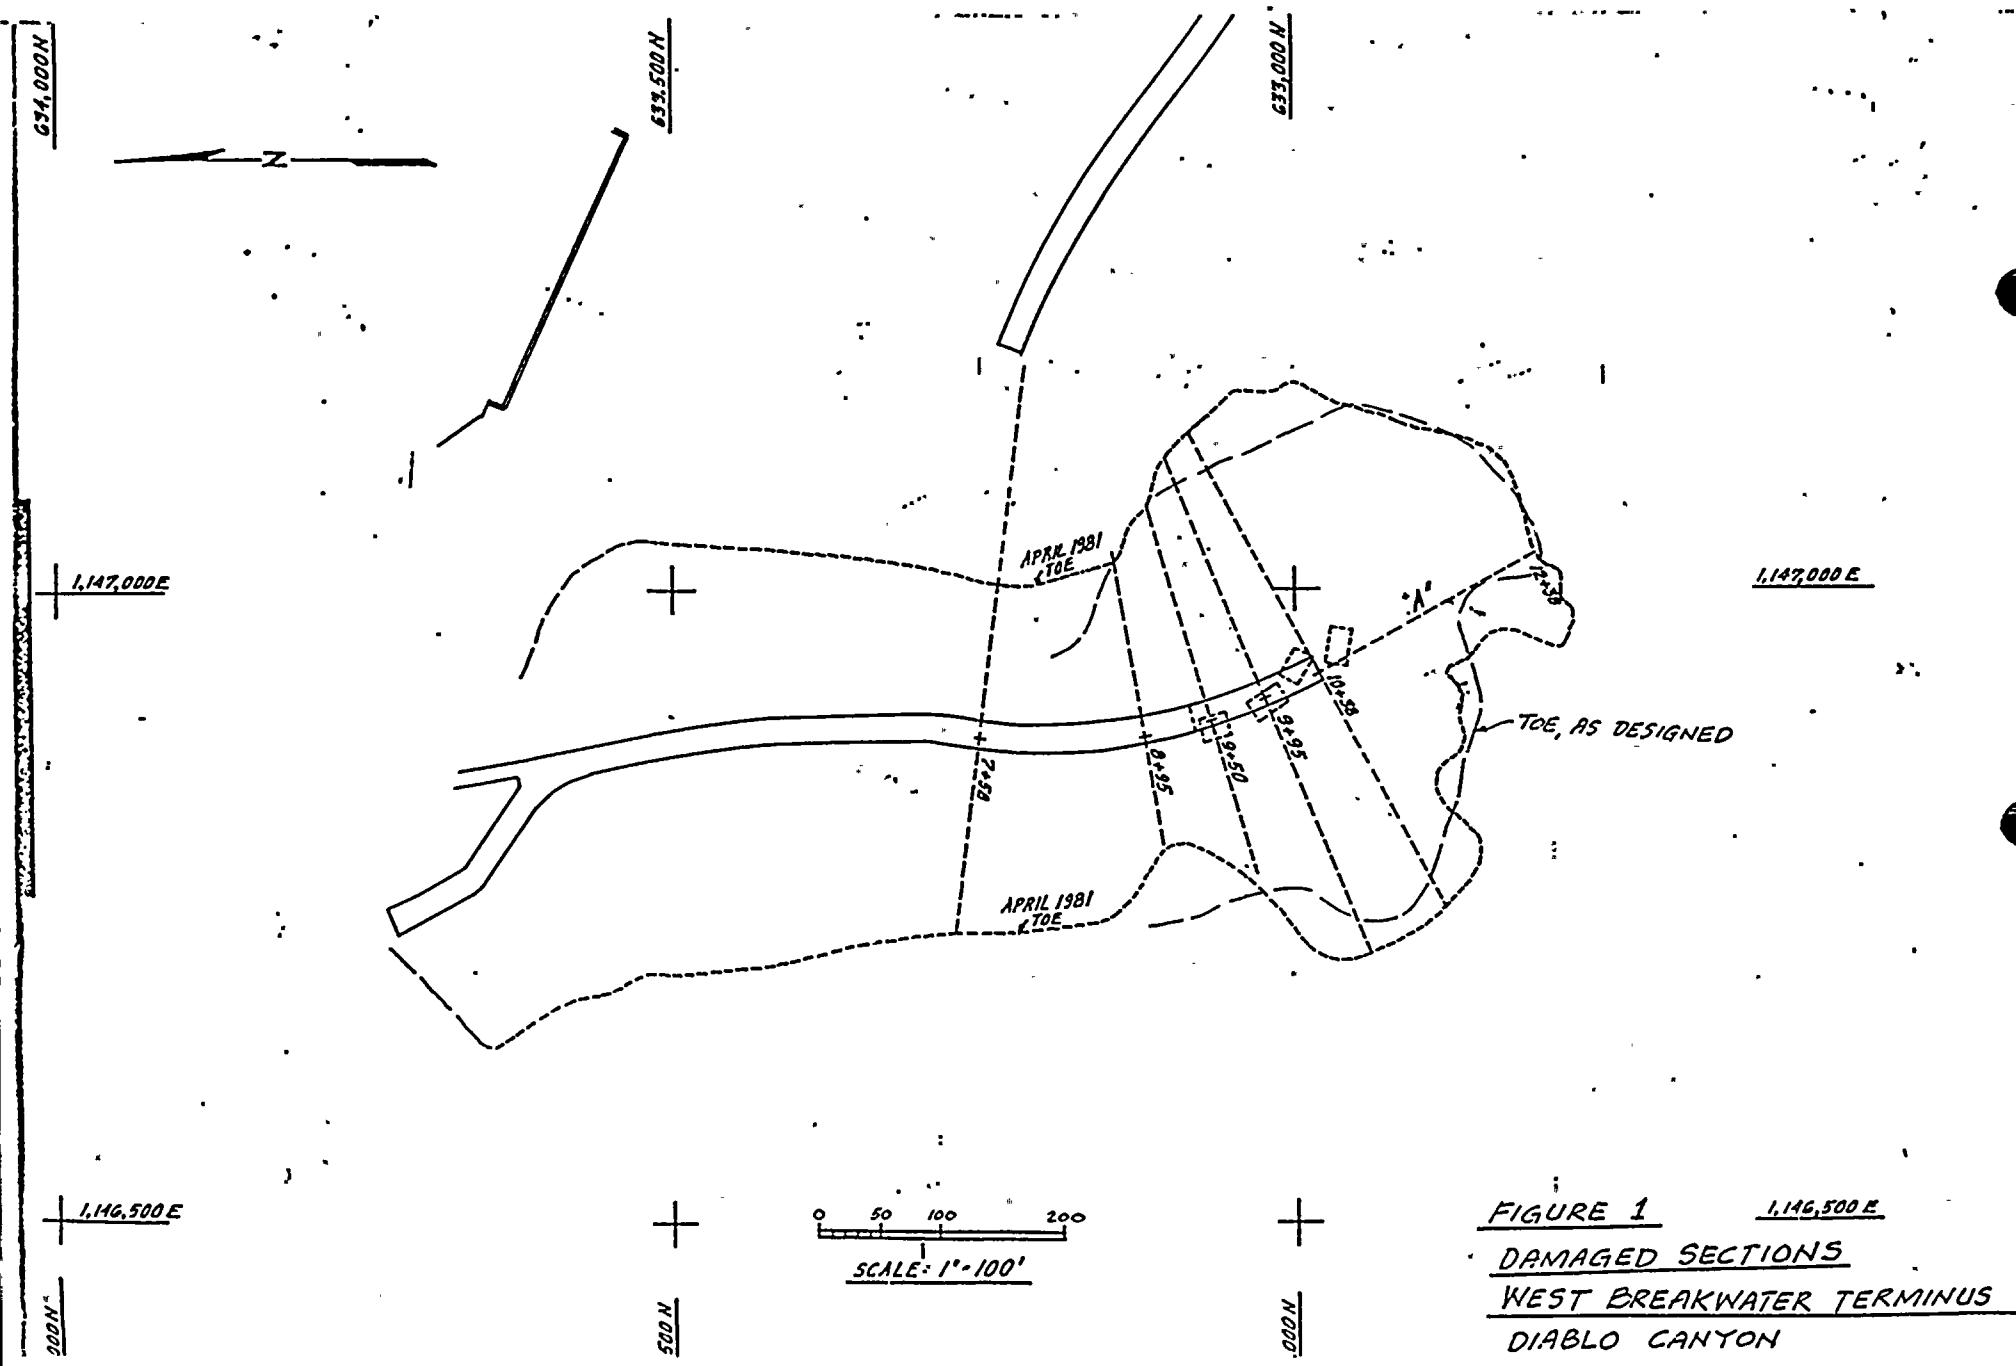
**FIGURE 1**  
1,146,500E  
DAMAGED SECTIONS  
WEST BREAKWATER TERMINUS  
DIABLO CANYON

The underwater mapping and surveying program that we discussed in our March 27, 1981 response to the request for additional information has been essentially completed. The enclosed figures present the results of this survey insofar as actual breakwater damage is concerned. Figure 1 is the plan view of the damaged portion of the west breakwater and locates the sections through the structure depicted on Figure 2. The dotted rectangles on Figure 1 represent the displaced concrete cap blocks. On Figure 2, the as-surveyed cross-sections are shown together with the as-designed configuration. In addition the most severe assumed damage condition for which the safety-related features of the intake were qualified is superimposed on this figure for comparison.

Study of Figure 1 shows that the actual damage is very limited in terms of the length of the west breakwater involved with no significant displacement noted at the toe of the slope in the damaged segment. In our survey we found no other damage to the west breakwater nor did we find any damage to the east breakwater. Figure 2 demonstrates that this limited damage, although unlike that assumed in the original analysis, is nevertheless bounded by the original assumptions.
