DIABLO CANYON SITE

UNIT NO. 2

REPORT OF CONTAINMENT STRUCTURE

STRUCTURAL INTEGRITY TEST

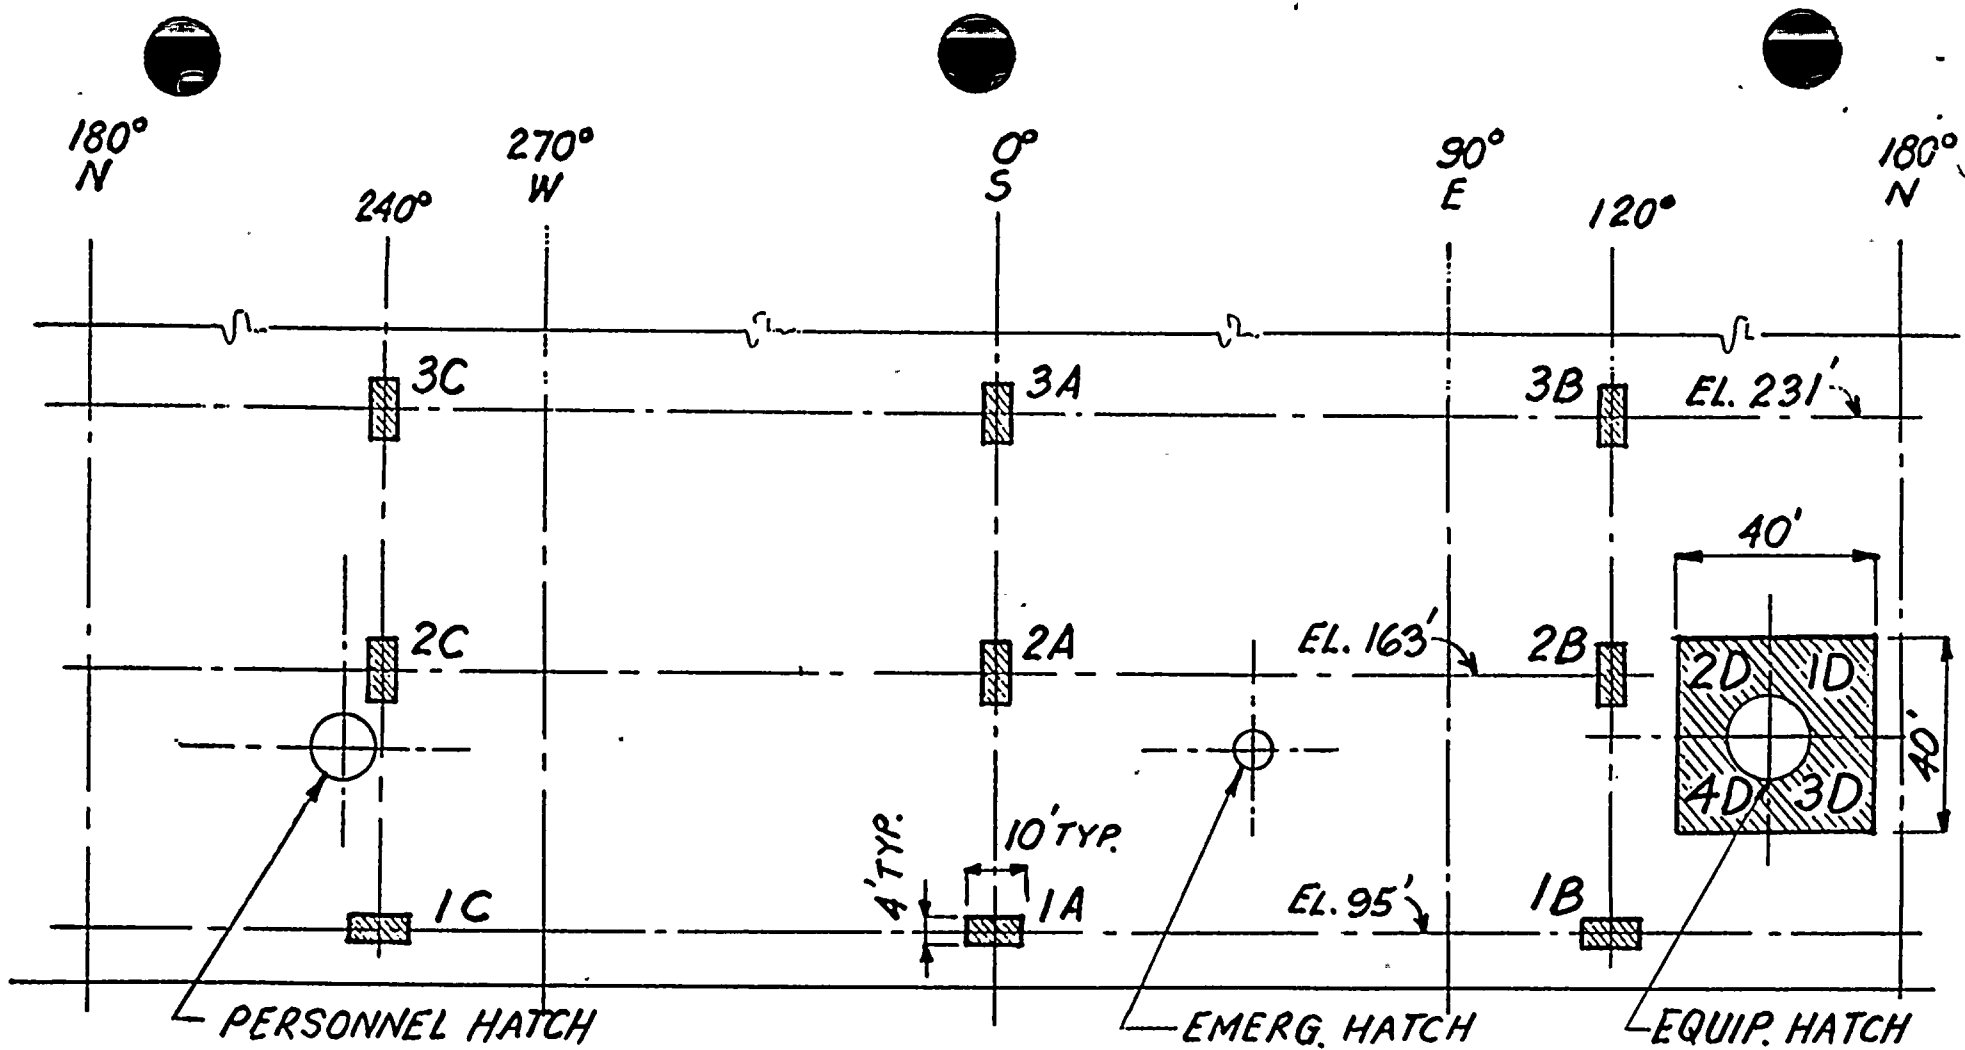
FIGURE 7

Cracking monitored at the designated whitewash areas (Figure 7) was reasonably close to the predicted response.

Table I gives a summary of cracks mapped which exceeded 10 mils during the test. Three whitewash areas - 1A, 1B, 1C - located at elevation 95' show no cracks in excess of 10 mils. The other six areas at elevations 163' and 231' showed a maximum of 11 cracks in excess of 10 mils in any one area, the largest being 40 mils.

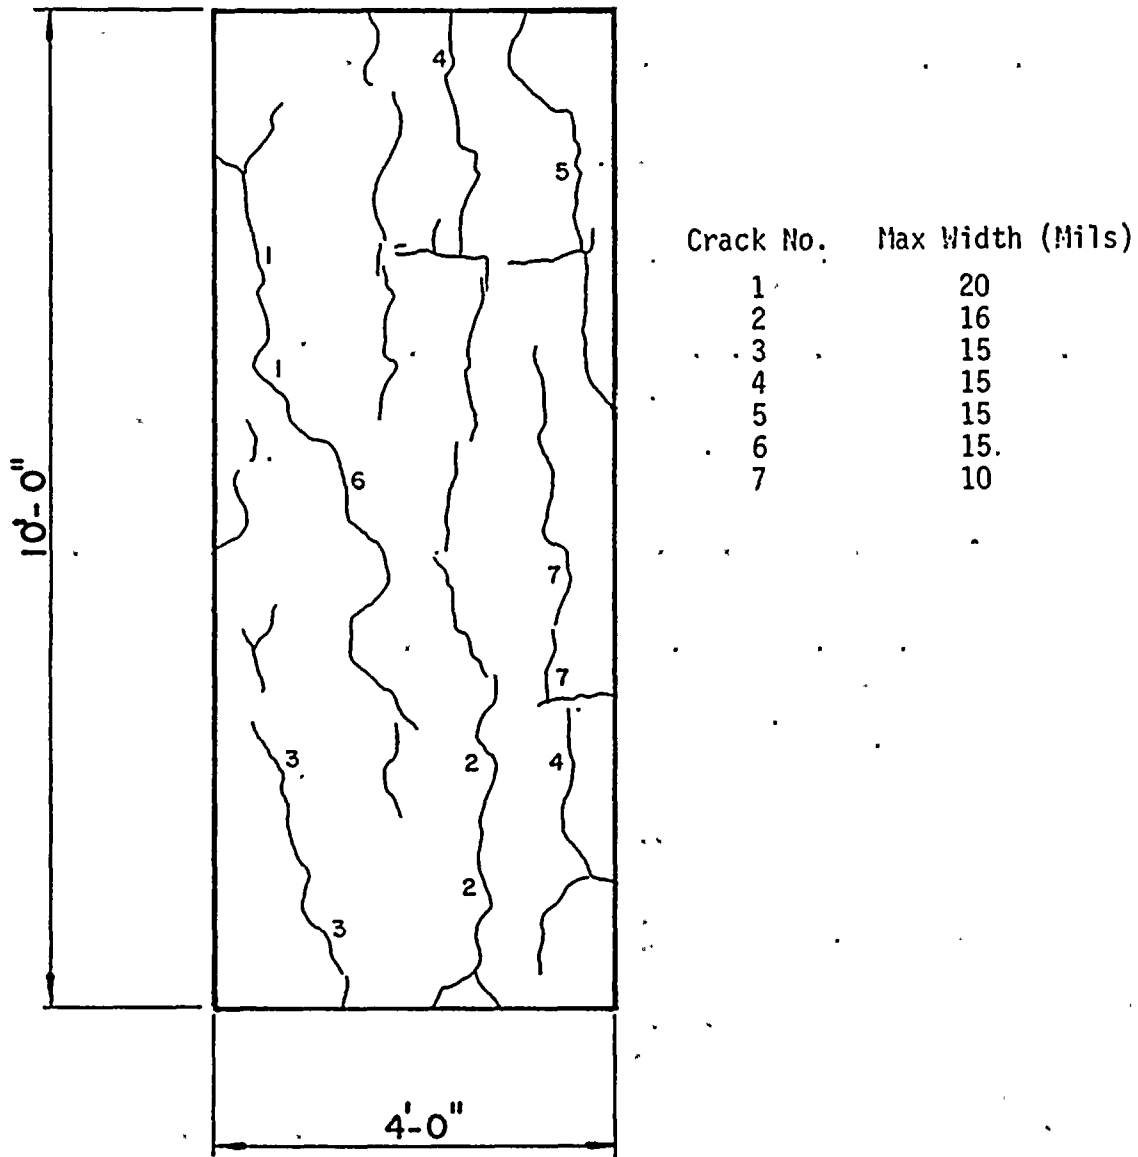
CRACK OBSERVATION AREA NO. 2A

FIGURE 12.1 - Crack Pattern at 54 PSIG

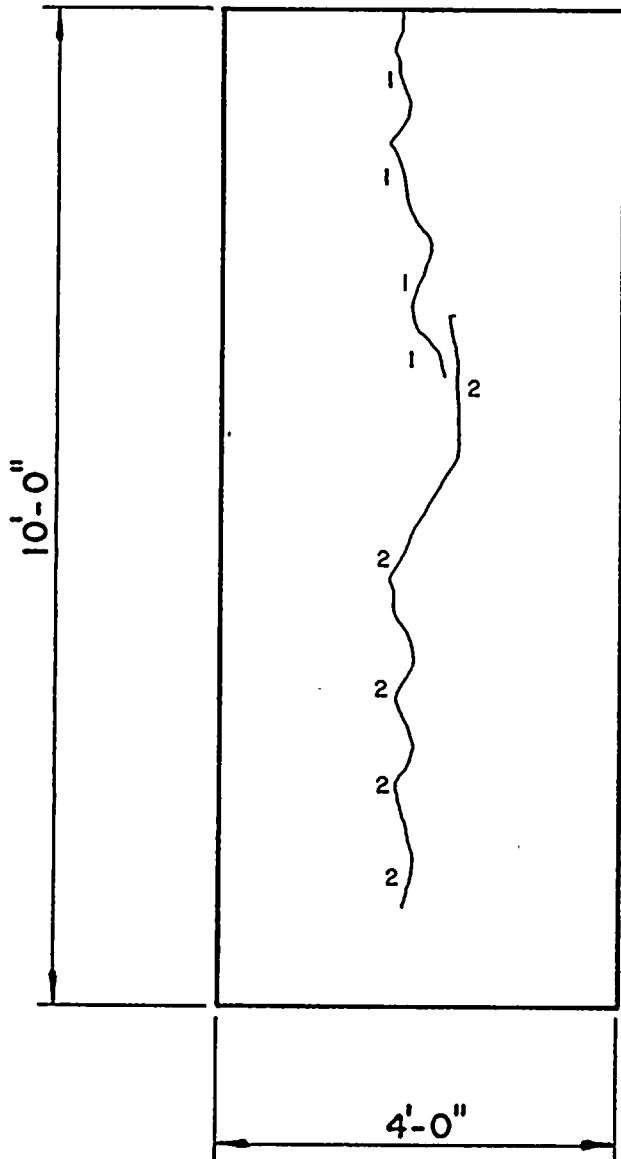
CRACK OBSERVATION AREA NO. 2B

Crack No.	Max Width (Mils)
1	18
2	25

FIGURE 12.2 - Crack Pattern at 54 PSIG

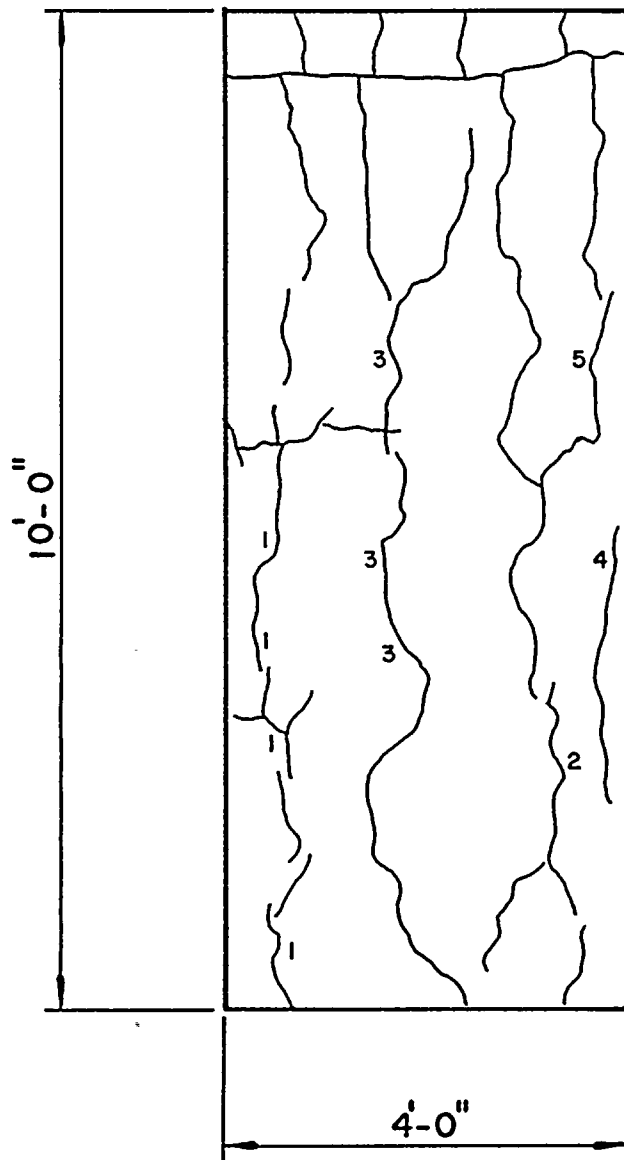
CRACK OBSERVATION AREA NO. 2C

Crack No.	Max Width (Mils)
1	10
2	10
3	15
4	10
5	10

FIGURE 12.3 - Crack Pattern at 54 PSIG

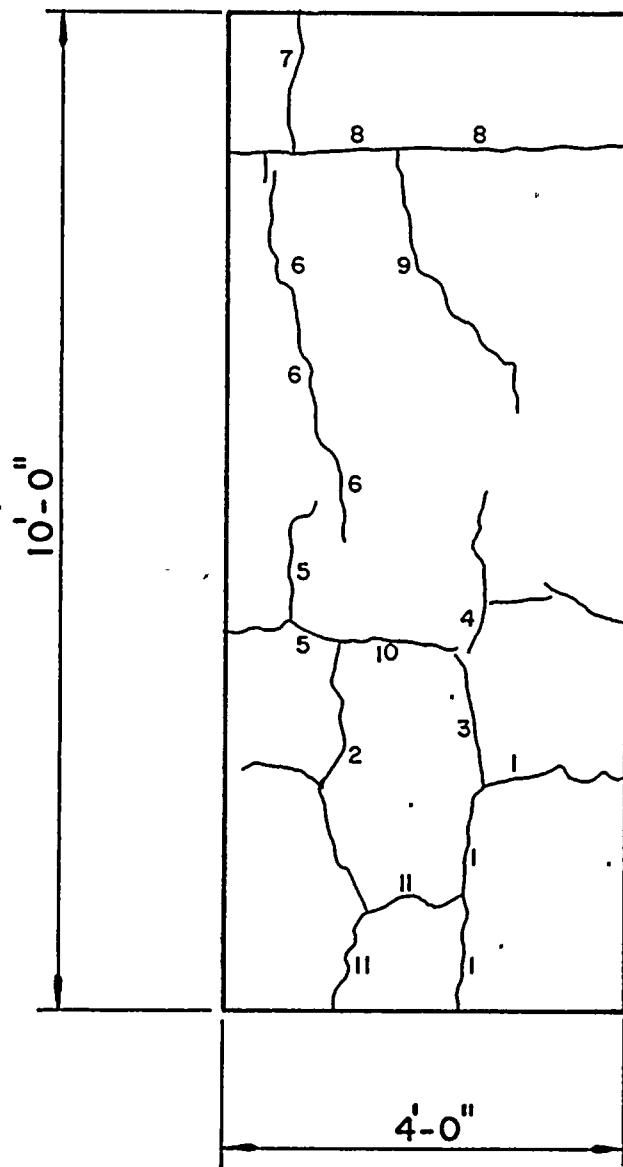
CRACK OBSERVATION AREA NO. 3A

Crack No.	Max Width (Mils)
1	20
2	15
3	20
4	15
5	20
6	20
7	20
8	30
9	15
10	13
11	15

FIGURE 12.4 - Crack Pattern at 54 PSIG

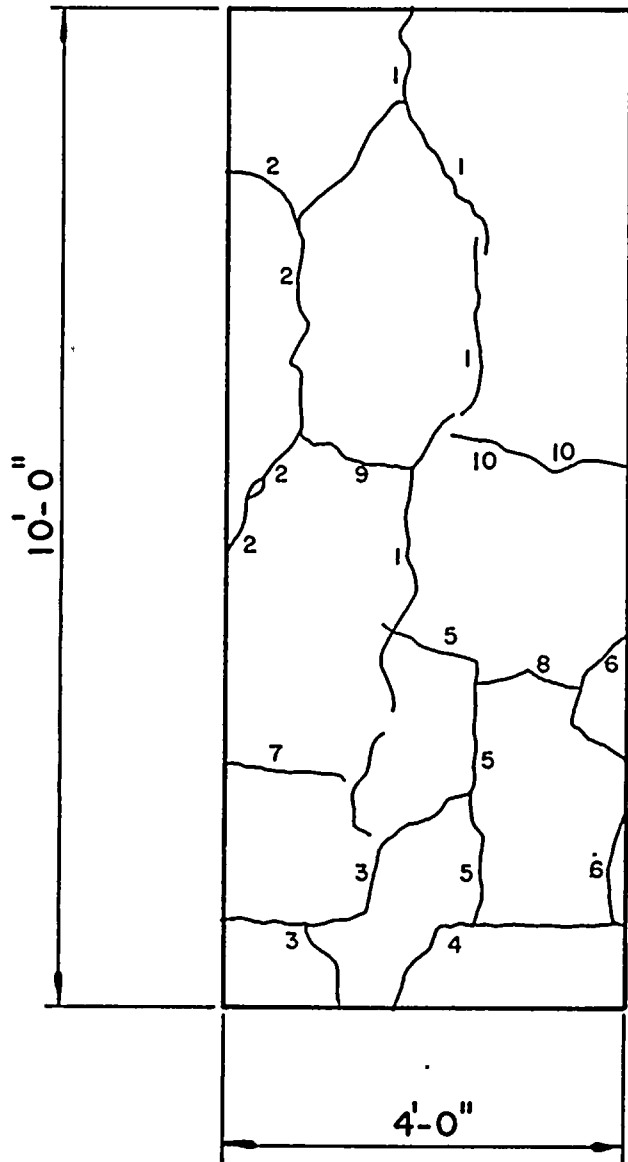
CRACK OBSERVATION AREA NO. 3B

Crack No.	Max Width (Mils)
1	25
2	19
3	13
4	15
5	15
6	16
7	15
8	16
9	18
10	20

FIGURE 12.5 - Crack Pattern at 54 PSIG

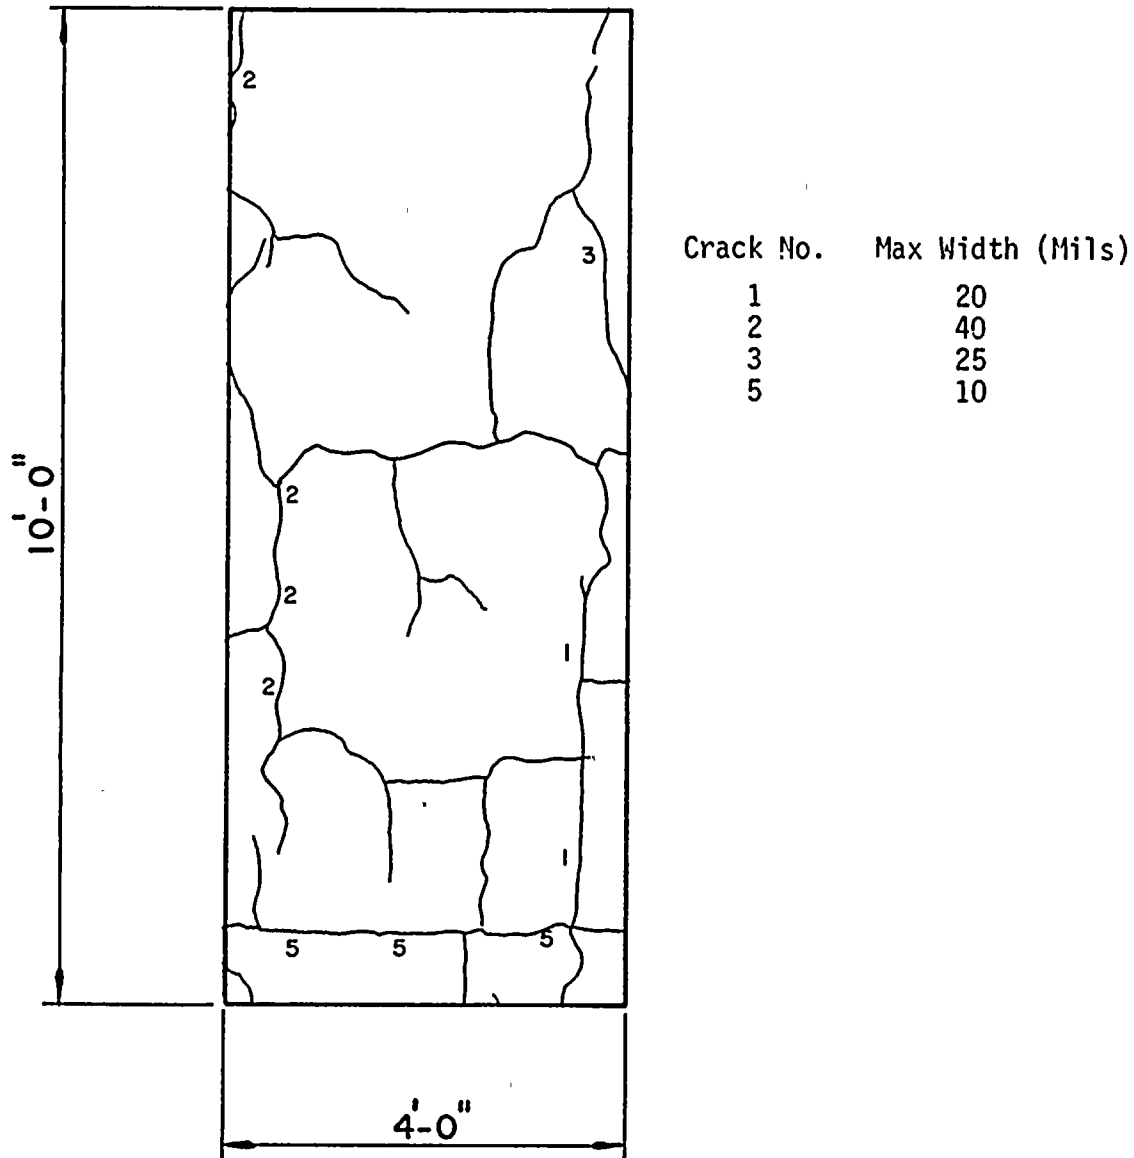
CRACK OBSERVATION AREA NO. 3C

FIGURE 12.6 - Crack Pattern at 54 PSIG

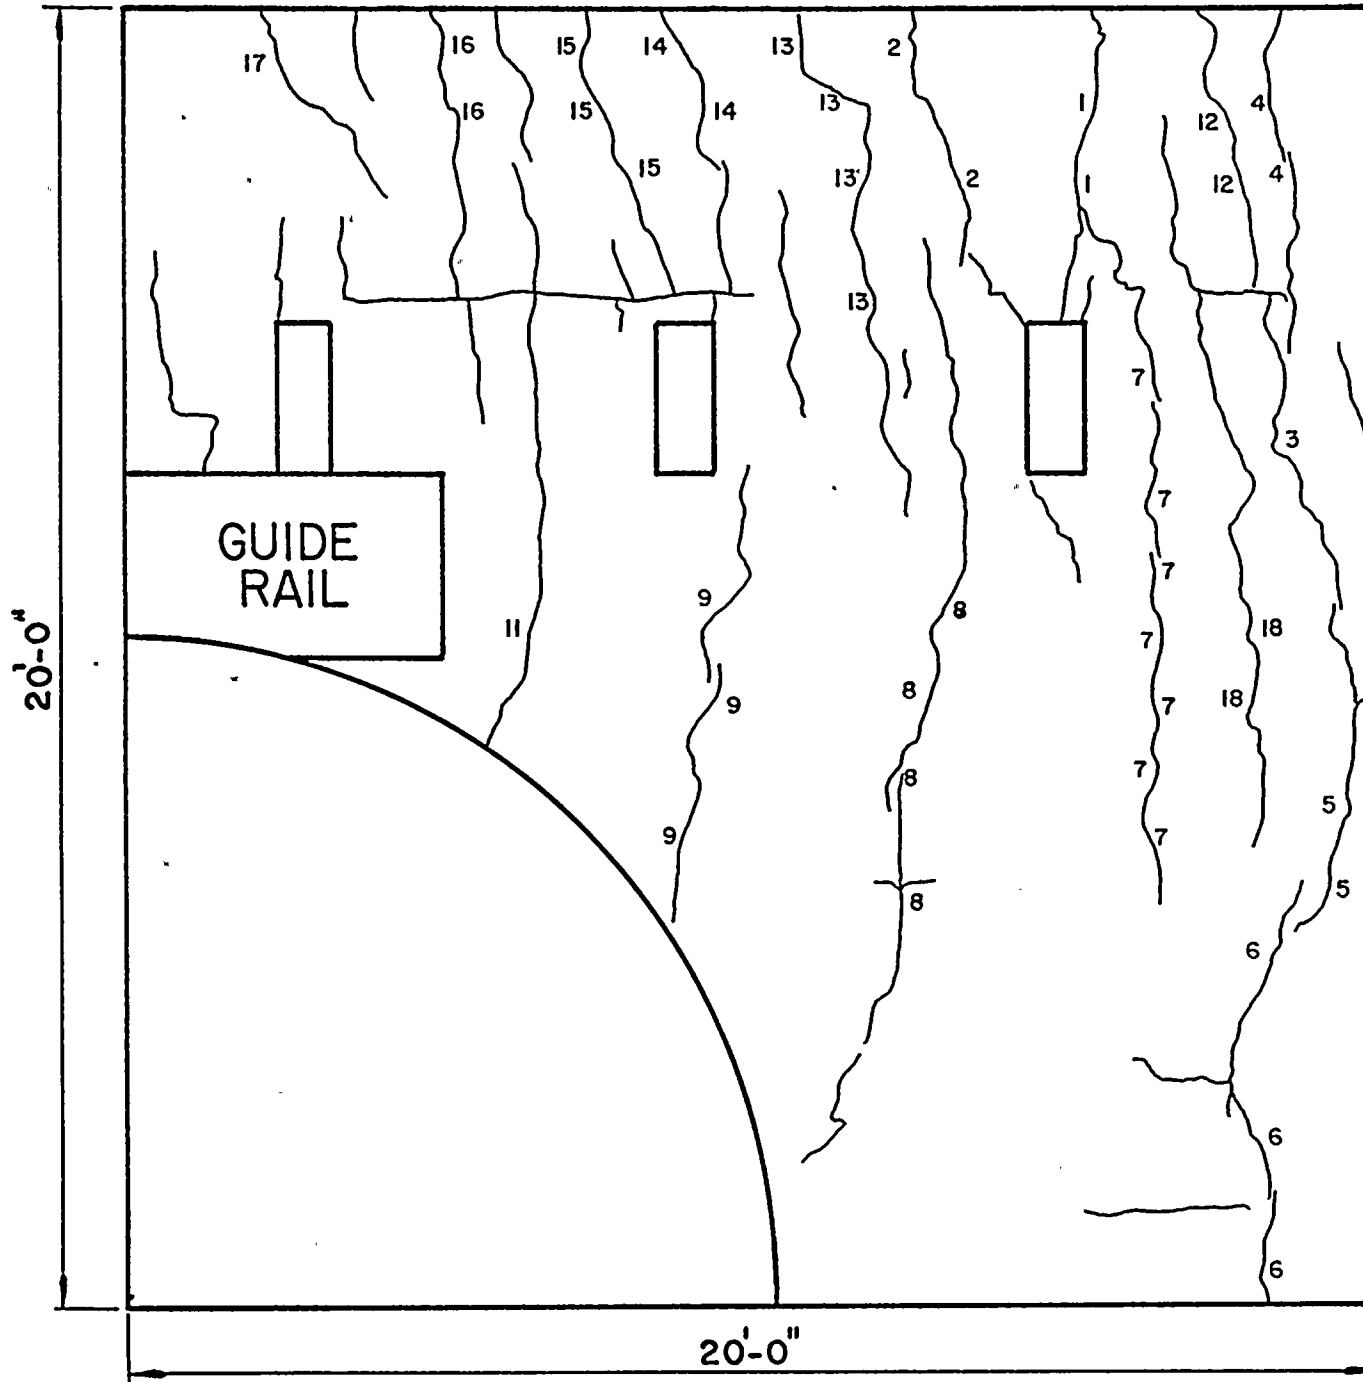
CRACK OBSERVATION AREA NO. I-D

Areas 1D, 2D, 3D, and 4D around the equipment hatch, each about 320 ft.², showed a maximum of 17 cracks over 10 mils with the largest being 40 mils.

Crack No.	Max Width
1	30
2	25
3	20
4	15
5	40
6	30
7	20
8	20
9	20
11	20
12	20
13	15
14	15
16	13
17	13
18	15

FIGURE 12.7 - Crack Pattern at 54 PSIG

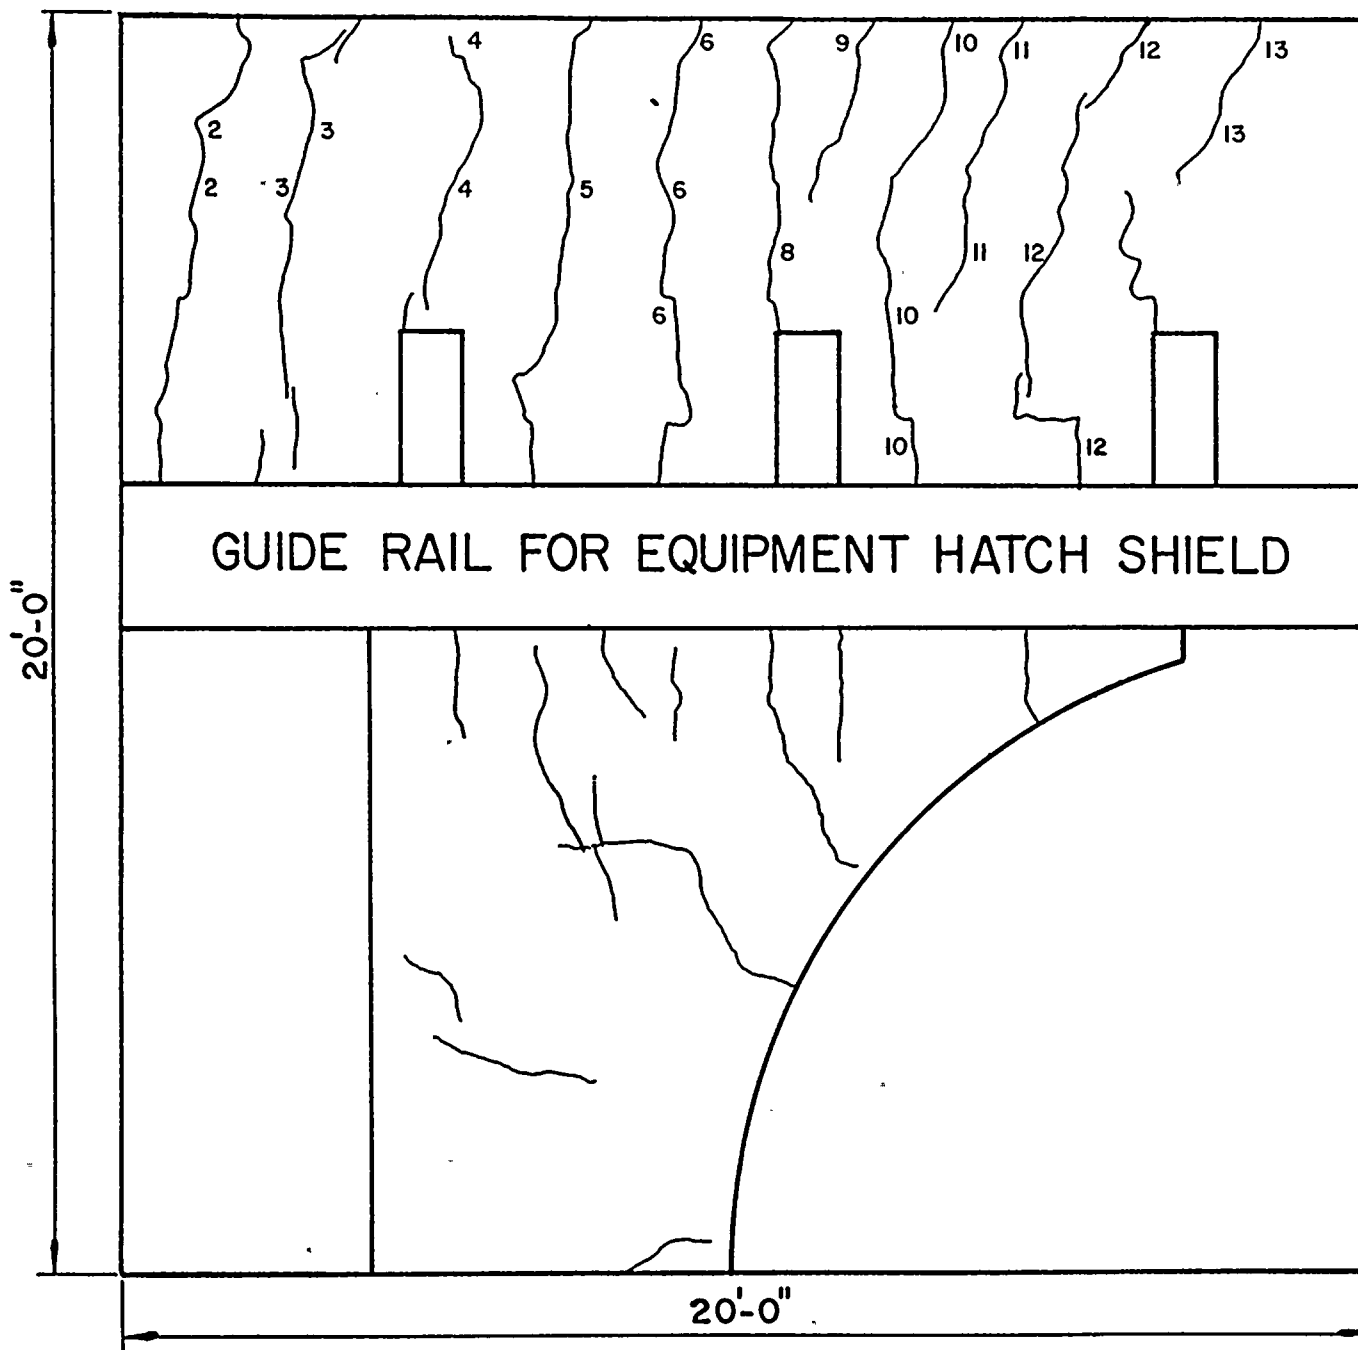
CRACK OBSERVATION AREA NO. 2-D

Crack No.	Max Width (Mils)
1	17
2	25
3	23
4	27
5	22
6	20
8	15
9	12
10	15
11	15
12	30
13	15

Figure 12.8 - Crack Pattern at 54 PSIG

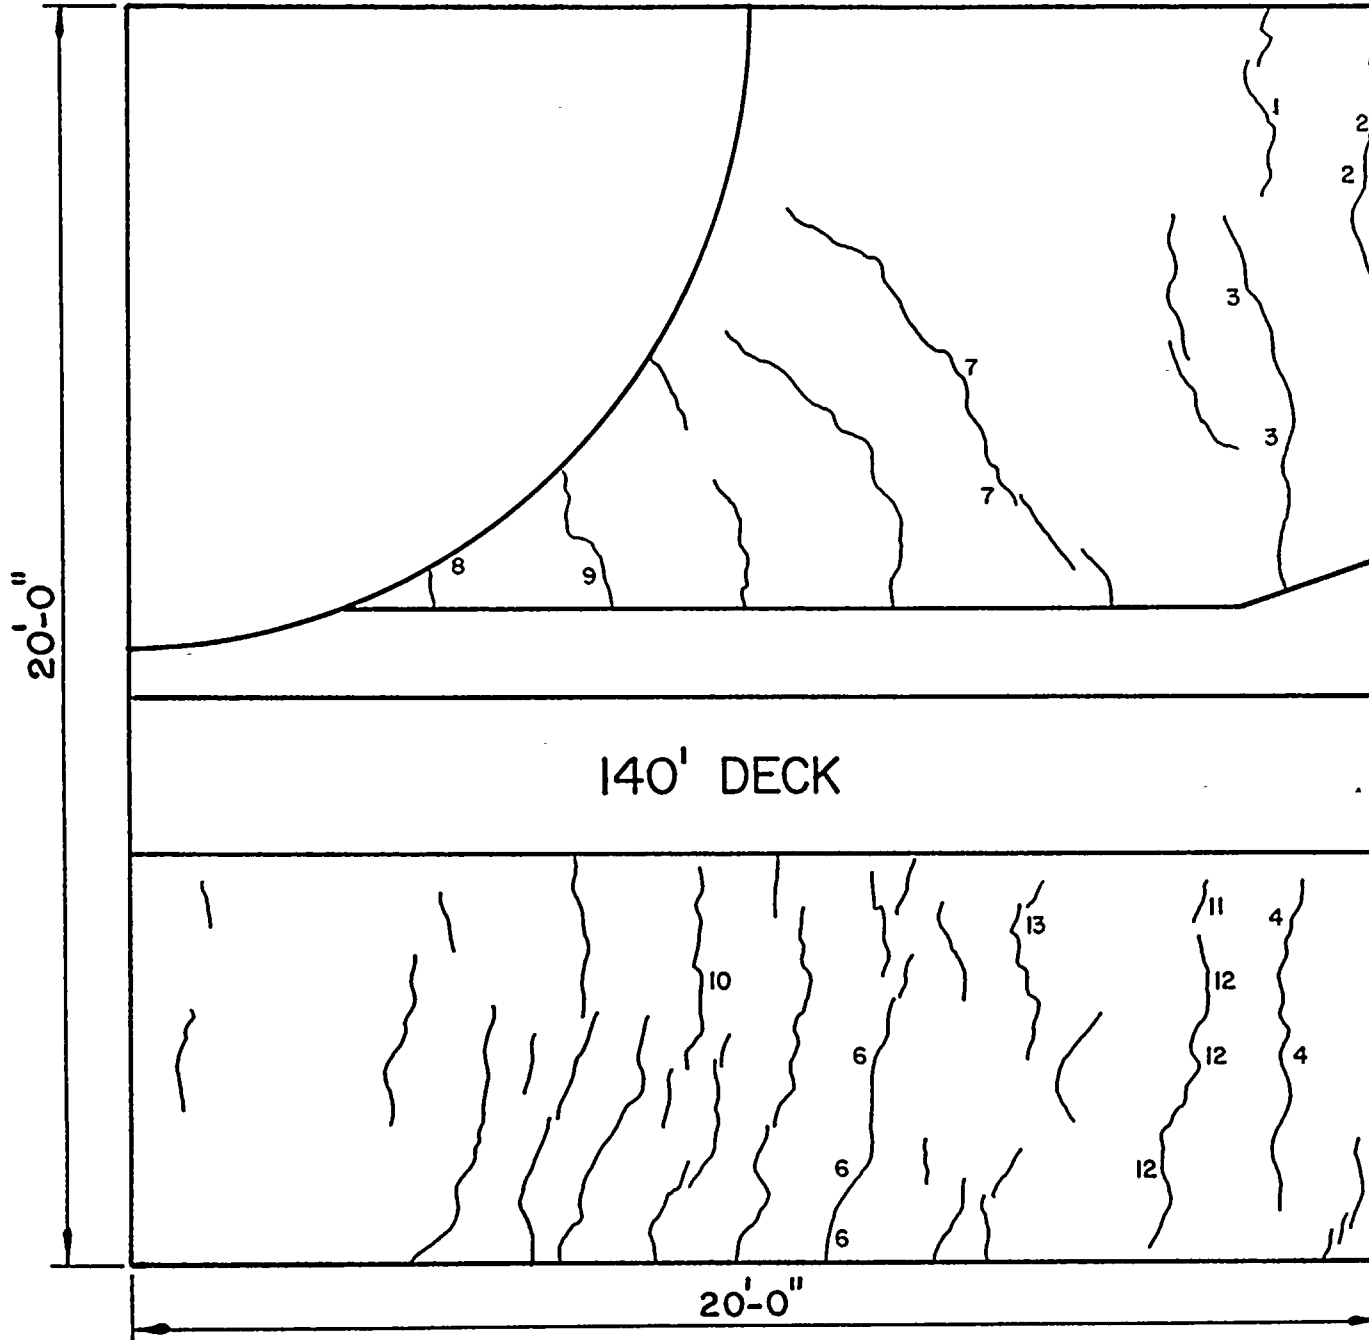
CRACK OBSERVATION AREA NO. 3-D

Crack No.	Max Width (Mils)
1	15
2	30
3	30
4	20
6	15
7	15
8	25
9	10
10	10
11	10
12	10
13	15

FIGURE 12.9 - Crack Pattern at 54 PSIG

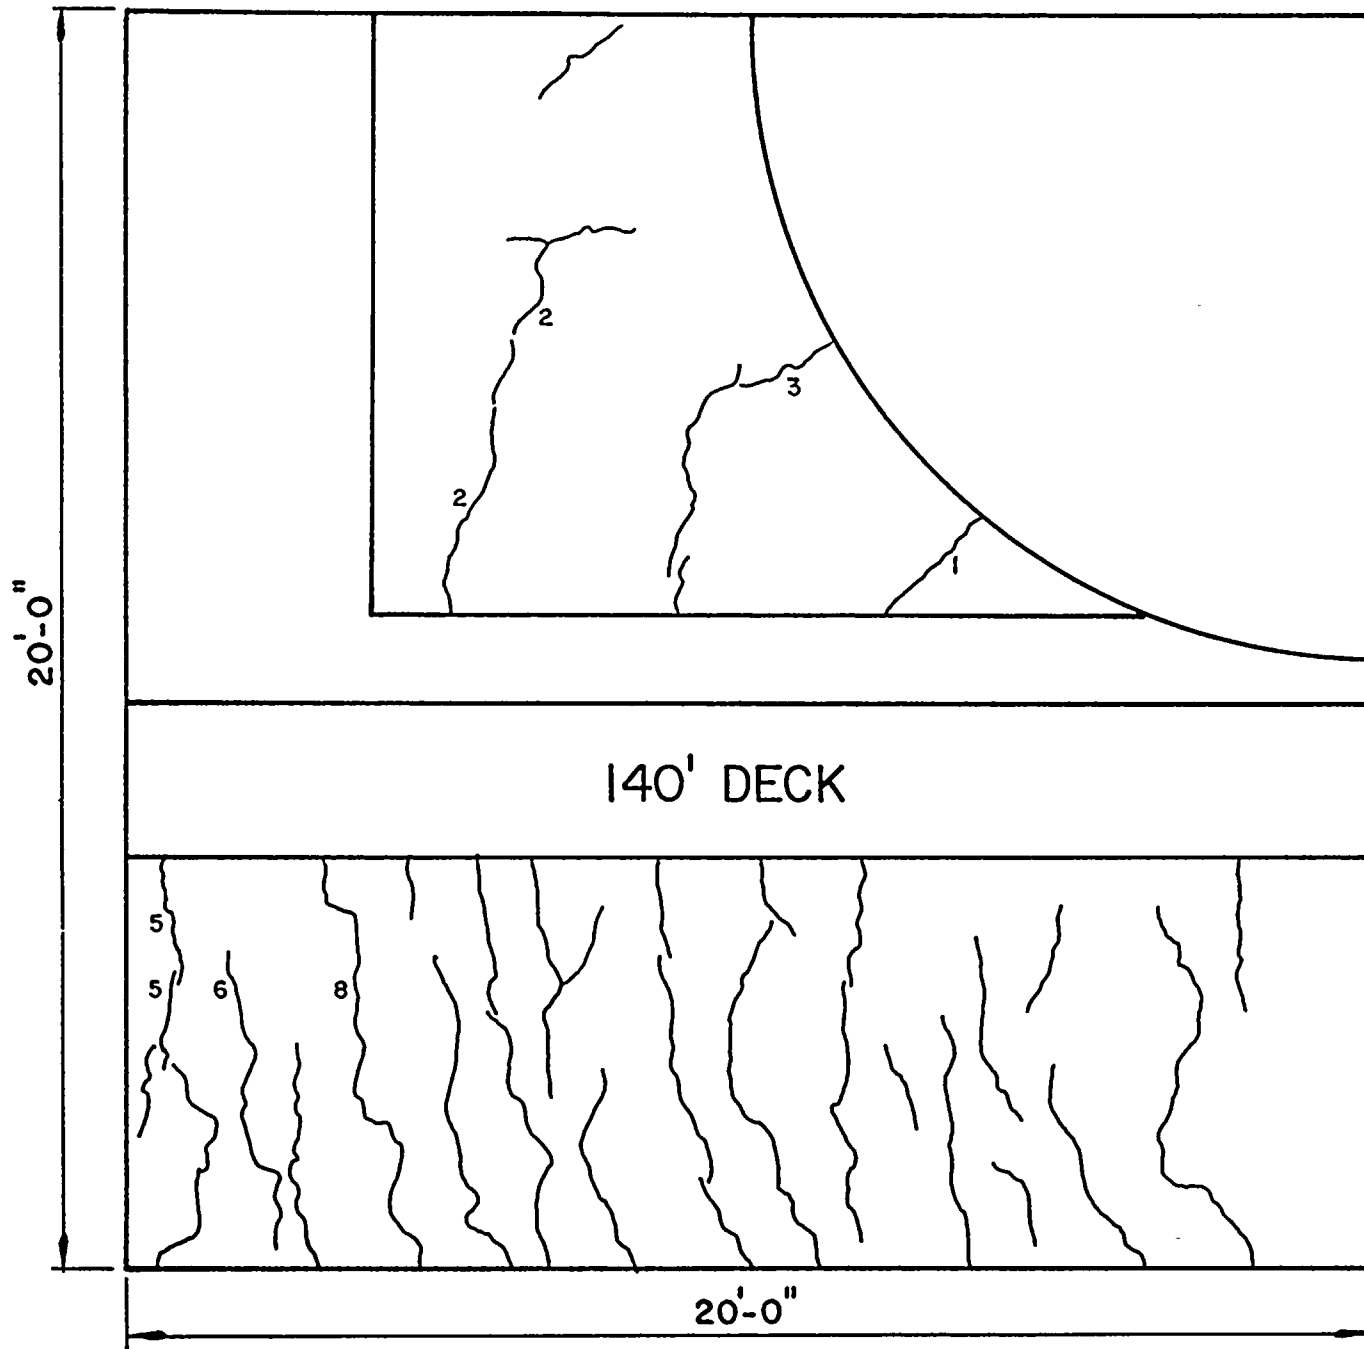
CRACK OBSERVATION AREA NO. 4-D

Crack No.	Max Width (Mils)
1	25
2	10
3	15
5	10
5	10
7	10
8	15
9	10

FIGURE 12.10 - Crack Pattern at 54 PSIG
