REGULATORY INFORMATION DISTRIBUTION SYSTEM (RIDS)

SUBJECT: Responds to NRC 900313 NOV & proposed imposition of civil penalty in amount of \$50,000 re IRS 50-275,323/89-31.

PG&E Letter No. DCL-90-070

RESPONSE TO NOTICE OF VIOLATION - ENFORCEMENT ACTION 89-241 REGARDING
NRC INSPECTION REPORT NOS. 50-275/89-31 AND 50-323/89-31

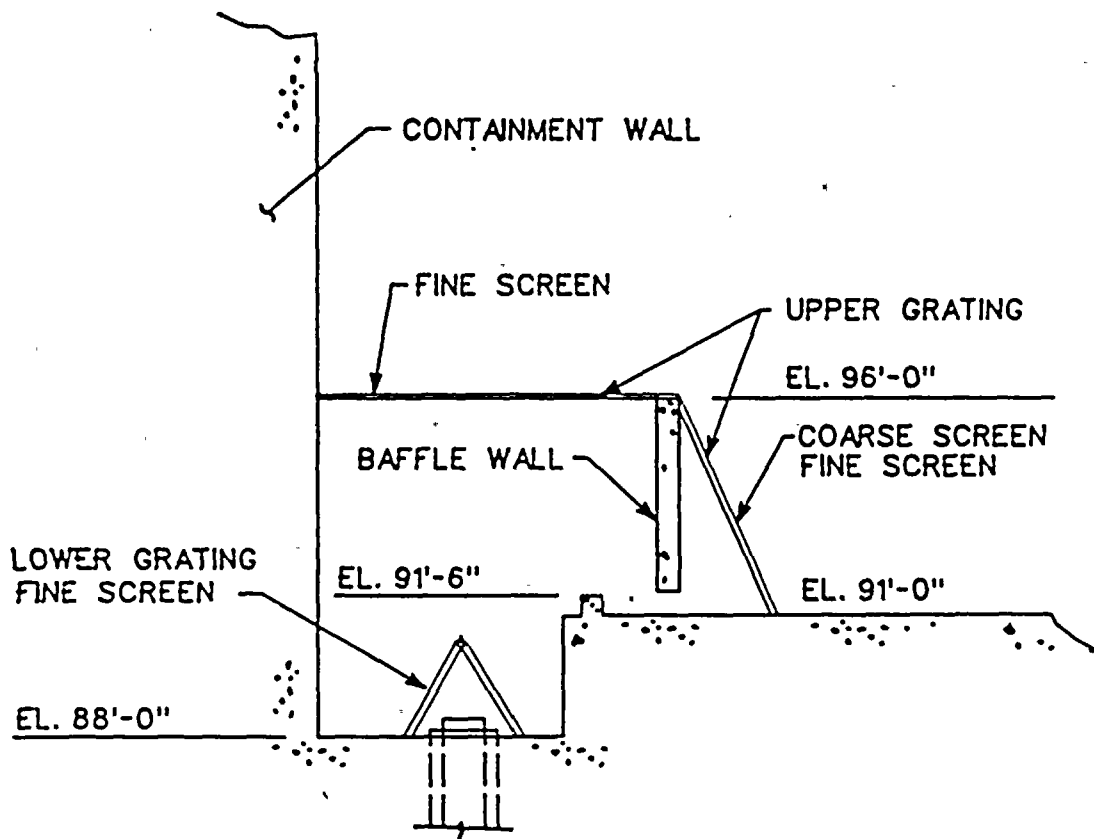
FIGURE 1

During the Unit 1 third refueling outage (which commenced October 6, 1989), a walkdown verification of the containment recirculation sump (sump) identified a 1-inch vertical gap in the upper grating assembly between the screen sections and other gaps around a concrete column pedestal in the inclined section of the upper grating assembly (see Figures 1, 2, and 3). PG&E acknowledges that the gaps in the sump screen assembly identified in 1985 and again in 1989 were not in accordance with the intended design configuration of

1. The critical construction parameter related to the maximum gap anywhere on the surface of the sump screens was not clearly defined by Engineering until December 15, 1986, when Revision 8 of sump Drawing 443259 was issued. The drawing revision was issued at that time to reflect the Unit 2 design changes that were made in 1985 to eliminate the gaps greater than 3/16-inch in the sump screen assembly. The apparent failure to specify adequate construction acceptance criteria for the sump screen gaps led to the Unit 1 as-built screen configuration described in the violation, i.e., screen gaps in excess of the dimensions described in the FSAR Update.

2. The 1985 problem report for Unit 1, which was based on a similar problem with the Unit 2 sump screens, identified potential deficiencies (gaps greater than 3/16-inch) in the unscreened portions only of the upper grating assembly. Two gaps were found and corrected in addressing the problem report. However, the inspection was not expanded to look for gaps in the screened portions of the upper grating assembly since the problem report did not identify that the screened portions might also be deficient.

1. Design Change Notice (DCN) DC1-EC-43762 was issued to repair the deficiencies of the Unit 1 sump, including the gaps in the upper grating assembly screen. The DCN identified the repairs necessary to assure that the sump is configured to meet design and functional requirements. This DCN has been closed out. A similar DCN was issued for as-building and repair of Unit 2 sump deficiencies, if any, during the current Unit 2 third refueling outage. The FSAR Update will be revised to reflect the Unit 1 and 2 as-built sump configurations.
