Pacific Gas and Electric Company

Re: Docket No. 50-275, OL-DPR-80  
Diablo Canyon Unit 1  
Licensee Event Report 1-90-018  
Fire Damper Cardox Actuation Fusible Link Assembly Incorrectly  
Installed For Indeterminate Reason

# LICENSEE EVENT REPORT (LER)

TITLE (4) **FIRE DAMPER CARDOX ACTUATION FUSIBLE LINK ASSEMBLY INCORRECTLY INSTALLED FOR INDETERMINATE REASON**

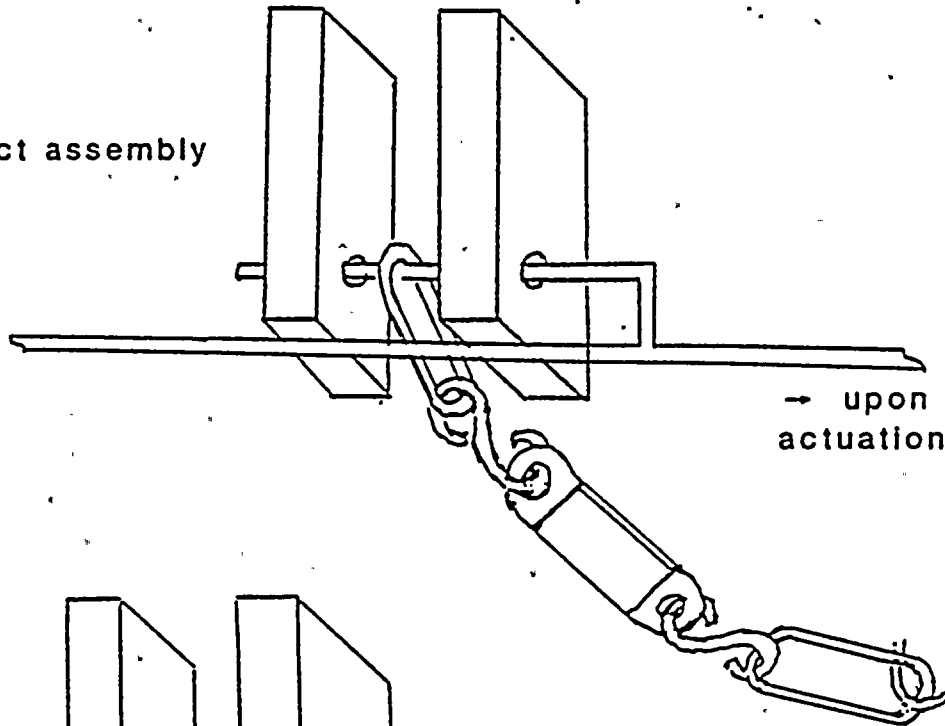
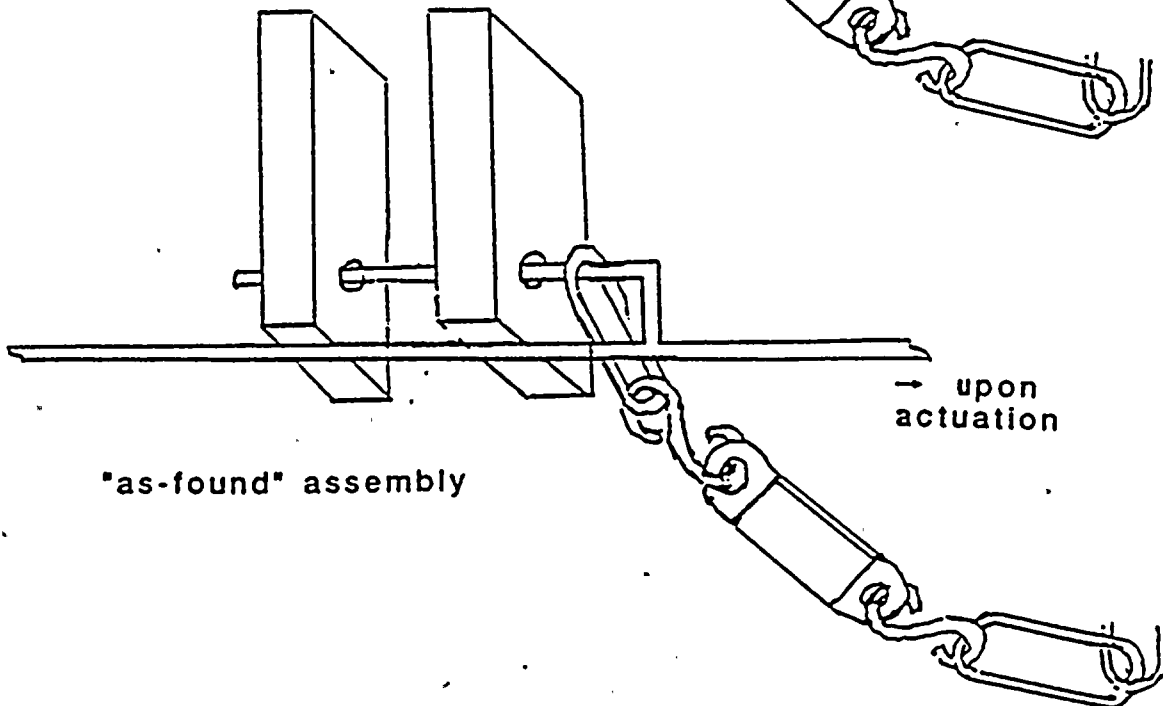
## Attachment 1

The cardox actuation rod and fusible link assembly for VAC-1-FD-220 were incorrectly installed, causing VAC-1-FD-220 to fail to close on CO<sub>2</sub> header pressurization.

correct assembly

Damper VAC-1-FD-220 was reassembled to the correct configuration and successfully tested by reperforming STP M-39B on December 12, 1990.

1. STP M-39B will be enhanced to include a drawing of the fusible link attachment between the cardox system and the ventilation dampers.
2. A qualified and experienced fire protection engineer has been hired as the test director for fire protection systems.
3. STP M-70 will be revised to include a caution statement and to provide verification of the fire damper as-left condition.
