U. S. NUCLEAR REGULATORY COMMISSION

Report Nos.: 50-275/91-17 and 50-323/91-17

Facility Name: Diablo Canyon Units 1 and 2

A meeting was held in the Region V Office, Walnut Creek, California to discuss the licensee's efforts in resolving failures of main condenser steam dump valves and to discuss the findings of the licensee's Event Investigation Team regarding a total loss of Unit 1 off-site power which occurred on March 7, 1991.

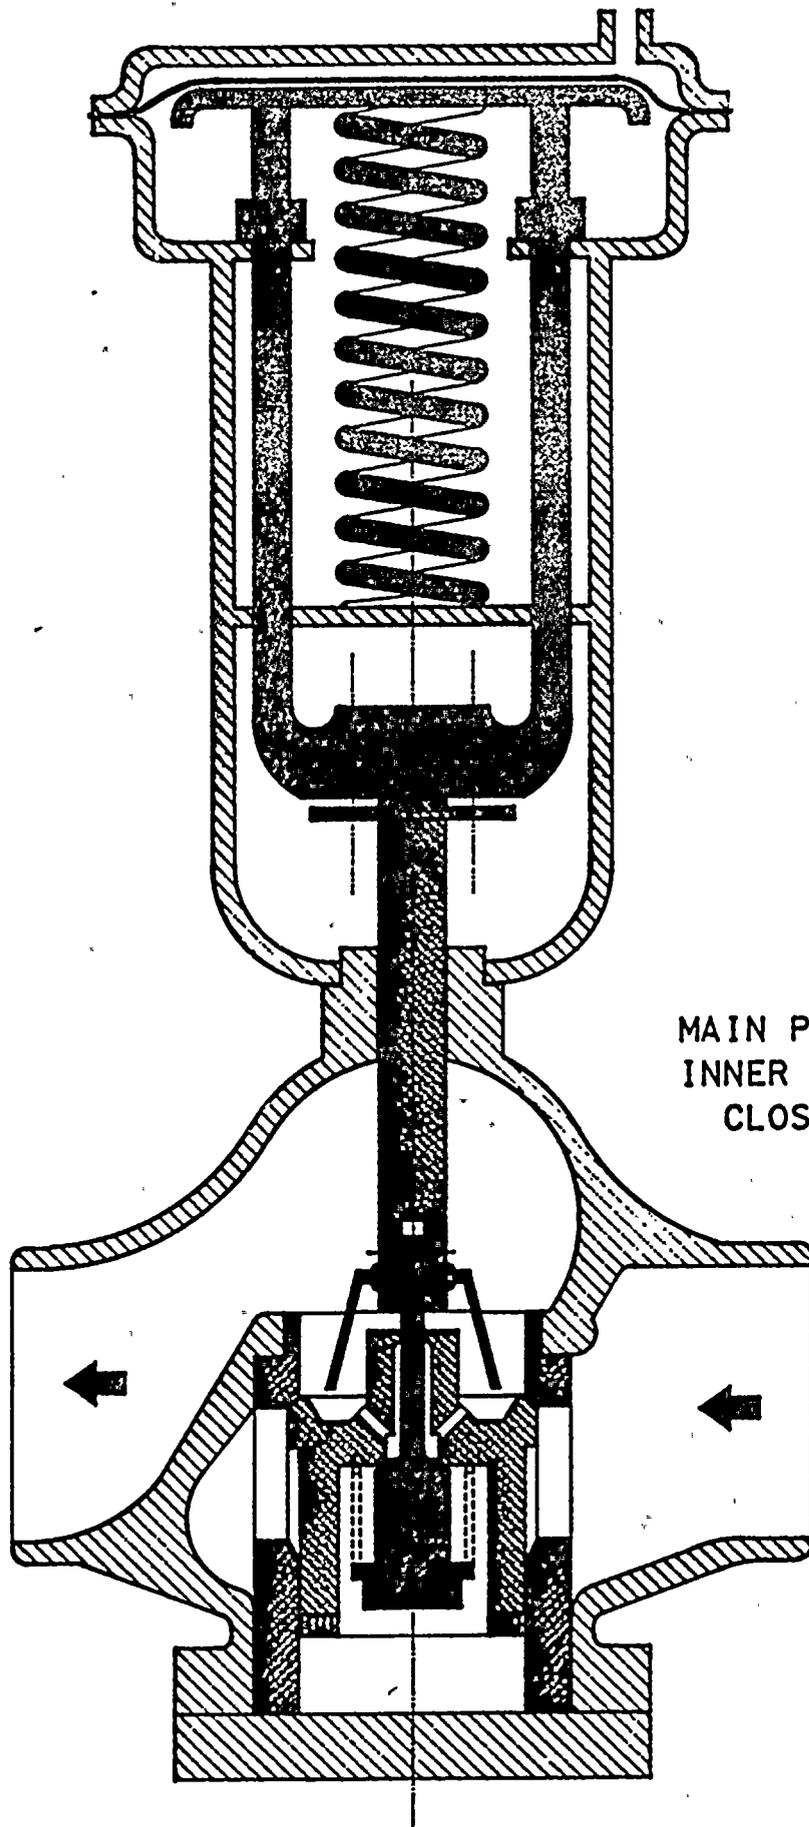
MAIN PLUG/
INNER PLUG
CLOSED

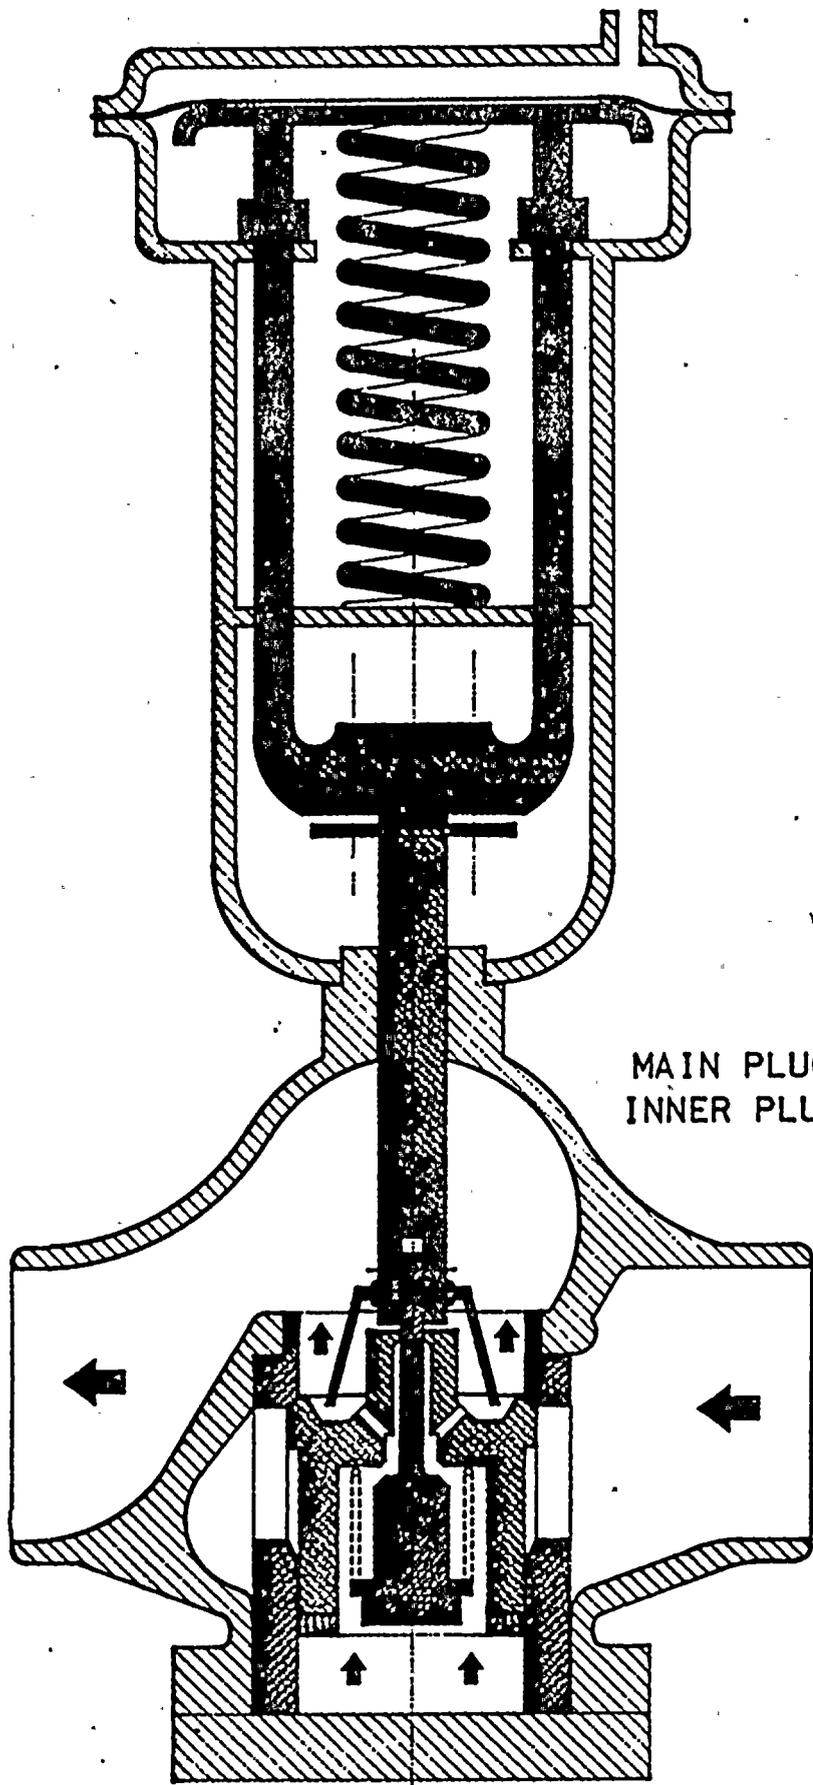
MAIN PLUG CLOSED
INNER PLUG OPENED

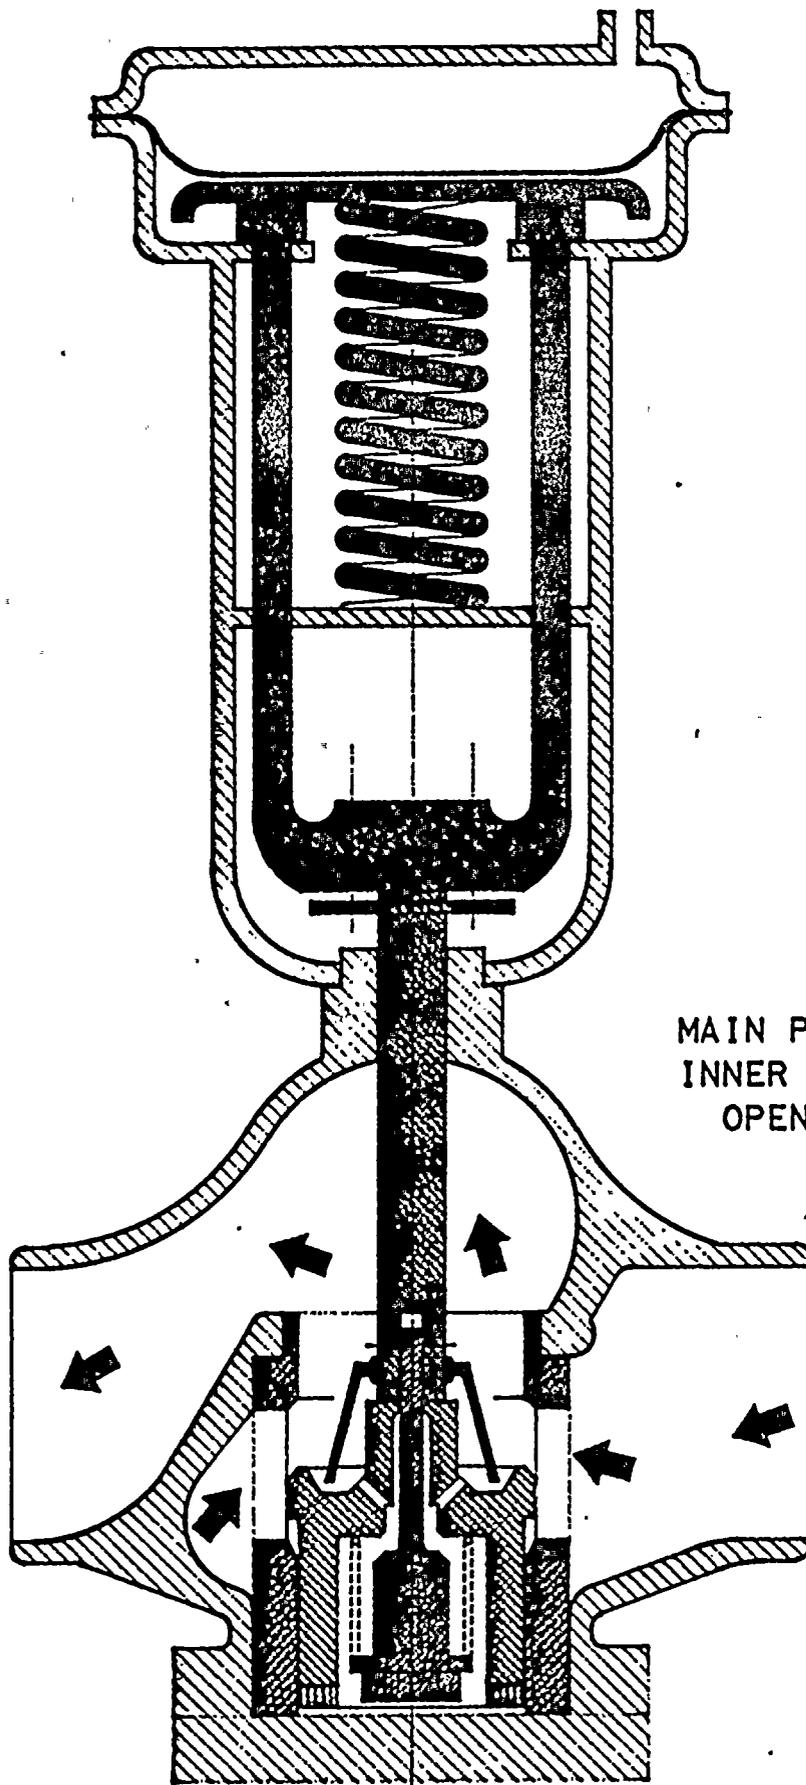
MAIN PLUG/
INNER PLUG
OPENED

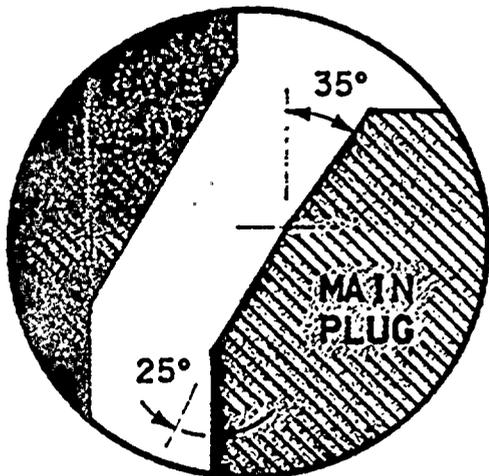
1975 TO 1991

Mr. Anderson then provided a history of steam dump valves at Diablo Canyon. Until 1988 and 1989, the main plug and cage had been lapped to provide a broad seating surface. In March 1990 the licensee had implemented a procedure change to not lap the seating surfaces unless needed. The procedure change was a result of a vendor recommendation to reduce possible leakage past the main plug. In April 1990, a weld on a valve stem broke, and PG&E decided to replace the internals of all

condenser steam dump valves. The seating surfaces of the replaced internals were not lapped, in accordance with the new procedure. Six steam dump valves had failed since December 1990. Mr. Anderson stated that by not lapping the seating surfaces of the main plug and cage, a single line of contact results when the valve is closed. Due to the material type, the closing forces on the main plug and cage, and the single line of contact, microwelding was considered to occur. Past efforts to lap the seating surfaces would have resulted in a larger area of contact and not have led to microwelding.

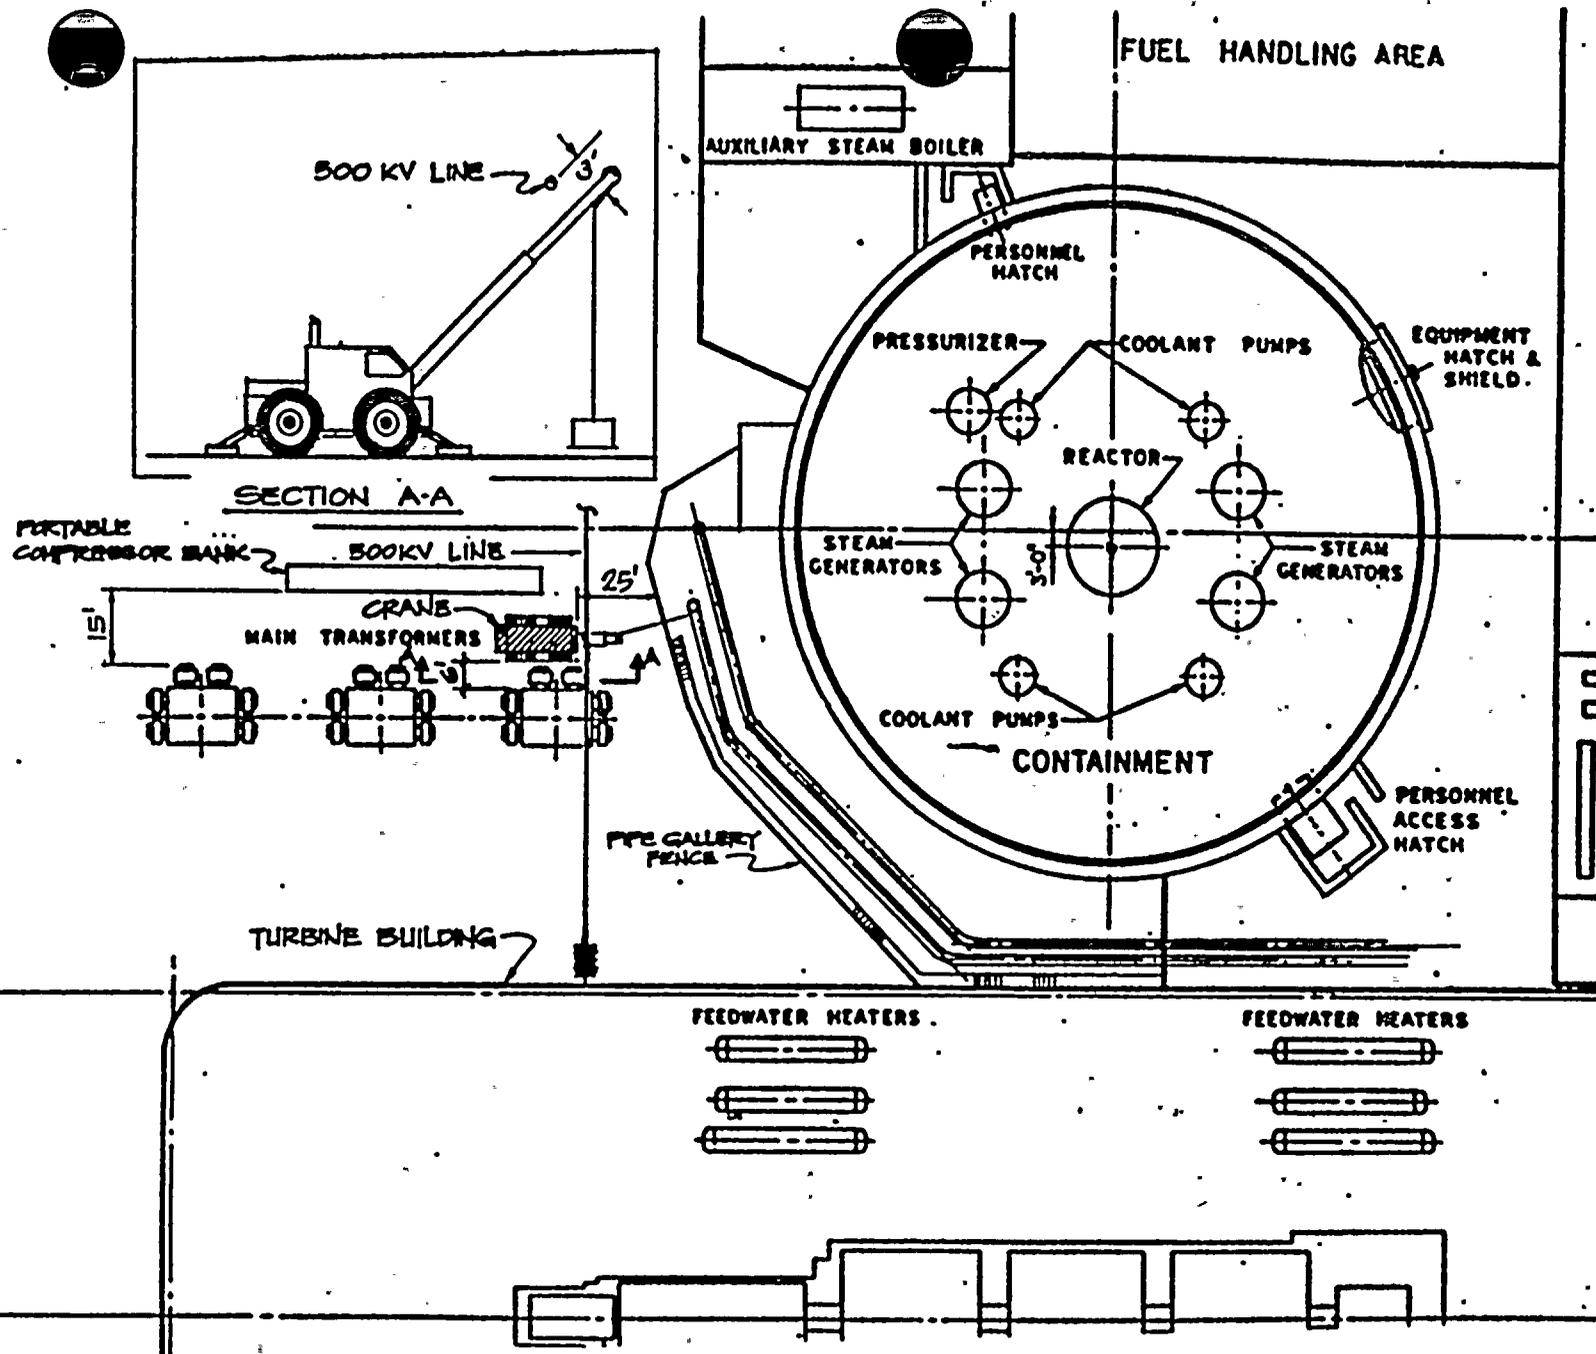
PG 4 E PLAN AND SECTION OF
 LOSS-OF-POWER OFFSITE EVENT
 3/7/91

Following a short break, the licensee presented their findings from an investigation into the loss of off-site power at Unit 1 on March 7, 1991. The loss of off-site power occurred after a crane, operating in close proximity to 500 kV power lines, caused a short-to-ground. This event resulted in the formation of an NRC Augmented Inspection Team (AIT) and a PG&E Event Investigation Team (EIT). The AIT's report of this event was documented in NRC Inspection Report 50-275/91-09. Mr. Womack, the EIT team leader, initiated the presentation.
