SUBJECT: LER 93-002-00: on 930304, TS 3.0.3 entered when one train of auxiliary bldg ventilation sys made inoperable by closure of manual damper. Caused by inadequate work instructions. Air flow reestablished through Fan 2E-1.W/930405 ltr.

Re: Docket No. 50-323, OL-DPR-82
Diablo Canyon Unit 2
Licensee Event Report 2-93-002-00
Entry Into Technical Specification 3.0.3 Due to Auxiliary Building
Ventilation System Inoperability Caused by Inadequate Work
Instructions

FACILITY NAME (1) DIABLO CANYON UNIT 2										DOCKET NUMBER (2) 0 5 0 0 0 3 2 3						PAGE (3) 1 OF 8			
TITLE (4) ENTRY INTO TECHNICAL SPECIFICATION 3.0.3 DUE TO AUXILIARY BUILDING VENTILATION SYSTEM INOPERABILITY CAUSED BY INADEQUATE WORK INSTRUCTIONS																			
EVENT DATE (6)			LER NUMBER (8)						REPORT DATE (7)			OTHER FACILITIES INVOLVED (8)							
MON	DAY	YR	YR	SEQUENTIAL NUMBER			REVISION NUMBER			MON	DAY	YR	FACILITY NAMES			DOCKET NUMBER (S)			
																0 5 0 0 0			
03	04	93	93	-	0	0	2	-	0	0	04	05	93				0 5 0 0 0		
OPERATING MODE (9)		THIS REPORT IS SUBMITTED PURSUANT TO THE REQUIREMENTS OF 10 CFR: (11)																	
		<div style="display: flex; justify-content: space-between;"> <div> 1 </div>

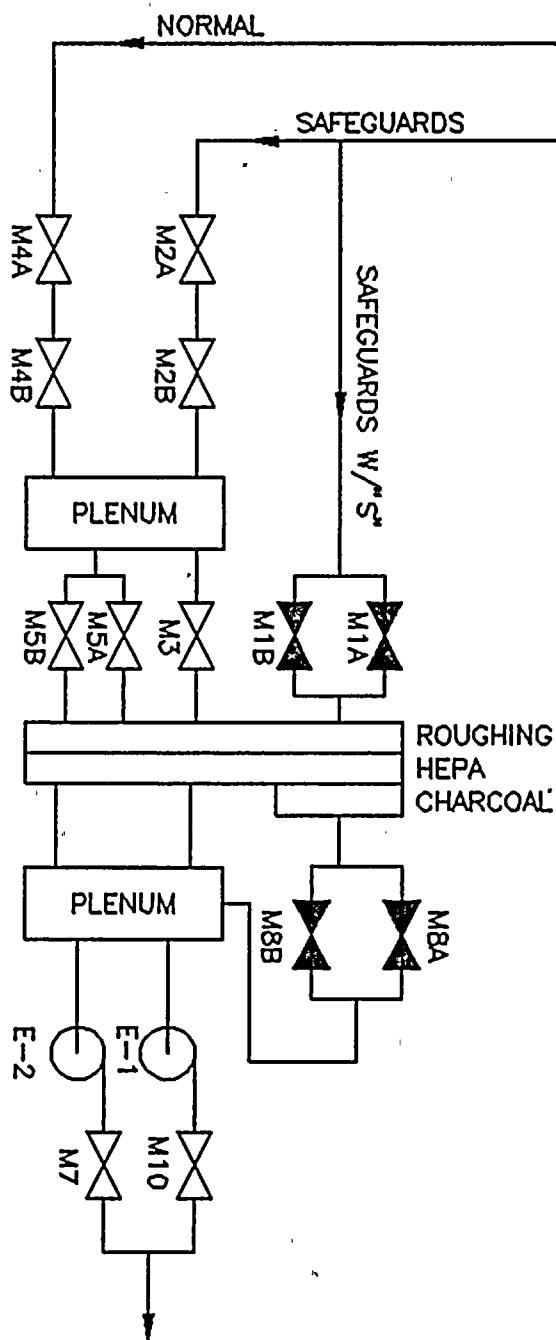
AUX BUILDING HEATING & VENTILATION SYSTEM (ABHVS)

alignment for this maintenance activity placed the ABVS in safeguards mode with an SI "S" signal, which automatically opens Dampers 8A, 8B, 1A, and 1B and closes Dampers 2A, 2B, 4A and 4B (see drawing on Page 8). This maintenance activity had been previously performed successfully using the same clearance alignment. The work order that implemented the maintenance activity required closing the dampers, but did not specifically identify which dampers. The alignment of this system specifies routing of flow through the charcoal filters, which requires that painting and welding restrictions be imposed in the auxiliary building for the duration of the clearance.

On March 4, 1993, Mechanical Maintenance personnel requested Operations approval to start work. The Unit 2 Shift Foreman determined that the work instructions were not specific regarding which dampers were required to be closed. The Mechanical Maintenance workers discussed the damper closure requirement with a maintenance engineer who previously had performed this activity and who indicated that MD-5A and MD-5B were required to be closed. The workers reported to the Shift Foreman and identified that MD-5A and MD-5B were required to be closed. The Shift Foreman agreed to the closure of those two dampers since this action maintained a flow path through MD-3. The maintenance workers were allowed to begin work and began so by closing MD-5A and MD-5B.

In order to enter the ducting that contained the FE-5016, an access hatch was required to be removed from the plenum in which the dampers were located. There was a differential pressure across the hatch. This prevented the workers from opening the hatch. Work was suspended and the Mechanical Maintenance foreman was contacted. The foreman noted that MD-3 on an upper elevation of the plenum was open. Although the maintenance personnel had informed the Unit 2 Shift Foreman that they were only going to close MD-5A and MD-5B, the work order instructions that required closure of the dampers were not specific as to which dampers to close. The Mechanical Maintenance foreman determined it was acceptable to close MD-3 since the work order instructions were not specific regarding the closure of dampers. This activity, previously performed under different alignment conditions, required MD-3 to be closed. When the Mechanical Maintenance foreman moved MD-3, a position

switch activated and signaled the ABVS control logic to shut down the only ABVS operable fan (2E-1). Fan 2E-2 was already inoperable for this maintenance activity. Since both Unit 2 ABVS fans were inoperable, the requirements of TS 3.7.6.1 were not met and TS 3.0.3 was entered. One train of the ABVS was restored within 15 minutes. As a result, the requirements of TS 3.7.6.1 were met and TS 3.0.3 was exited.

MD-5A, MD-5B and MD-3 were reopened. The air flow was reestablished through Fan 2E-1 fan and TS 3.0.3 action statement was exited.
