SUBJECT: LER 93-002-01: on 930904, TS 3.7.6.1 was violated due to  
 auxiliary building ventilation sys inoperability caused by  
 inadequate work instructions. Revised recurring task.  
 W/930907 ltr.

Re: Docket No. 50-323, OL-DPR-82  
Diablo Canyon Unit 2  
Licensee Event Report 2-93-002-01  
Entry Into Technical Specification 3.0.3 Due to Auxiliary Building  
Ventilation System Inoperability Caused by Inadequate Work  
Instructions

TITLE (4) **ENTRY INTO TECHNICAL SPECIFICATION 3.0.3 DUE TO AUXILIARY BUILDING VENTILATION SYSTEM INOPERABILITY CAUSED BY INADEQUATE WORK INSTRUCTIONS**

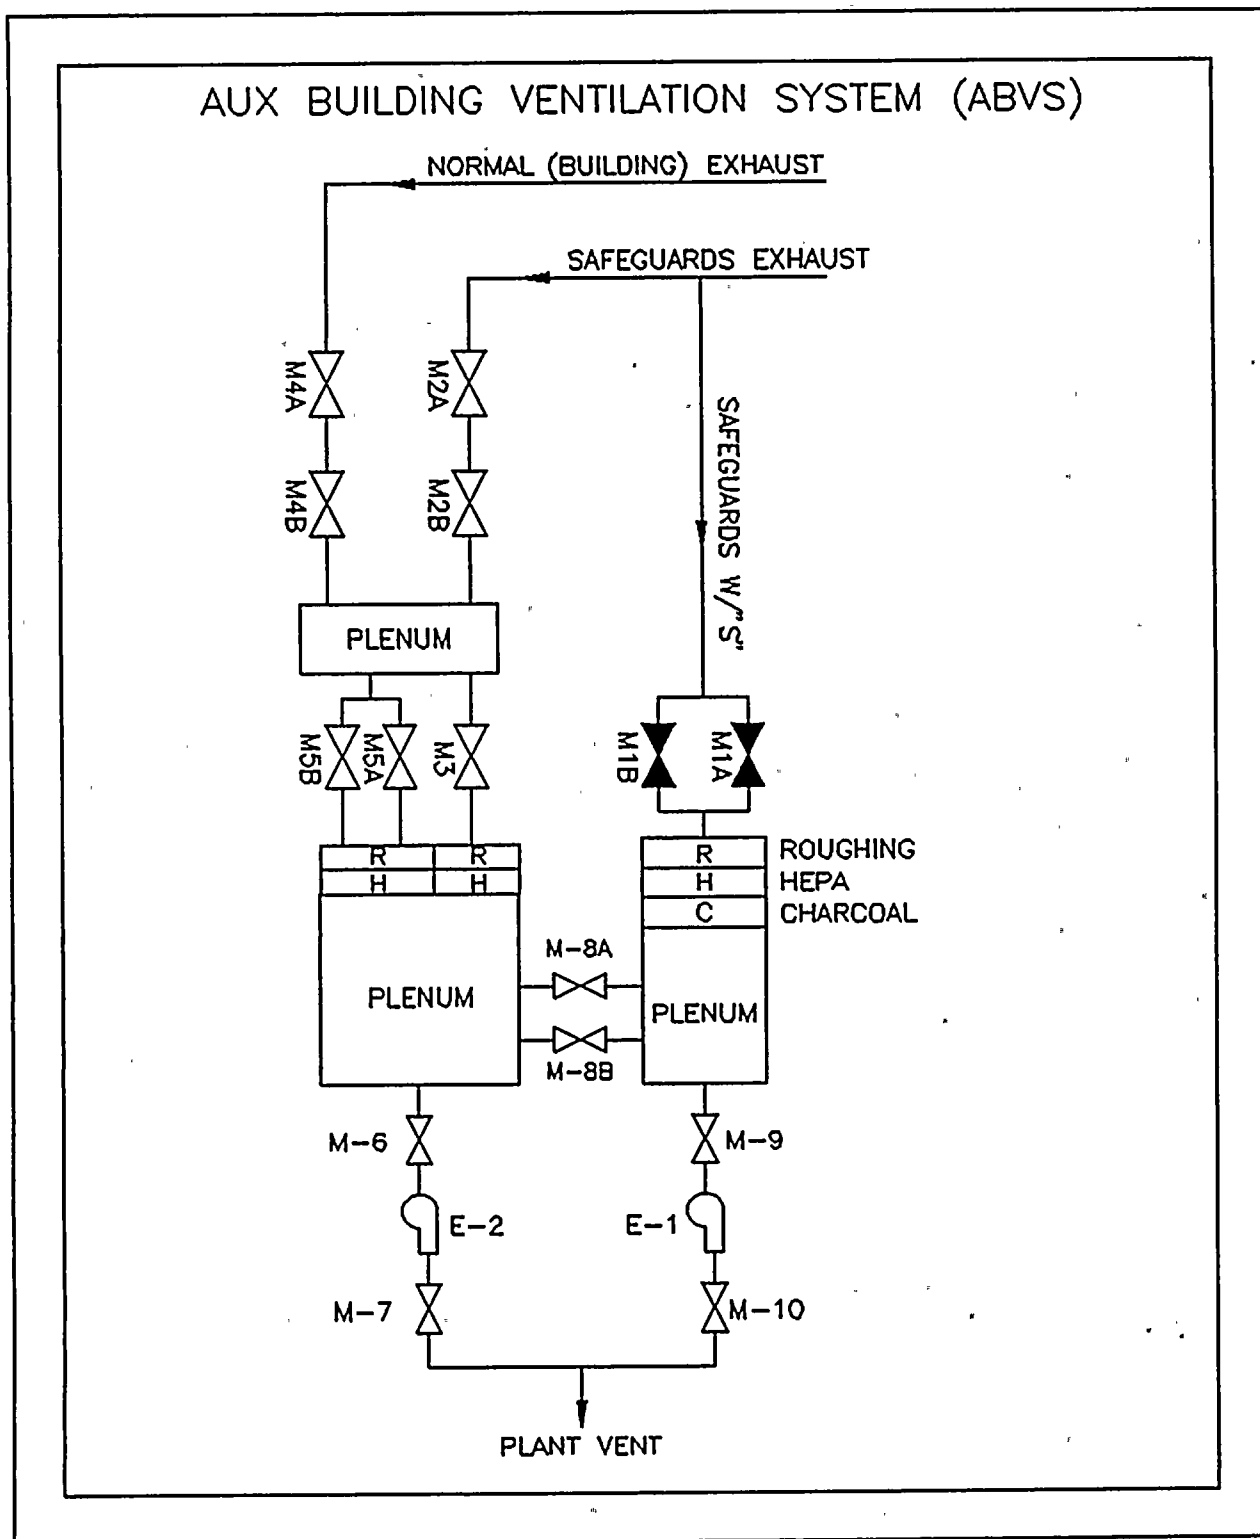
Dampers 1A, and 1B and closes Dampers 2A, 2B, 4A, 4B, 8A and 8B (see drawing on Page 9). This maintenance activity had been previously performed successfully using the same clearance alignment. The work order that implemented the maintenance activity required closing the manual dampers, but did not specifically identify which manual dampers. The alignment of this system specifies routing of flow through the charcoal filters, which requires that painting and welding restrictions be imposed in the auxiliary building for the duration of the clearance.

On March 4, 1993, Mechanical Maintenance personnel requested Operations approval to start work. The Unit 2 Shift Foreman determined that the work instructions were not specific regarding which dampers were required to be closed. The Mechanical Maintenance workers discussed the damper closure requirement with a maintenance engineer who previously had performed this activity and who indicated that MD-5A and MD-5B were required to be closed. The workers reported to the Shift Foreman and identified that MD-5A and MD-5B were required to be closed. The Shift Foreman agreed to the closure of those two dampers since this action maintained a flow path through MD-3. The maintenance workers were allowed to begin work and began so by closing MD-5A and MD-5B.

In order to enter the ducting that contained the FE-5016, an access hatch was required to be removed from the plenum in which the dampers were located. There was a differential pressure across the hatch. This prevented the workers from opening the hatch. Work was suspended and the Mechanical Maintenance foreman was contacted. The foreman noted that MD-3 on an upper elevation of the plenum was open. Although the maintenance personnel had informed the Unit 2 Shift Foreman that they were only going to close MD-5A and MD-5B, the work order instructions that required closure of the dampers were not specific as to which dampers to close. The Mechanical Maintenance foreman determined it was acceptable to close MD-3 since the work order instructions were not specific regarding the closure of dampers. This activity, previously performed under different alignment conditions, required MD-3 to be closed. When the Mechanical Maintenance foreman moved MD-3, a position switch activated and signaled the ABVS control logic to shut down the only ABVS operable fan (2E-1). Fan 2E-2 was already inoperable for this

maintenance activity. Since both Unit 2 ABVS fans were inoperable, the requirements of TS 3.7.6.1 were not met and TS 3.0.3 was entered. One train of the ABVS was restored within 15 minutes. As a result, the requirements of TS 3.7.6.1 were met and TS 3.0.3 was exited.

The immediate cause of this event was the inadvertent trip of the ABVS Exhaust Fan 2E-1 due to the loss of the suction flow path.

1. MD-5A, MD-5B and MD-3 were reopened. Flow was reestablished through Fan 2E-1. The TS 3.0.3 action statement was exited.
2. All Preventive Maintenance (PM) for the Unit 1 ABVS and Fuel Handling Building Ventilation System (FHBVS) was suspended until actions were taken to prevent recurrence.

1. The RT clearance instructions associated with Units 1 and 2 ABVS flow element cleaning were revised to include specific directions regarding the need for the clearance to be performed the way it is described.

2. The RT Work Order (WO) instructions associated with Units 1 and 2 ABVS flow element cleaning were revised to clearly identify the dampers requiring manipulation. The instructions were also reviewed and updated as necessary to correct any potential for the system to be aligned in a manner that may impact its functional/operational requirements.
