REGULATORY INFORMATION DISTRIBUTION SYSTEM (RIDS)

SUBJECT: LER 93-005-01: on 891029, discovered three medium voltage cable failures due to chemical degradation & unknown causes. Established preventive maint program for sump pumps & drains. W/931004 ltr.

PG&E Letter No. DCL-93-233

Re: Docket No. 50-275, OL-DPR-80  
Docket No. 50-323, OL-DPR-82  
Diablo Canyon Units 1 and 2  
Licensee Event Report 1-93-005-01  
Medium Voltage Cable Failures Due to  
Chemical Degradation and Unknown Causes

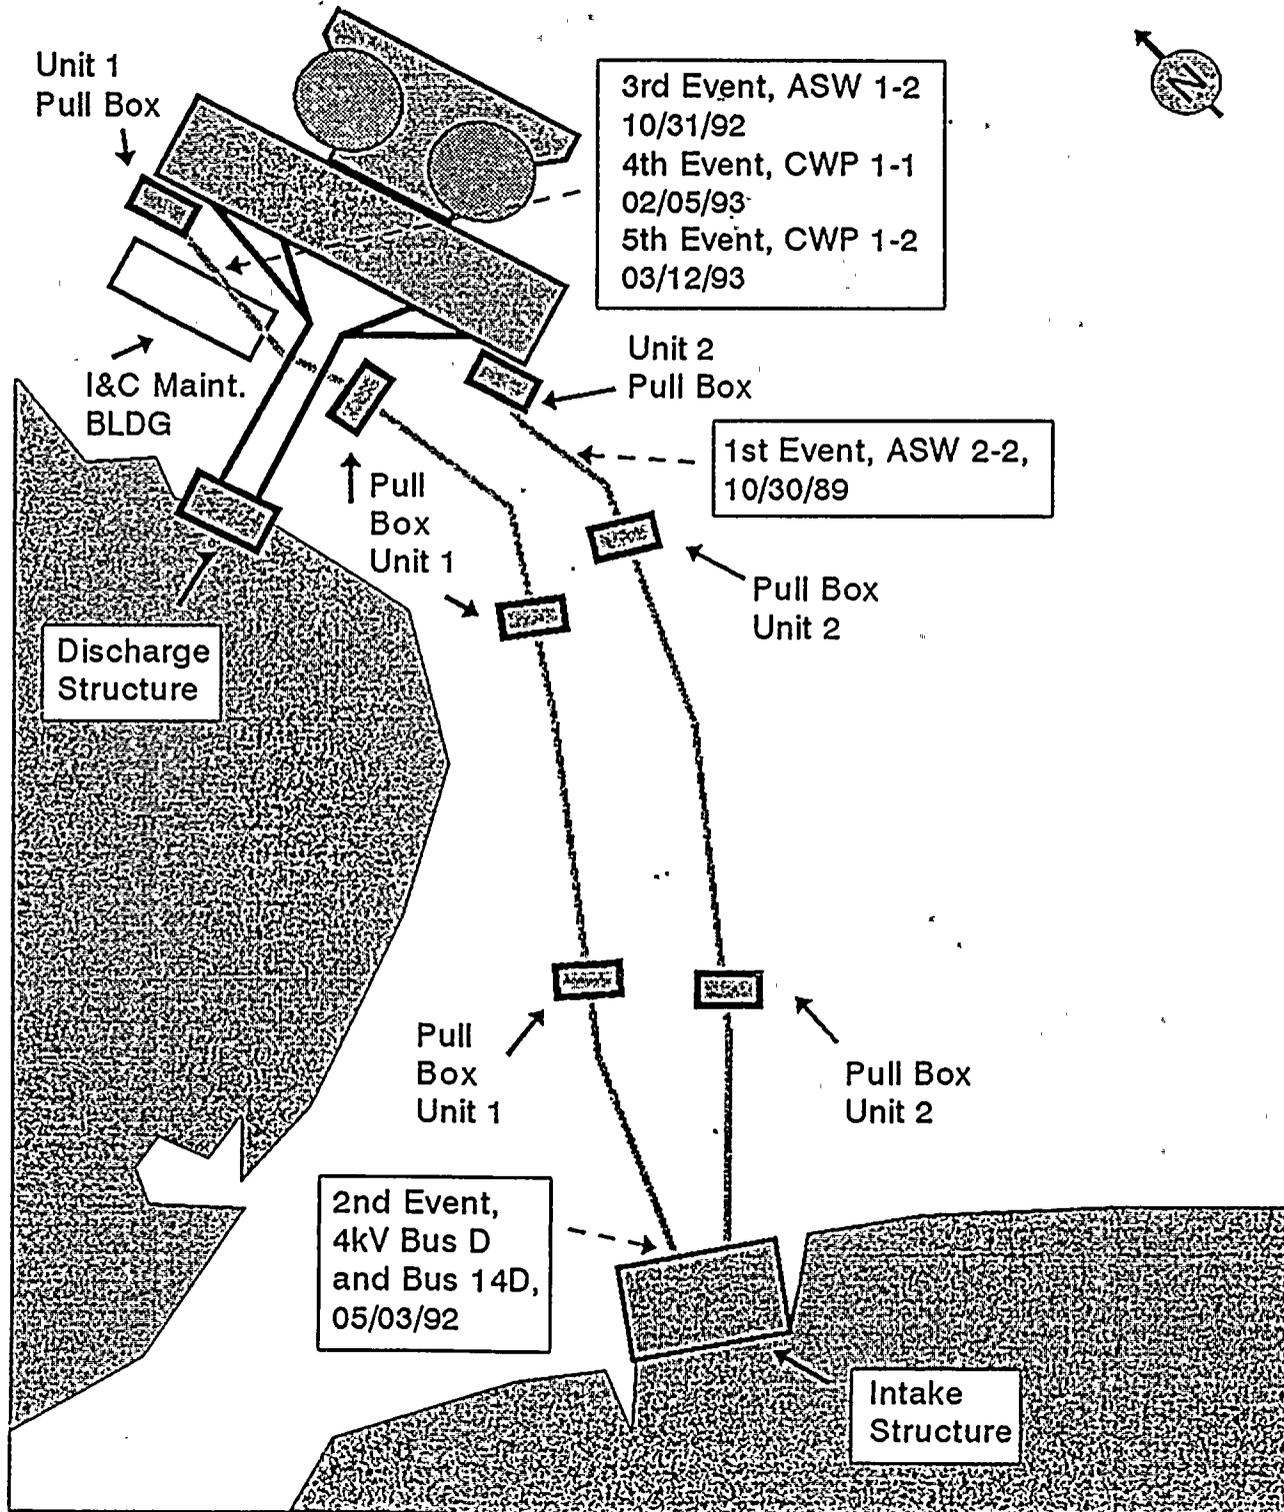
## Figure 1: Site Overview of Conduit Trench for Units 1 & 2

The subject cables are routed in two separate sets of duct bank conduits, one for each unit, between the turbine building and the intake structure. Concrete vaults are located at various intervals to serve as pull boxes for the circuits. These duct bank conduits are directly buried in sand and are covered for their entire length by a six-inch thick concrete cap. The duct bank conduits include 12kV, 4kV, and 480V (CBL4) power cables, 120V ac control cables (EF)(CBL3), 125V dc control cables (EJ)(CBL3), and instrument cables (EF)(CBL1).

The pull boxes immediately outside of the turbine building have drains (DRN), which are routed to common sump vaults (manholes) (FA)(PBX) for Units 1 and 2. These manholes are equipped with automatic submersible Class II sump pumps (PBX)(P).

The Unit 1 and Unit 2 trenches are similar, except that the Unit 1 duct bank rises to cross over the circulating water discharge tunnel and then slopes downhill towards the intake structure. This design makes the Unit 1 section of cable conduits near the turbine building susceptible to submergence if the pull box sump pumps are not functional and if the water within the pull boxes rises above the conduit openings.

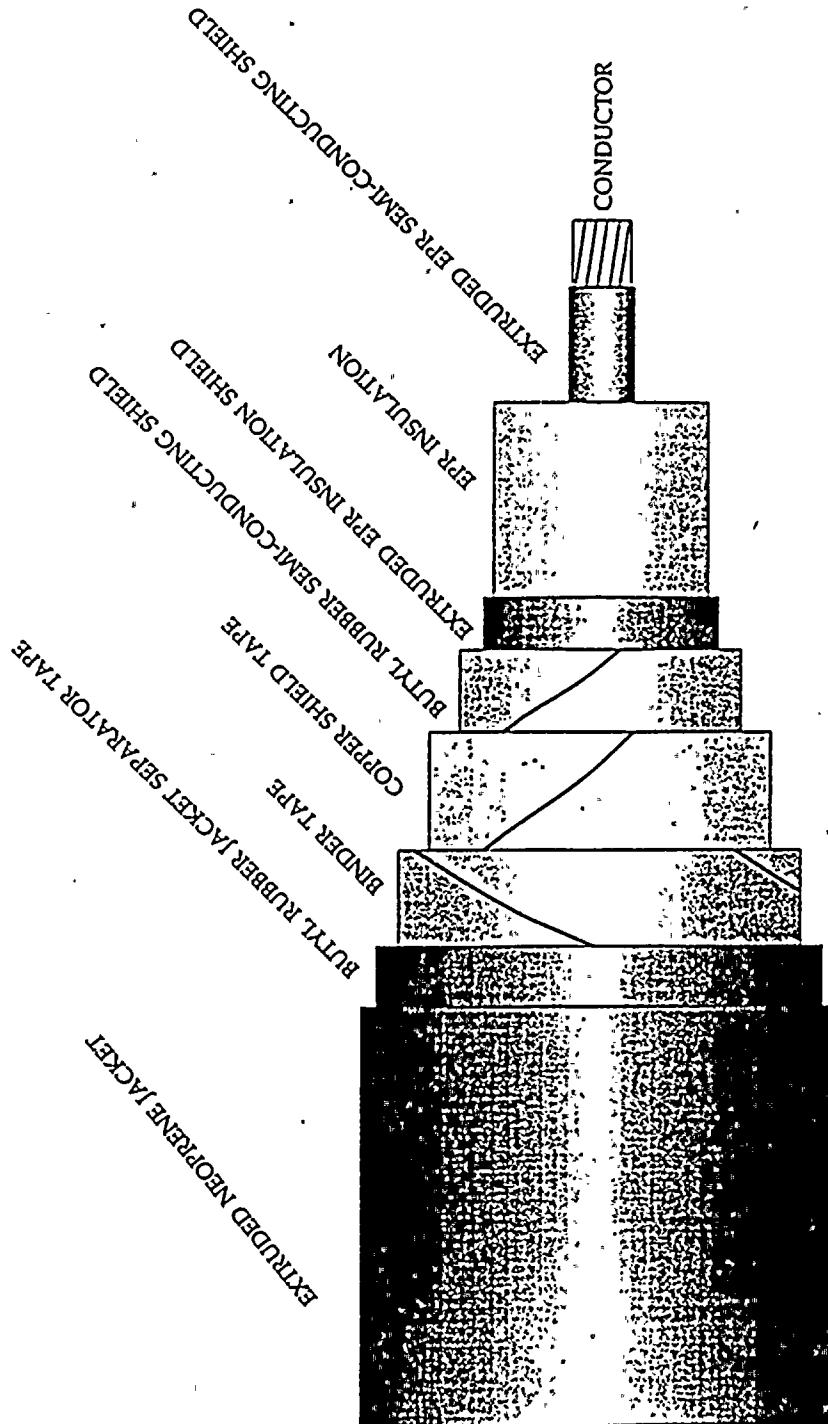
**FIGURE 2 : DESIGN OF 4KV AND 12KV OKONITE CABLES**

The cable construction is similar for both the 4kV and 12kV cables. The cables are a shielded single-conductor cable design and are constructed in concentric layers (see Figure 2). There are four cable layers of interest for this LER: (1) the insulation (EA)(CBL)(INS) layer, which is approximately 115 mils of black EPR for the 4kV cables and approximately 220 mils of black EPR for the 12kV cables; (2) the tinned copper shield tape, which acts to equalize the electrical stress; (3) the wax coated synthetic binder tape, which holds the copper shield against the cable, thereby allowing the outer jacket to

be extruded over the cable during manufacture; and (4) the outside layer, which is a neoprene jacket. The function of the outer neoprene jacket is to protect the cable during installation (impact and abrasion resistance) and to act as a physical barrier between the outside environment and the shield once the cable is installed. The cable jackets are not bonded to the cable shield or insulation layers.

Construction of Okonite 5kV and 15 kV Cables Used at DCCP
