LICENSEE EVENT REPORT (LER)

FACILITY NAME (1) DIABLO CANYON UNIT 1	DOCKET NUMBER (2) 0 5 0 0 0 2 7 5	PAGE (3) 1 OF 9
--	---	----------------------------------

TITLE (4) **CONTROL ROOM VENTILATION SYSTEM OUTSIDE DESIGN BASIS DUE TO PERSONNEL ERROR**

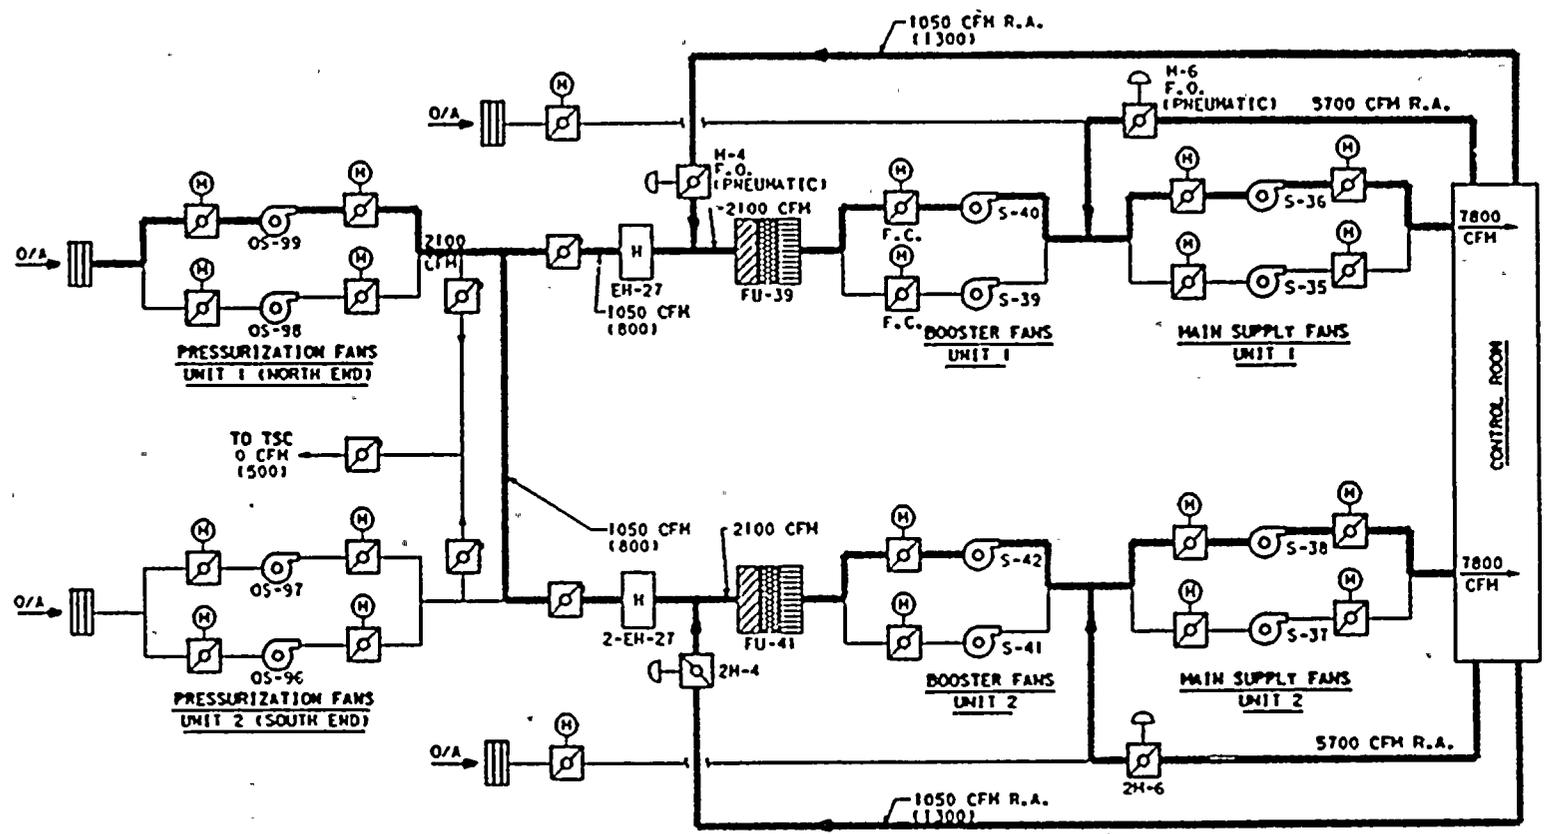
CONTROL ROOM HVAC SYSTEM

The pressurization air splits between Units 1 and 2. The booster fans provide enough suction to draw the mixture of pressurization air and some recirculation air (via damper M-4) from the control room through the HEPA and charcoal filters and deliver the air to the suction of the main supply fans. The main fans mix this air with additional recirculation air from the control room (via damper M-6), cool the air, and deliver the air back to the control room. The booster and main fan subtrains (two per Unit) in each Unit are not interlocked with each other, so that failure of any of the components does not result in any automatic action. The failure of a main fan is alarmed in the control room via flow switches (VI)(FS) located at the fan suctions. However, a failure of a booster fan or booster fan damper is not alarmed and therefore is not easily detectable.

Since the booster fan provides the motive force to draw the pressurization and recirculation air through the charcoal and HEPA filters, a booster fan or damper failure results in the pressurization air finding the path of least resistance, which is a flow reversal through the M-4 damper recirculation duct. Therefore, a portion of outside air is then directly discharged into the control room, bypassing the charcoal filters. With neither an alarm to notify control room operators of the failure nor an automatic switchover to the unaffected redundant CRVS train, the potential therefore existed for undetected airborne radioactive infiltration into the control room and that could cause GDC 19 control room thyroid dose limits to eventually be exceeded in the event of a LOCA.

1. An Operations Department Night Order was issued that discussed the possible ramifications of booster fan or damper failure during CRVS Mode 4 operation.
2. Emergency Procedure (EP) E-0, "Loss of Reactor or Secondary Coolant," was revised to include instructions to operators to confirm CRVS operation status during CRVS Mode 4 operation and to include actions to be taken if booster fan or damper failure is diagnosed.
3. Streamers were installed on the CRVS recirculation duct register to enable control room operators to diagnose CRVS booster fan or damper operation status.
4. Surveillance Test Procedure (STP) M-6A, "Routine Surveillance Testing of CRVS" will be revised to verify proper operation of the CRVS streamers and booster fans.
