LICENSEE EVENT REPORT (LER)

FACILITY NAME (1) DIABLO CANYON UNIT 1	DOCKET NUMBER (2) 0 5 -0 0 0 2 7 5	PAGE (3) 1 OF 14
--	--	----------------------------

TITLE (4) **MEDIUM VOLTAGE CABLE FAILURES**

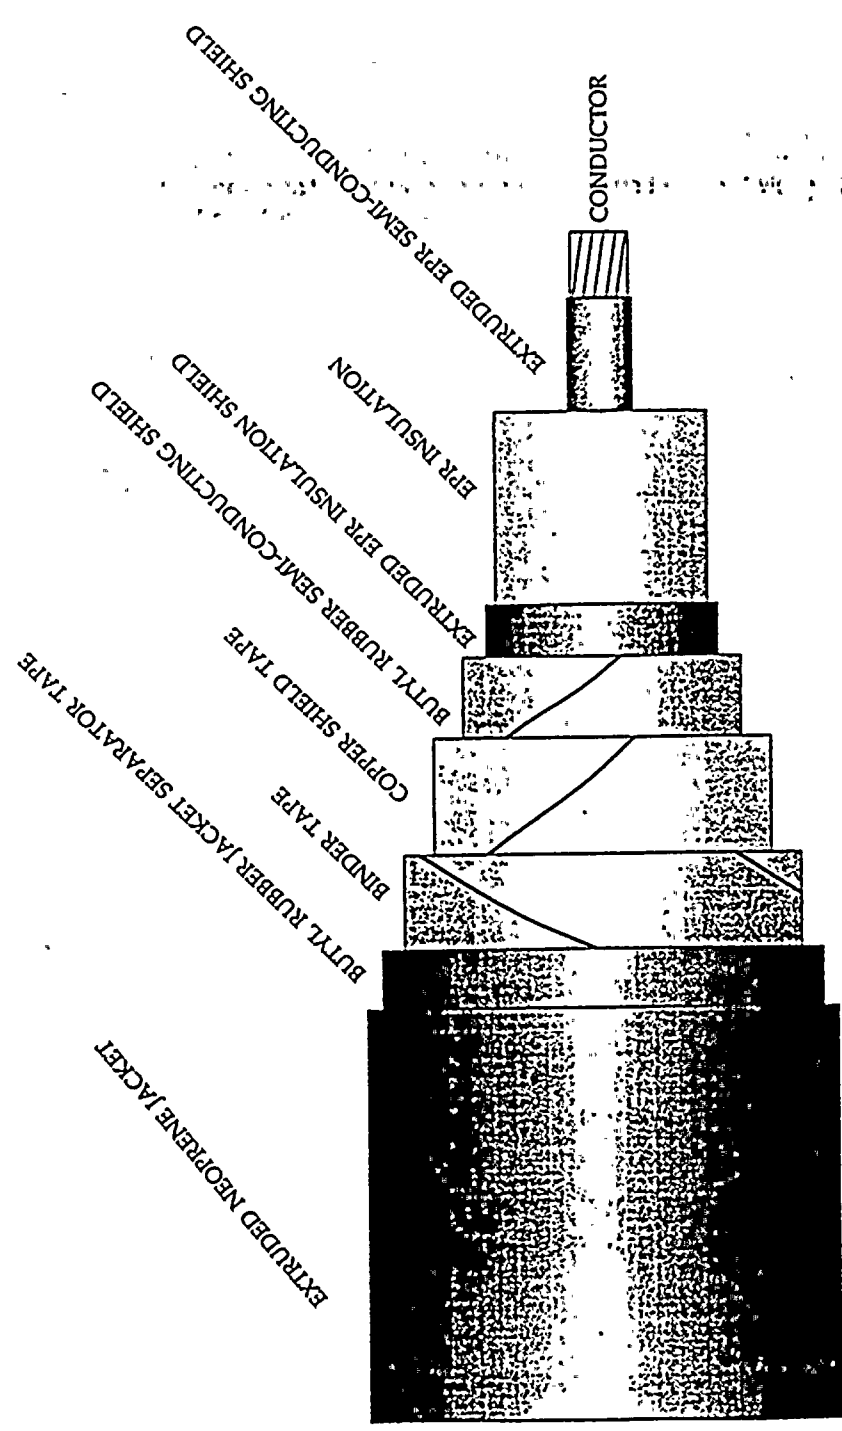
TEXT (17) **FIGURE 2 : DESIGN OF 4KV AND 12KV OKONITE CABLES**

The cable construction is similar for both the 4kV and 12kV cables. The cables are a shielded single-conductor cable design and are constructed in concentric layers (see Figure 2). There are four cable layers of interest for this LER: (1) the insulation (EA)(CBL)(INS) layer, which is approximately 115 mils of black EPR for the 4kV cables and approximately 220 mils of black EPR for the 12kV cables; (2) the tinned copper shield tape, which acts to equalize the electrical stress; (3) the wax coated synthetic binder tape, which holds the copper shield against the cable, thereby allowing the outer jacket to be extruded over the cable during manufacture; and (4) the outside layer, which is a neoprene jacket. The function of the outer neoprene jacket is to protect the cable during installation (impact and abrasion resistance) and to act as a physical barrier between the

outside environment and the shield once the cable is installed. The cable jackets are not bonded to the cable shield or insulation layers.

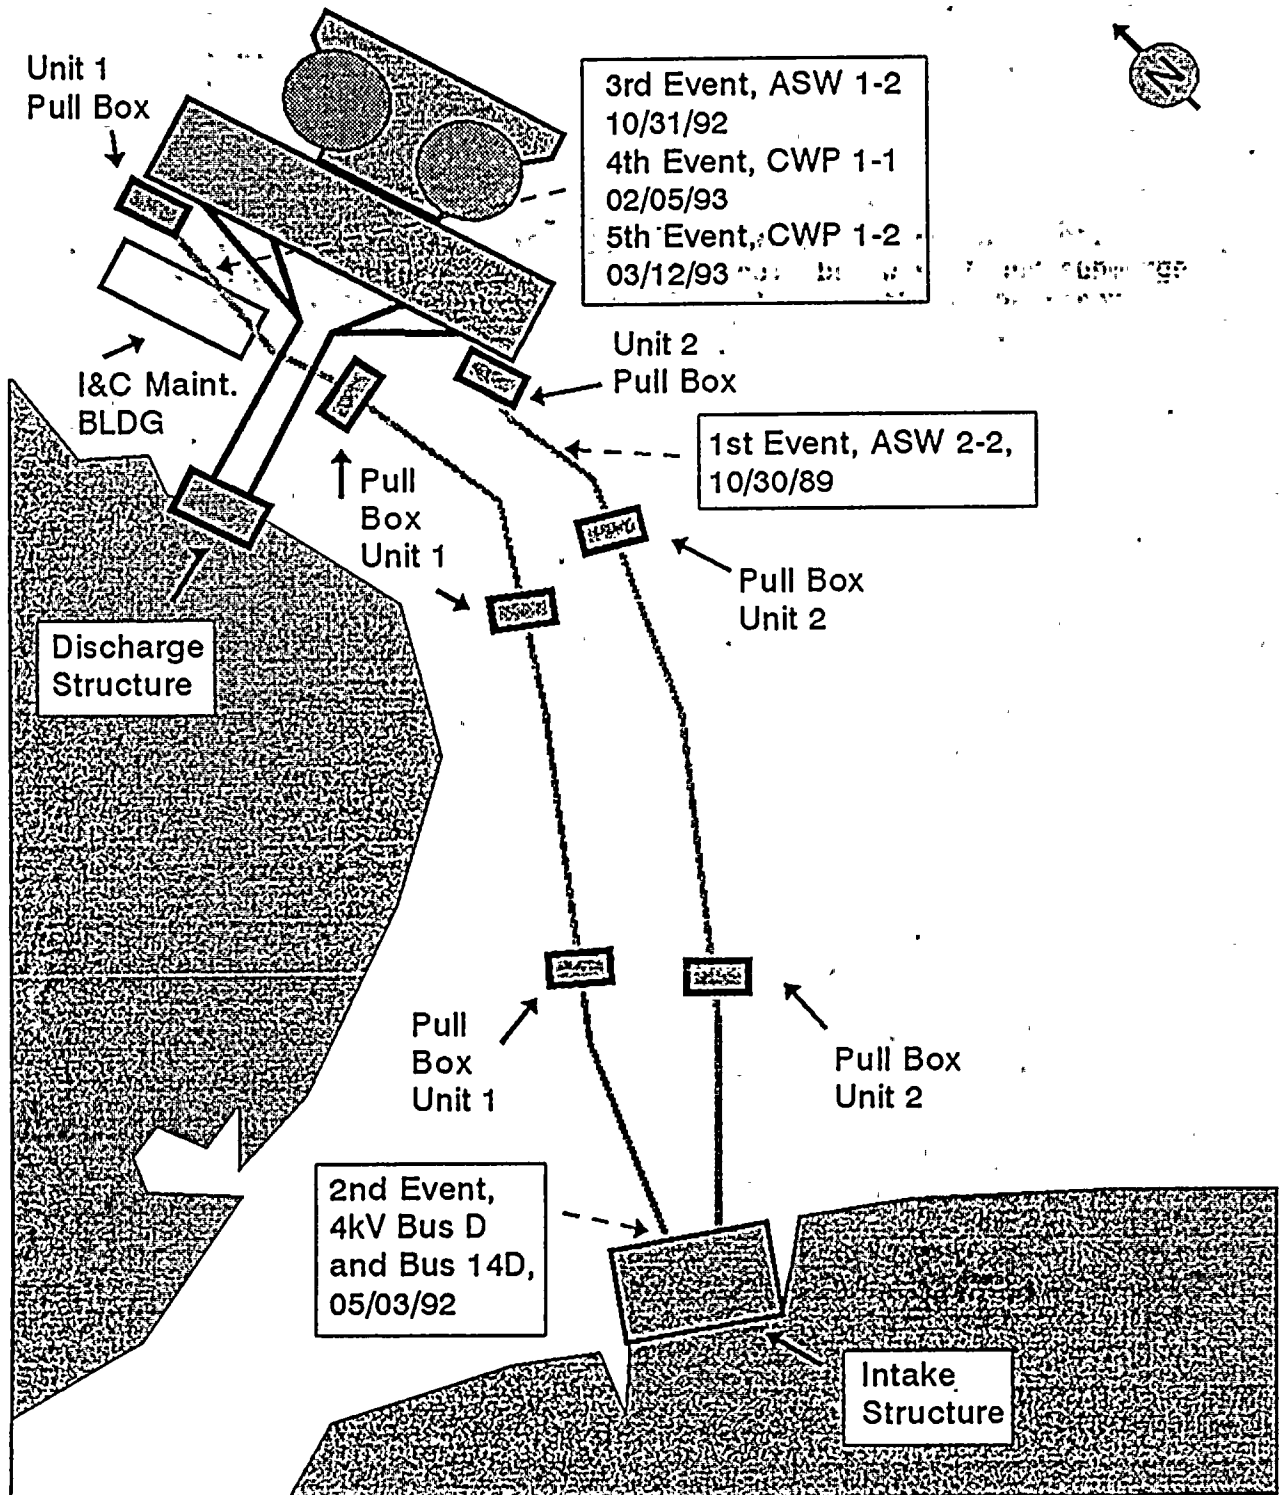
Figure 1: Site Overview of Conduit Trench for Units 1 & 2

The subject cables are routed in two separate sets of duct bank conduits, one for each unit, between the turbine building and the intake structure. Concrete vaults are located at various intervals to serve as pull boxes for the circuits. These duct bank conduits are directly buried in sand and are covered for their entire length by a six-inch thick concrete cap. The duct bank conduits include 12kV, 4kV, and 480V (CBL4) power cables, 120V ac control cables (EF)(CBL3), 125V dc control cables (EJ)(CBL3), and instrument cables (EF)(CBL1).

The Unit 1 and Unit 2 trenches are similar, except that the Unit 1 duct bank rises to cross over the circulating water discharge tunnel and then slopes downhill towards the intake structure. This design makes the Unit 1 section of cable conduits near the turbine building susceptible to submergence if the pull box sump pumps are not functional and if the water within the pull boxes rises above the conduit openings.
