SUBJECT: LER 88-015-01: on 880507, RCP motor upper oil reservoir assemblies degradation attributed to metal fatigue.
W/8 ltr.

FACILITY NAME (1): **DIABLO CANYON UNIT 1** DOCKET NUMBER (2): **05000275** PAGE (3) **1** OF **1**

TITLE (4): **RCP MOTOR UPPER OIL RESERVOIR ASSEMBLIES DEGRADATION ATTRIBUTED TO METAL FATIGUE**

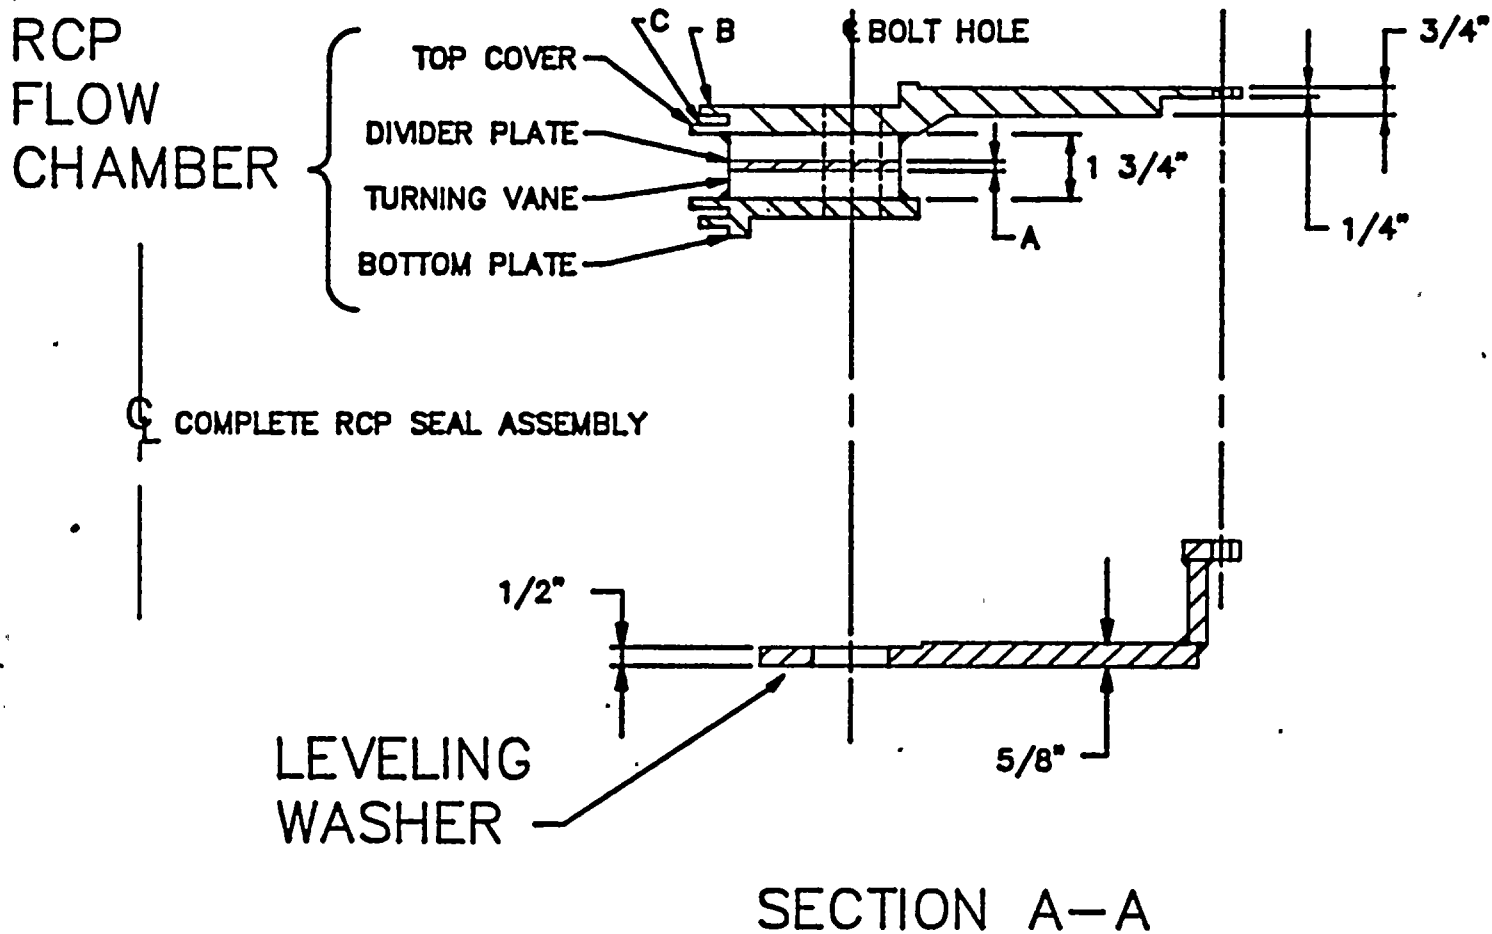
FIGURE 1
FLOW CHAMBER SECTION

Based on investigations conducted, the following postulated sequence of events led to the cracking and other damage found in the RCP motor upper bracket assemblies. First, vibration of the oil pump assembly caused fatigue cracking of the flow chamber fillet welds (See Figure 1, note on the cross section of the RCP flow chamber that these are on the fillet welds that weld the turning vane to the top cover and bottom plate). Failure of these welds has several possible secondary effects: (1) it could cause a downward shift in the resonant frequency of the pump assembly as a result of reduced stiffness of the flow chamber; (2) it could result in increased relative motion between the flow chamber and leveling washer because of loss of preload compression due to a gap between the vanes and the face plates (See Figure 1 and the cross section of the flow chamber and leveling washer assembly); and (3) it could increase the stresses on the 3/8" bolts at the peripheral joint because of the increased flexibility from (1) and (2). Second, the 3/8" bolts at the outer periphery of the flow chamber loosened and broke as a result of fatigue stresses caused by the primary rocking motion and the secondary relative motion between the flow chamber and the leveling washer. Failure and loosening of these bolts is not the primary cause of damage in the assembly because two of the flow chambers had fillet weld cracking with no signs of bolt failure or loosening. Third, the leveling washer cracked at the welds attaching it to the columns (See Figure 2). The leveling washer cracking is apparently the last event in the sequence because it only occurred on the motor with the worst damage to the other oil reservoir assembly components.

either contributed to or caused the observed damage. Gaps found between the top cover and bottom plate and the diverter vanes of the flow chambers (See Figure 1) are potentially a significant contributor to the failure by reducing the stiffness of the bearing assembly and by subjecting the fillet welds joining these three members to the cyclic tensile stresses from the pump vibration.

- B. New flow chambers were installed in the Unit 1 RCP motors. The new flow chambers are fabricated from A36 carbon steel rather than the A514 carbon steel used in the original flow chambers. The new material is more weldable than the original material.

- The new flow chambers are also of a more recent design which has a 3/4 inch thick divider plate rather than the 1/4 inch thick divider plate used on the original flow chamber.

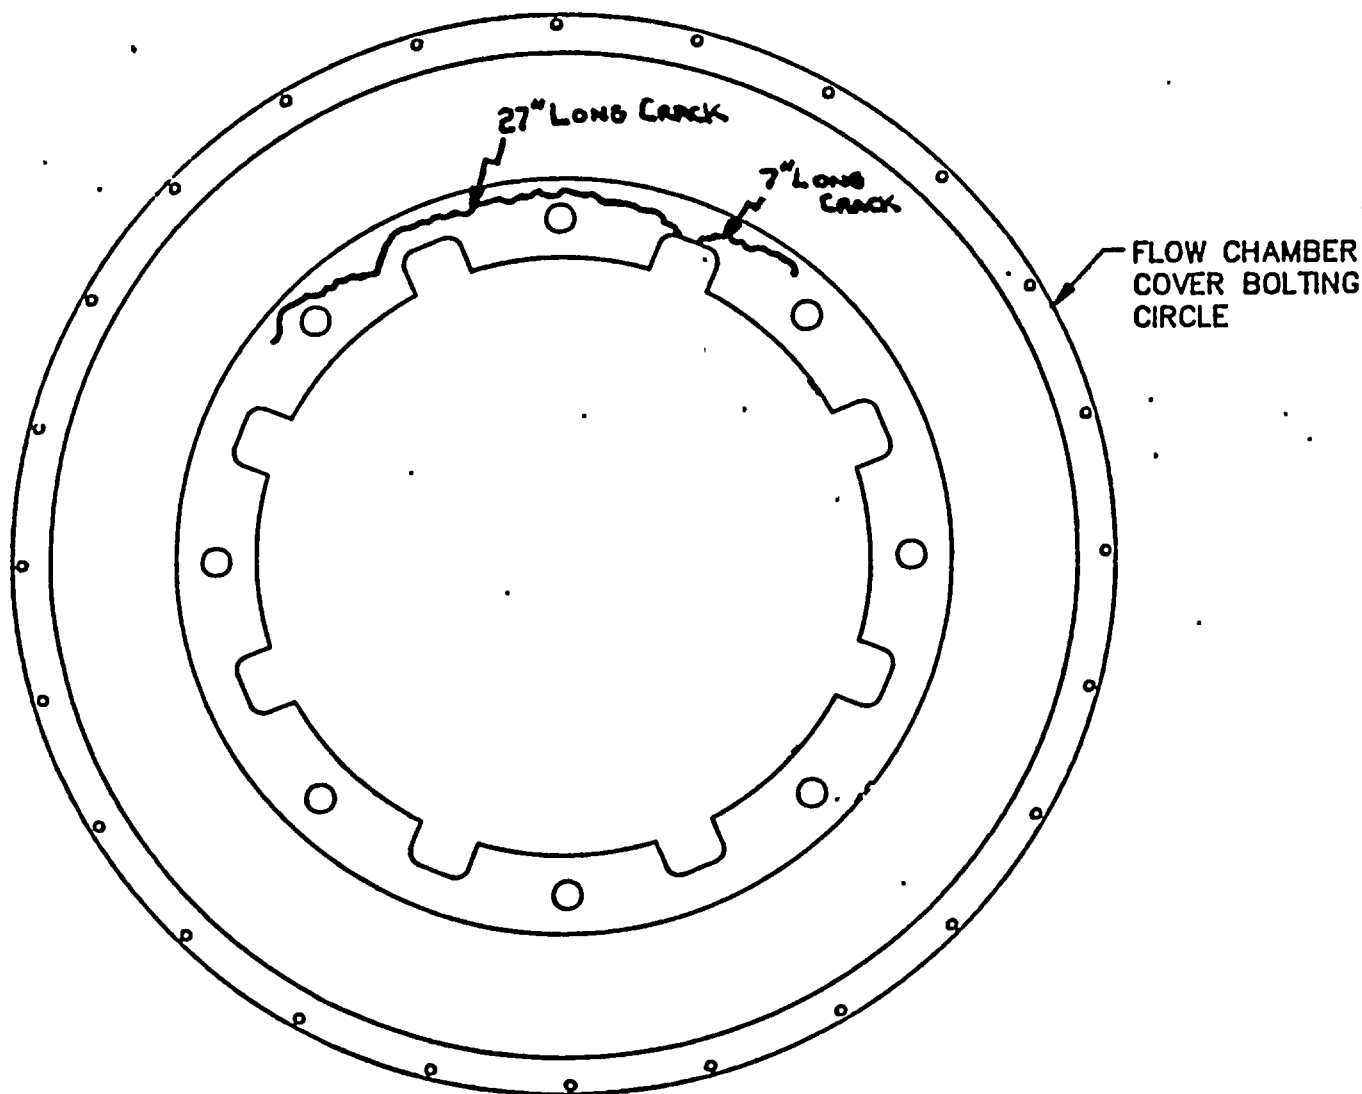
FIGURE 2
LEVELING WASHER CRACK DETAILS

On May 7, 1988, during routine outage maintenance of Unit 1 reactor coolant pump (RCP) motor (AB)(MO) 1-2, the 3/8 inch bolting securing the flow chamber to the leveling washer (AB)(LW) within the upper lube oil reservoir was found to be damaged in an arc of about 150 degrees around the flow chamber flange. Bolts were broken, bent, or otherwise deformed, and the gasket material in the area of the damaged bolting was missing. Two cracks were also identified in the leveling washer section of the motor upper bracket.

On May 8, 1988, magnetic particle examination of the RCP 1-2 leveling washer cracks was performed. A magnetic particle examination of the RCP 1-2 lube oil flow chamber (AB)(BAF) was also performed. Ten cracks were identified in the flow chamber assembly welds. The flow divider plate in the flow chamber was broken or cracked in two places.

- C. The RCP 1-2 leveling washer cracks were weld repaired. The repair was nondestructively examined to verify its integrity. Structural deformation of the leveling washer due to the crack and to the weld repair of the crack was performed by precision machining of the leveling washer to flow chamber flange and the leveling washer to flow chamber machined mating surface.
