**Pacific Gas and Electric Company**

PG&E Letter No. DCL-93-078

Re: Docket No. 50-275, OL-DPR-80 Docket No. 50-323, OL-DPR-82 Diablo Canyon Units 1 and 2 Report of Potential for Inadequate Electrical Isolation in Certain 120 VAC Power Circuits for PG&E Class IA and IB1 Instrumentation

Report of Potential for Inadequate Electrical Isolation in Certain 120 VAC Power Circuits for PG&E Class IA and IB1 Instrumentation

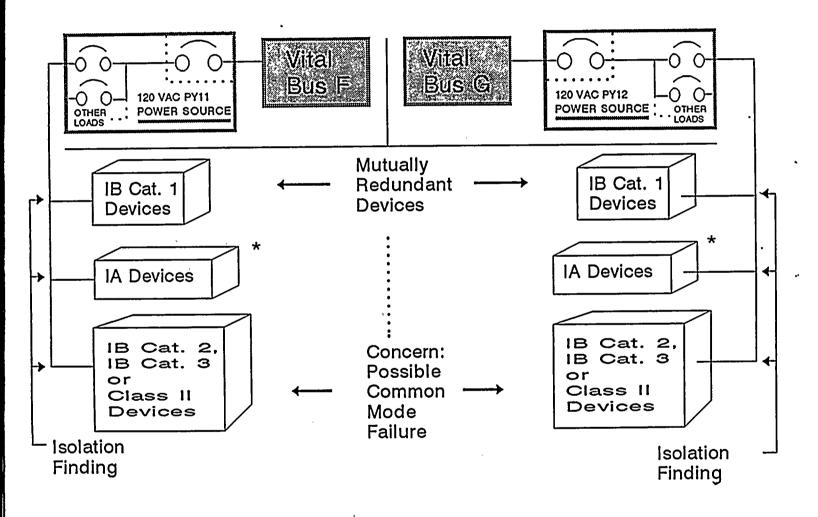
PG&E reviews have identified the potential for inadequate electrical isolation in Class IA and IB1 instrumentation power circuits. As illustrated in Figure 1, there is the possibility that unisolated lower classification devices (i.e., PG&E Instrument Classes IB2, IB3, IC or II) could fail as a result of a postulated event. This failure affects only the power circuits, and not the process or position signals or their associated wiring. The majority of the lower classification devices identified to date are located in the control board, control room and cable spreading room. The assumed common failure mode is electrical shorting caused by loss of physical integrity. The loss of physical integrity may be internal to the device or may be external (i.e., resulting from failure of the mounting fasteners/supports for the device). There are a number of credible events that must be considered, including seismic activity, fire, harsh post-accident environments, missiles, pipe whip, jet impingement, flooding, tornado, and tsunami.

The simultaneous electrical shorting of the lower classification devices due to a postulated event would trip their respective circuit breakers. If <u>redundant</u> PG&E Class IA or IB1 devices were also supplied power by these breakers, then these devices would be deenergized as well. Such an occurrence would be a deviation from the single failure criterion in that a single event would have caused the simultaneous loss of redundant Class IA or IB1 instrumentation.

\* Note: Does not affect RPS/ESFAS Initiation Systems.

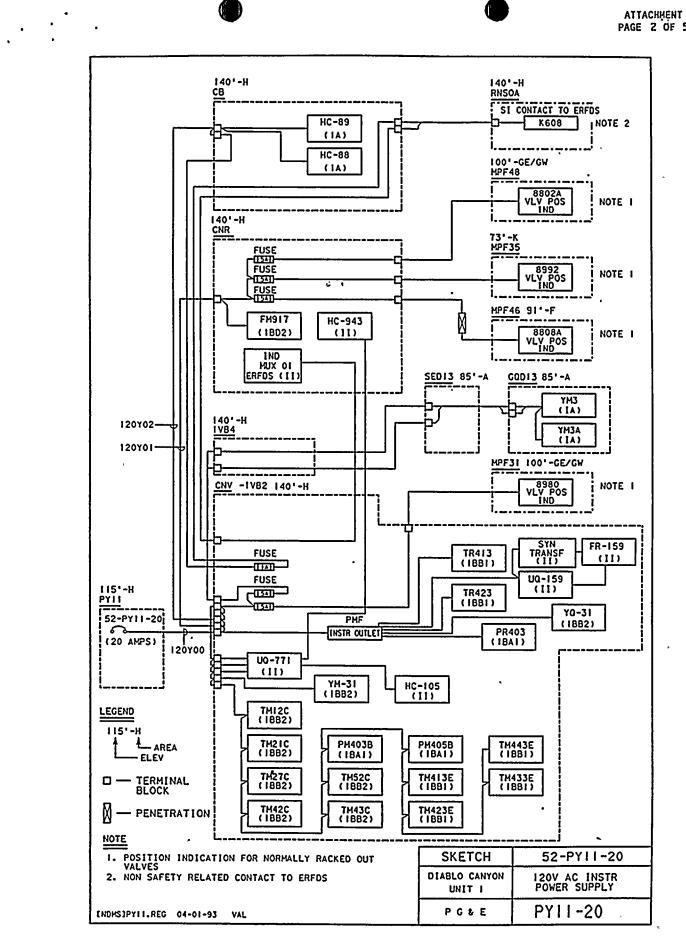
# DEVICES FED FROM PY-11 BREAKER 20 (120Y00)

- Circuit 120Y00 -- Breaker 52-PY11-20
- Circuit 220Y00 -- Breaker 52-PY12-20

Both circuits in the circuit pair have Class IA and IB1 loads in combination with unisolated loads of lower classification. Electrical shorting failure of unisolated lower classification loads in both circuits could trip both breakers for the circuit pair. The redundant higher classification devices that could be lost are the following:

- Emergency Diesel Generators (EDG) speed-switching tachometers YM-3 and YM-2.
- Reactor coolant wide-range (WR) temperature recorders TR-413, TR-423, TR-433 and TR-443.
