Velan Valve Corporation  
2500 Industrial Park  
Winoona, Vermont 05498  
TEL: 802-863-4012  
FAX: 802-863-4014

Subject: Notification as required by 10CFR Part 21

As required by 10CFR Part 21 we are advising you of a potential safety related problem with our 2 1/2", 3" and 4" forged swing check valves.

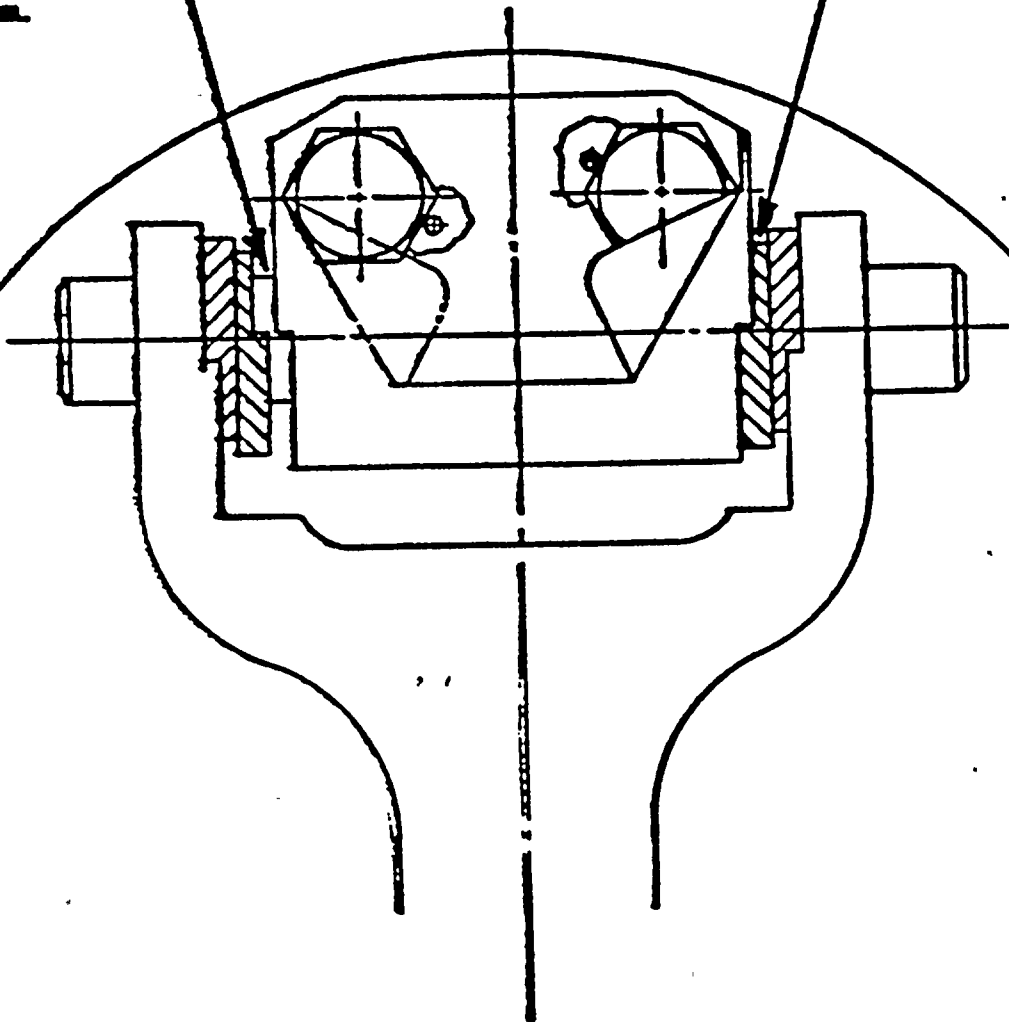
The problem is that the swing check valve may jam in the open position because of an accumulation of tolerances in the cage unit of the swing check assembly (sketch attached). Design changes have been made to eliminate this in future production of these valves and spare parts.

**Clearance**  
**May cause**  
**problem.**

**Engagement**  
**Satisfactory**

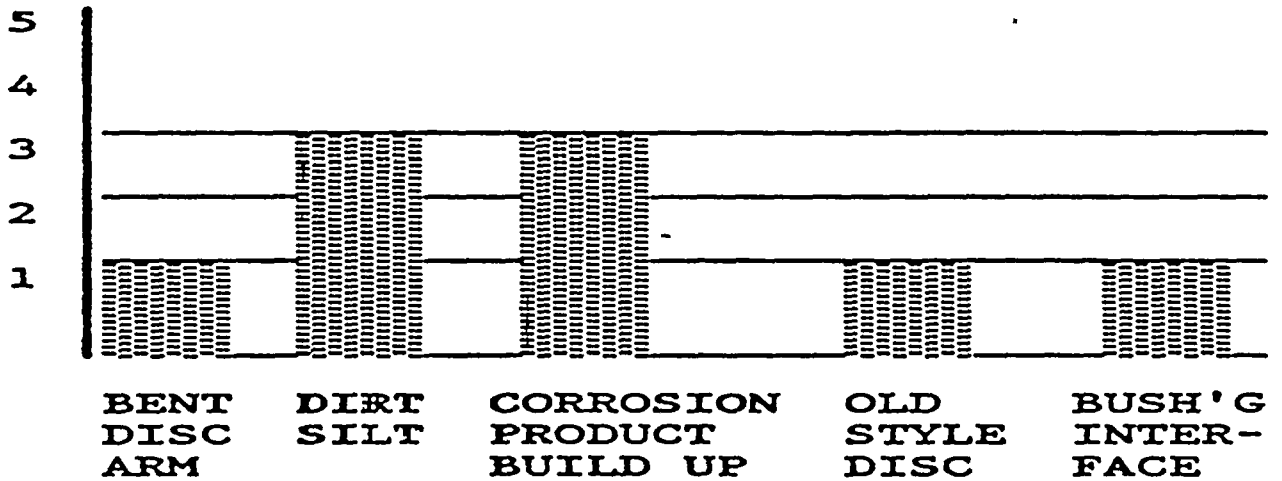
**VELAN  
CHECK VALVE**

**42 INCIDENTS REVIEWED**

**80% OF INCIDENTS WERE SEAT  
TO DISC LEAKAGE**

**20% OF INCIDENTS WERE STUCK  
DISCS**

**STUCK DISC CAUSES**

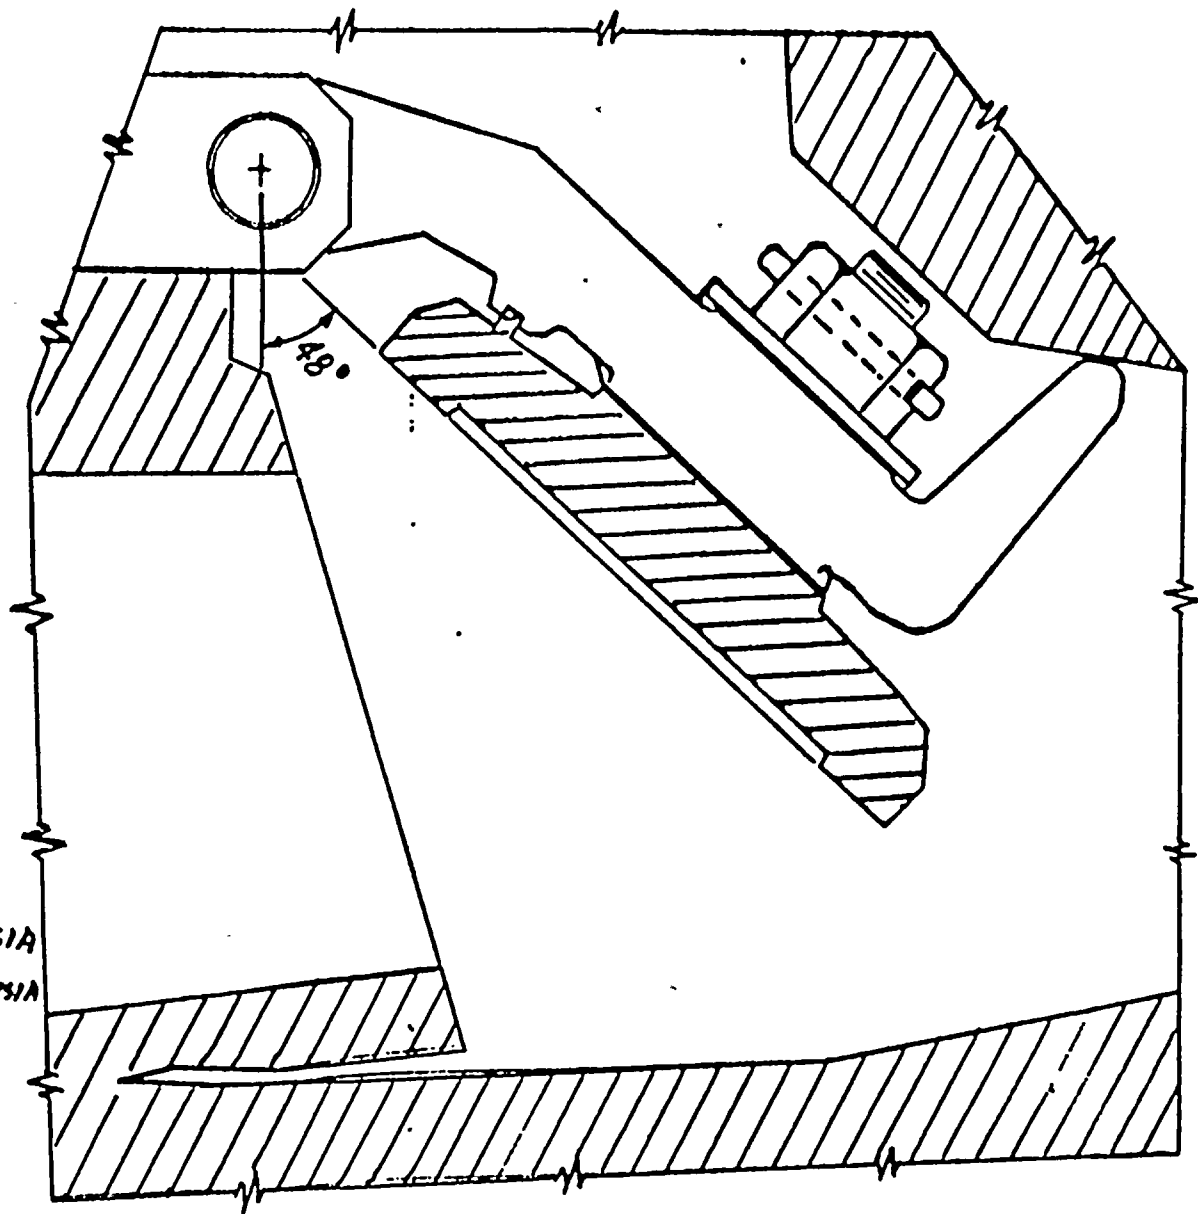
UPSTREAM PRESSURE = 1000 PSIA  
DOWNSTREAM PRESSURE = 2250 PSIA  
FORCE ACTING TO CLOSE  
VALVE WITH REVERSE  
FLOW > 15,000 LBS.
