PG&E Letter DCL-94-202

Docket No. 50-275, OL-DPR-80
Docket No. 50-323, OL-DPR-82
Diablo Canyon Units 1 and 2
Licensee Event Report 1-94-016-00
Diesel Generators Started as Designed Upon De-Energization
of Startup Bus Due to Offsite Wildfire

TITLE (4) **Diesel Generators Started as Designed Upon De-Energization of Startup Bus Due to Offsite Wildfire**

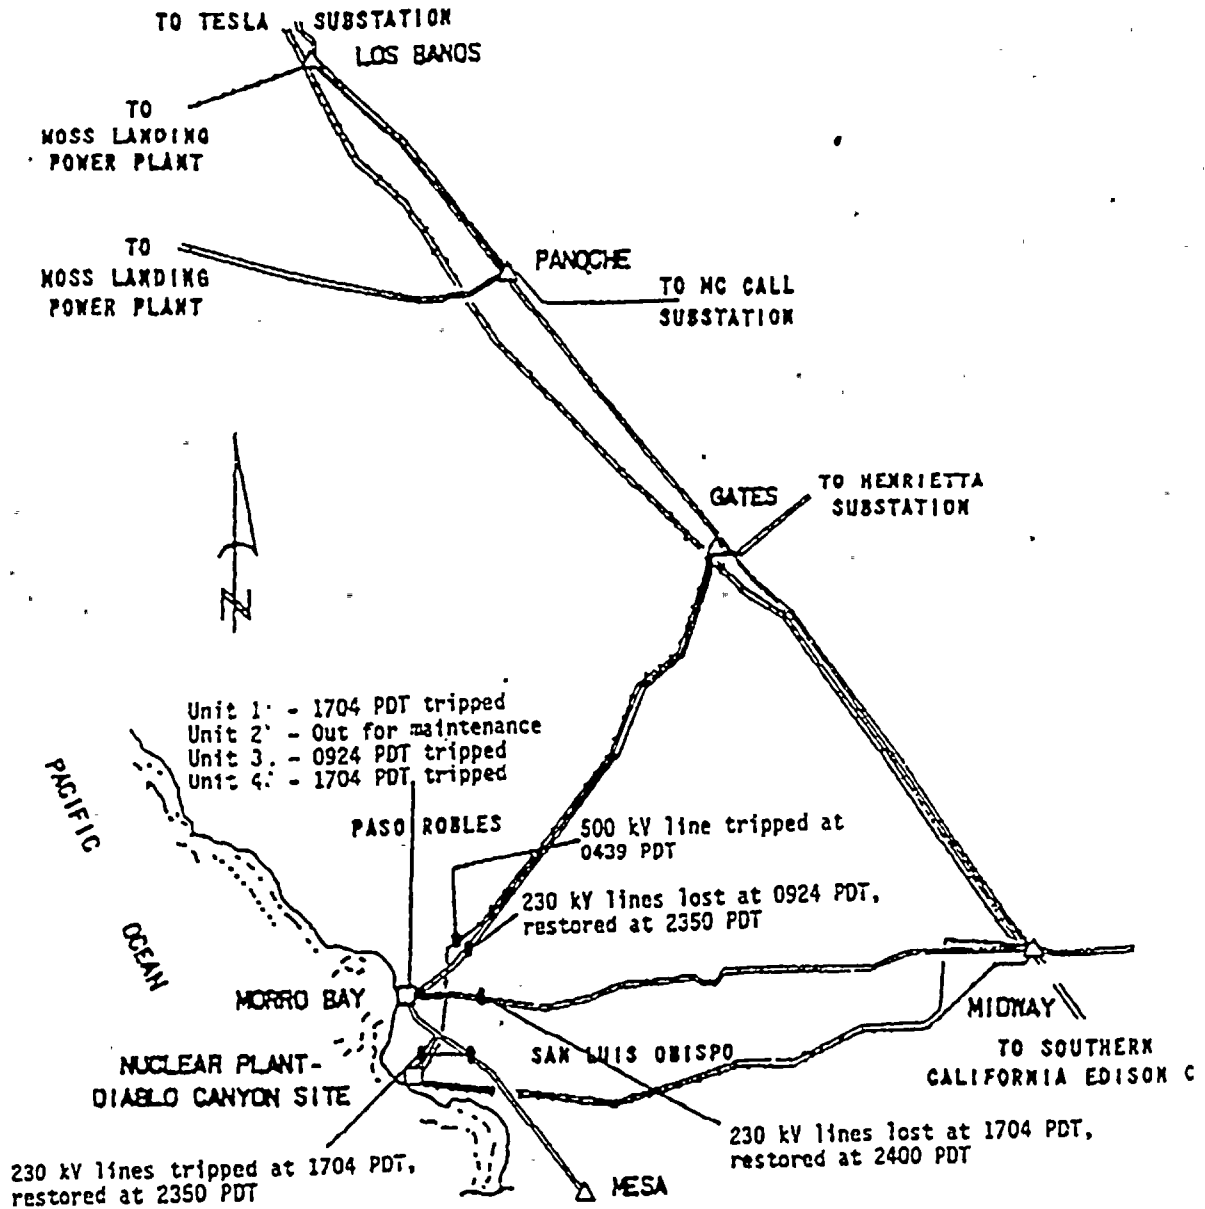
Figure 1

Standby offsite power to DCPP is provided from two 230kV lines and can be provided from three 500kV lines when the DCPP main generator is not operating. Two of the 500kV lines feed the PG&E grid through the Midway substation, and the other 500kV line feeds the PG&E grid through the Gates substation. DCPP can be fed offsite power via the main and auxiliary transformers from these three 500kV sources. Two Morro Bay-to-Mesa substation 230kV lines feed DCPP via the startup transformers and are the principle sources of startup power. These two 230kV lines are fed from four operating units at Morro Bay power station and are capable of being fed from the two 230kV lines from the Gates substation or the two 230kV lines from the Midway substation (see Figure 1).
