# LICENSEE EVENT REPORT (LER)

FACILITY NAME (1) <b>Diablo Canyon Unit 1</b>	DOCKET NUMBER (2) <b>0 5 0 0 0 2 7 5 1</b>	PAGE (3) <b>1</b> OF <b>14</b>
--	---	-----------------------------------

TITLE (4) **Engineered Safety Features Actuation System Outside Design Basis Due to High Energy Line Break Interaction With Solid State Protection System Circuits**

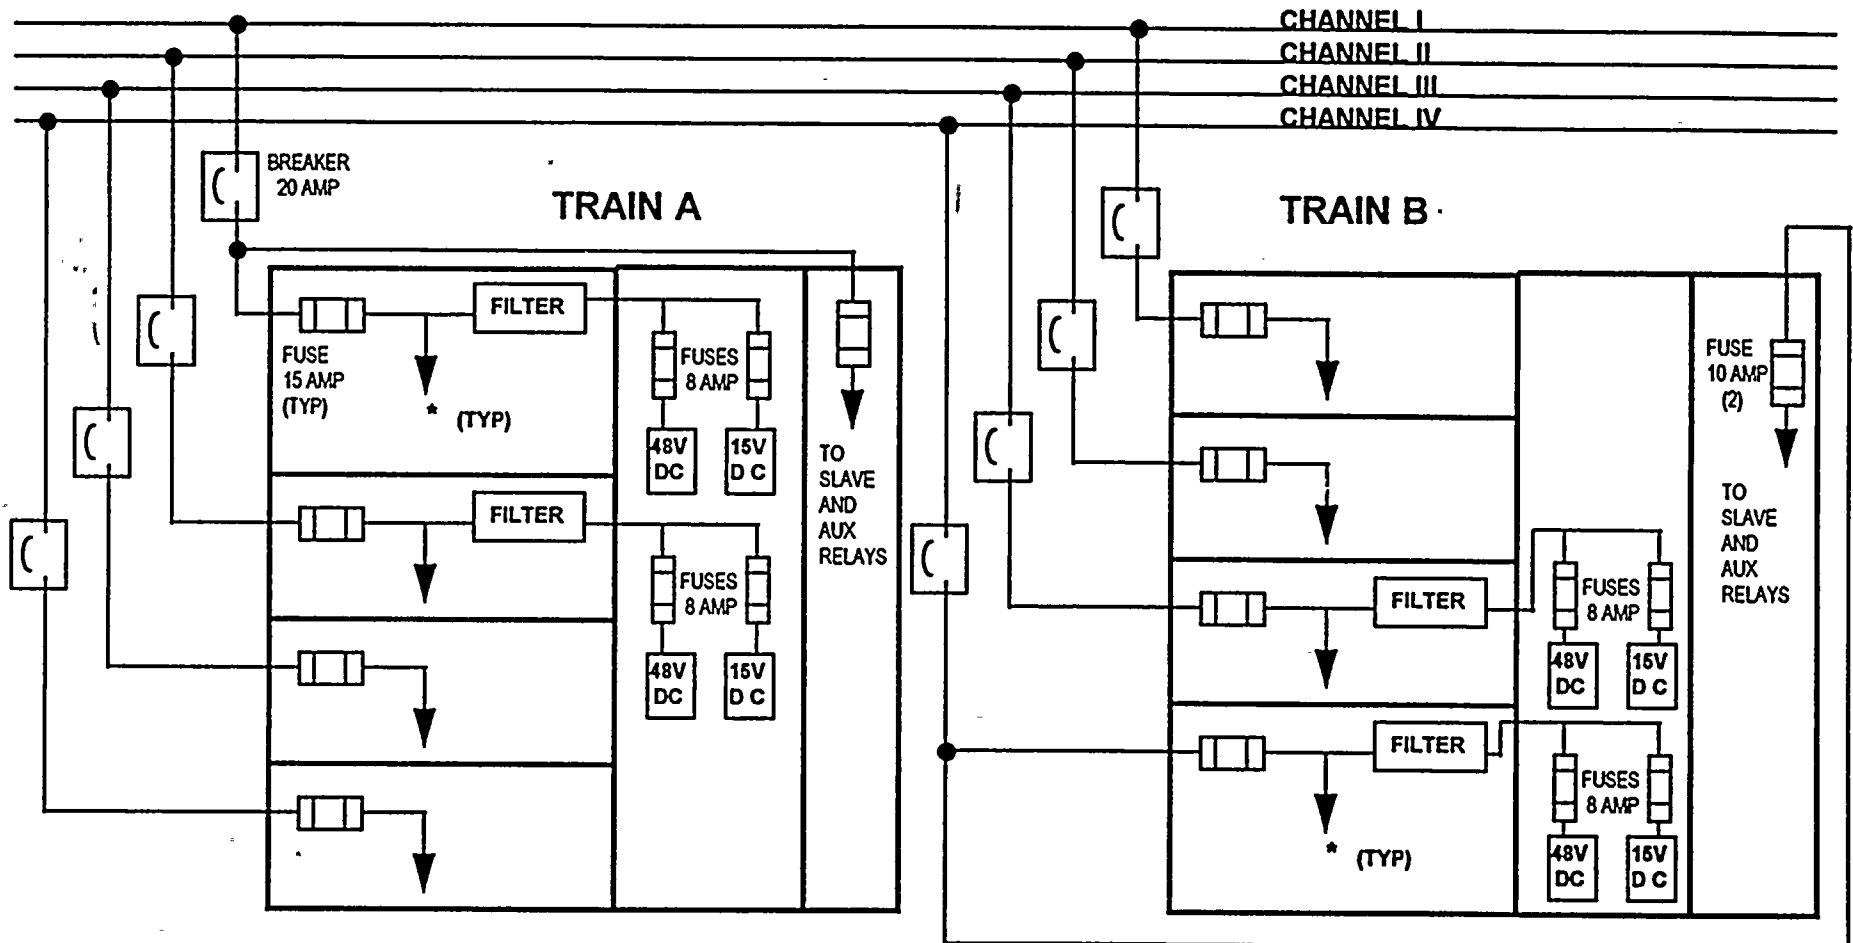
# SSPS 120 VAC POWER DISTRIBUTION BEFORE DESIGN CHANGE

On February 1, 1995, at 1025 PST, with Unit 1 and Unit 2 in Mode 1 (Power Operation) at 100 percent power, PG&E determined that a high energy line break (HELB) could result in the failure of one train of the solid state protection system (SSPS)[JG]. The occurrence of the HELB coincident with a single active failure of the other SSPS train would result in the Engineered Safety Features Actuation System (ESFAS)[JE] being outside plant design bases since two trains of SSPS would not be available to mitigate the consequences of the HELB. On February 1, 1995, at 1055 PST, a one-hour, non-emergency report was made for Unit 1 and Unit 2 in accordance with 10 CFR 50.72(b)(1)(ii)(B). Subsequent investigation has determined, for Unit 1 only, that both trains of SSPS could have been rendered inoperable by a HELB for two circuit routing locations within the turbine building [NM]. Refer to Attachments No. 1 and No. 2 for a single line representation of the SSPS.

The design changes to provide electrical isolation between the direct contact input circuitry and the Class IE SSPS power supplies, and associated post-modification testing, were completed on February 2, 1995, at 1455 PST for Unit 1 and on February 3, 1995, at 1259 PST for Unit 2. Refer to Attachment No. 2 for a "before" and "after" representation of the modification.

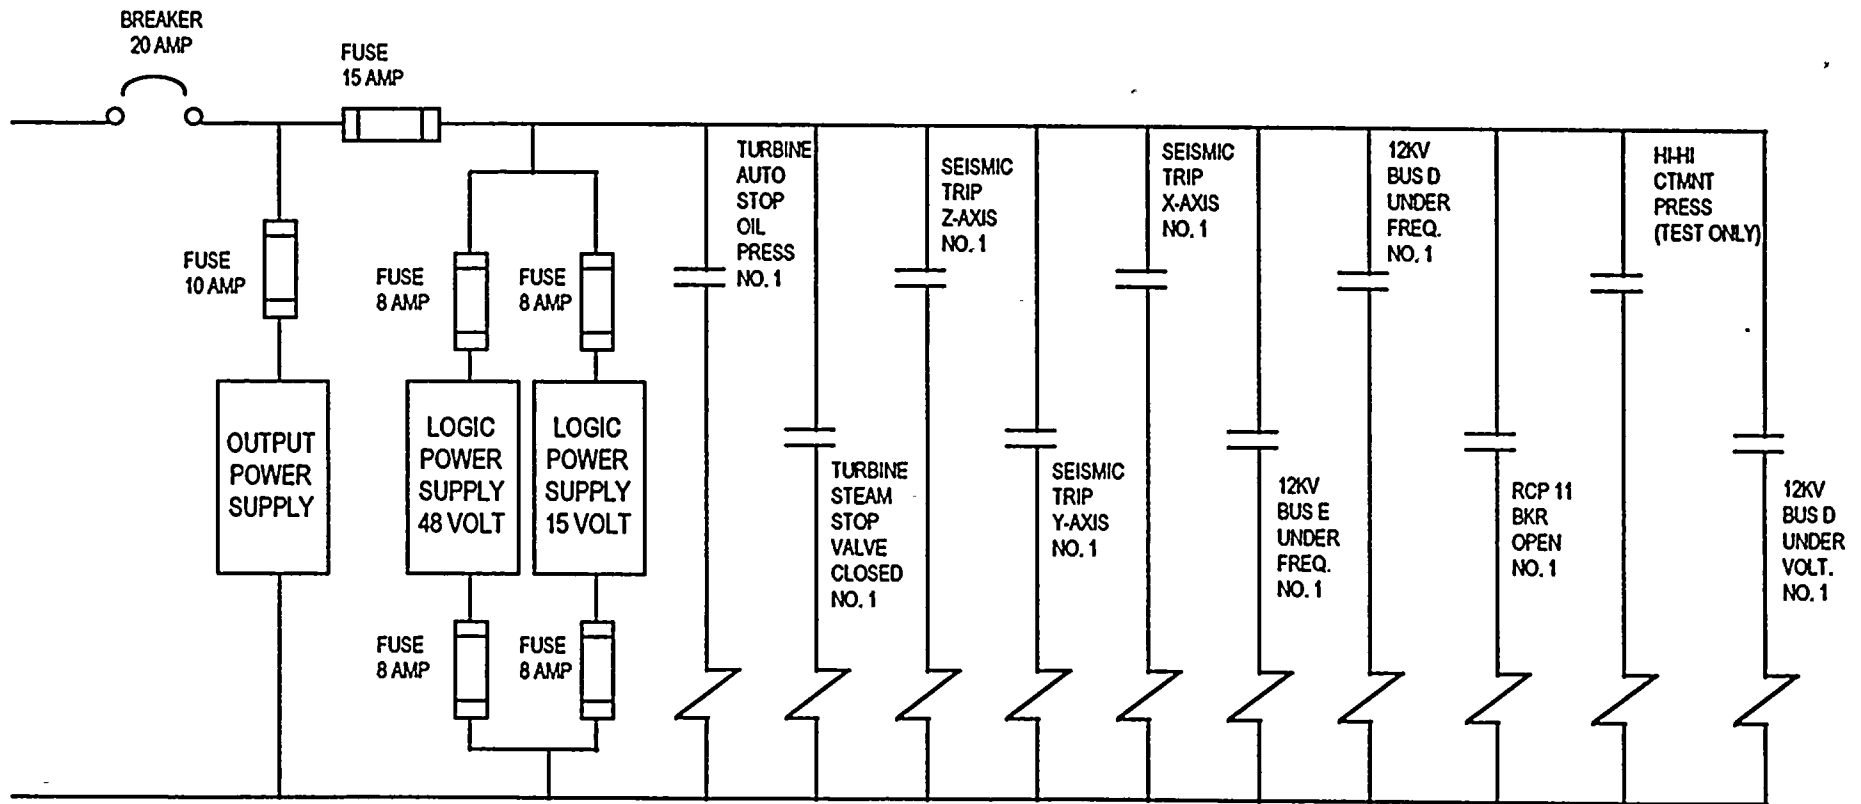
**SSPS, TRAIN A, CHANNEL 1  
SIMPLIFIED SCHEMATIC DIAGRAM OF DIRECT CONTACT INPUTS  
BEFORE DESIGN CHANGE**

On November 27, 1991, a nonconformance report (NCR) was issued to address the concern that formal documentation did not exist to demonstrate that a seismic event could not disable SSPS functions through the effects of the seismic event on certain nonsafety-grade SSPS direct contact inputs. Corrective actions for the NCR included a revised evaluation of IN 91-11, seismic analysis of the nonsafety-grade input devices and their enclosures, and an FSAR Update change. Other non-seismic design basis accidents/events were not considered. Refer to Attachment No. 2, page 1, for a schematic representation of the affected inputs.
