ACCESSION NBR: 9511300163 DOC. DATE: 95/11/20 NOTARIZED: NO DOCKET #
 FACIL: 50-275 Diablo Canyon Nuclear Power Plant, Unit 1, Pacific Ga 05000275
 AUTH. NAME AUTHOR AFFILIATION
 BEHNKE, D.H. Pacific Gas & Electric Co.
 RUEGER, G.M. Pacific Gas & Electric Co.
 RECIP. NAME RECIPIENT AFFILIATION
 Document Control Branch (Document Control Desk)

Docket No. 50-275, OL-DPR-80
Diablo Canyon Unit 1
Licensee Event Report 1-95-014-00
Diesel Generators Started and Loaded as Designed Upon Failure of Auxiliary
Transformer 1-1 Due to Inadequate/Ineffective Procedures Related to the
Control of Grounding Devices

TITLE (4) **Diesel Generators Started and Loaded as Designed Upon Failure of Auxiliary Transformer 1-1 Due to Inadequate/Ineffective Procedures Related to the Control of Grounding Devices**

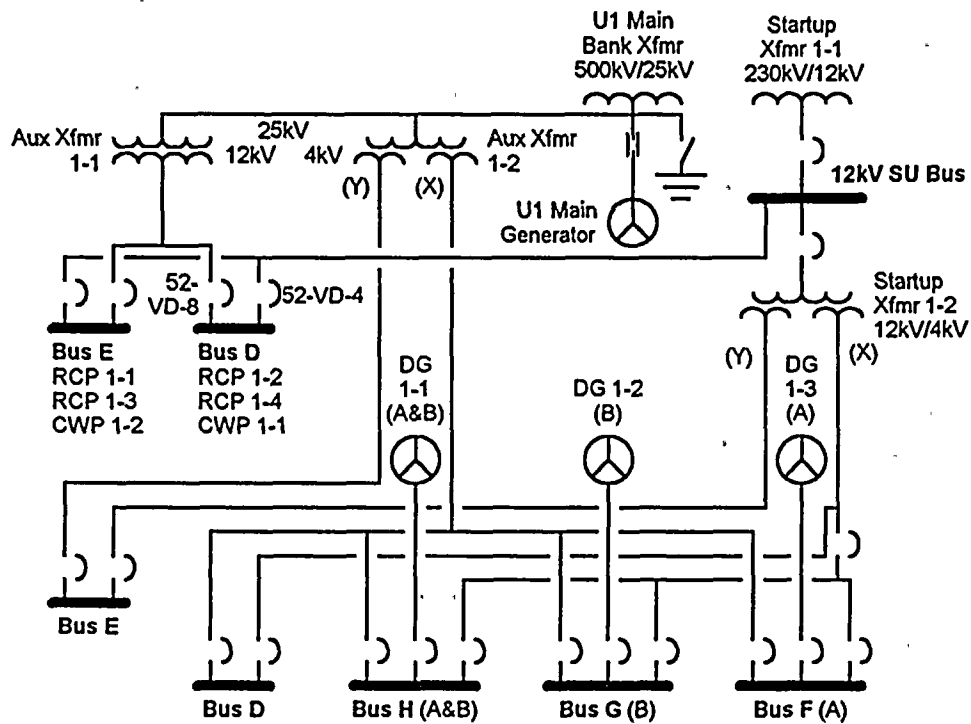
FIGURE 1

Breaker 52-VD-4 is the startup feeder breaker to 12 kV bus D (see figure 1).

Breaker 52-VD-8 is the auxiliary feeder breaker to 12 kV bus D (see figure 1).
