SUBJECT: LER 95-003-00: on 951120, TS 3.5.2 not met during ECCS on-line
 maint. Caused by personnel error. Precautions added warning
 not to clear safety injection pump coincident w/RHRP w/o
 verification. W/951221 ltr.

Docket No. 50-323, OL-DPR-82
Diablo Canyon Unit 2
Licensee Event Report 2-95-003-00
Technical Specification 3.5.2 not Met During Emergency Core Cooling System
On-Line Maintenance Due to Personnel Error

TITLE (4) **Technical Specification 3.5.2 not Met During Emergency Core Cooling System On-Line Maintenance Due to Personnel Error**

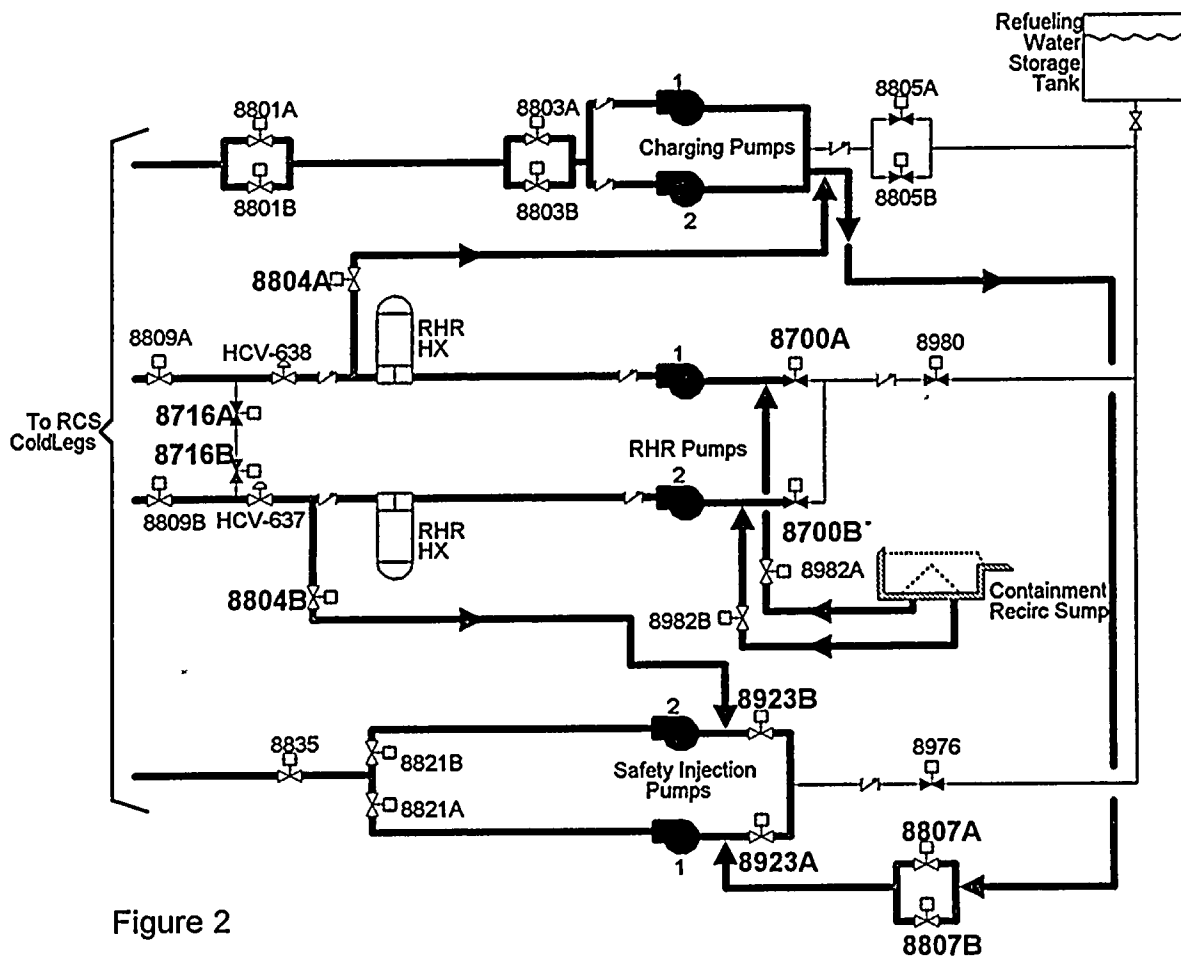
Emergency Procedure (EP) E-1.3, "Transfer to Cold Leg Recirculation," provides guidance for manual transfer from the injection phase to the cold leg recirculation phase. (Refer to Figure 2 for component and flow path alignment.) The basic ECCS realignment steps of EP E-1.3 are as follows:

1. Split Residual Heat Removal (RHR) Train discharge headers by closing motor operated valves (MOV) 8716A and 8716B.
2. Align RHR PUMP suction to the containment recirculation sumps.
3. Align RHR PUMP discharge to supply the SI and CC pumps suction by opening MOVs 8804A, 8804B, and SI/CC pumps suction cross-tie MOVs 8807A and 8807B.

With all components operable and normally aligned, either RHR pump would have provided suction to both centrifugal charging (CC) pumps through the suction cross-tie MOVs 8807A and 8807B because the SI pumps suction MOVs 8923A and 8923B would have been open.

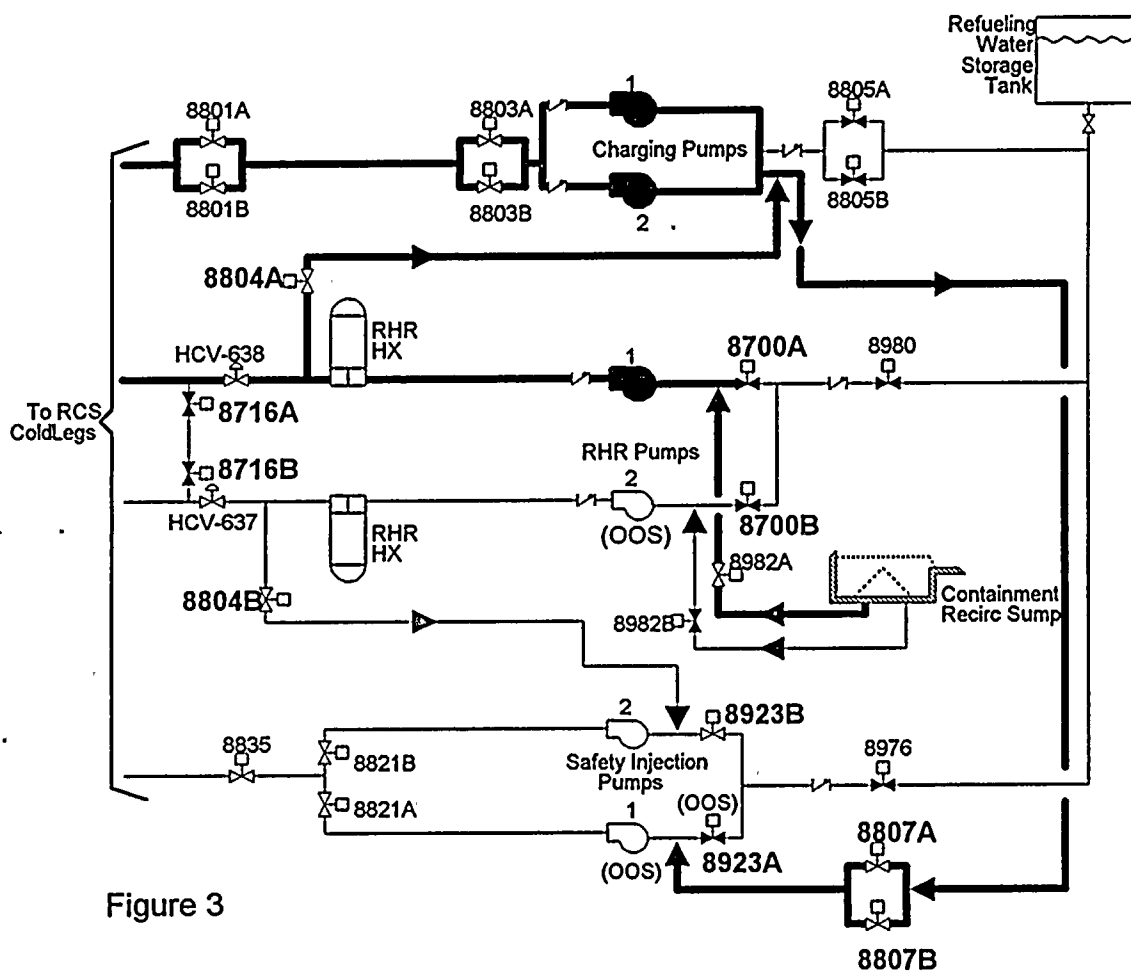
Following is the sequence that would have occurred if a LOCA had occurred in the 14 hours and 30 minutes of the event. (Refer to Figure 3 "ECCS Composite Drawing - Event Scenario - Cold Leg Recirculation Phase.")

1. SI pump 1 was cleared and therefore out-of-service (OOS).
2. RHR PUMP 2 was cleared (OOS) and therefore unable to supply SI pump 2 suction.
3. Because MOV 8923A was cleared and closed (OOS), RHR pump 1 would not have been able to supply SI pump 2 through the SI/CC pump suction cross-tie MOVs 8807A and 8807B.
4. RHR pump 1 would not have been able to supply flow to SI pump 2 through MOV 8804B because RHR cross-tie MOVs 8716A and 8716B would have been closed in accordance with EP E-1.3 as described above in II.B (Background).

Therefore, SI pump 2 would have been available only for the injection phase. Only RHR pump 1 and the two CC pumps would have been available for transferring to cold leg recirculation. This condition constituted operation outside of TS 3.5.2 since neither SI pump 1 nor SI pump 2 were capable of being transferred to cold leg recirculation.

The immediate cause of failure to comply with TS 3.5.2 was the closure and clearing of MOV 8923A concurrent with RHR PUMP 2 being out of service.
