LICENSEE EVENT REPORT (LER)

FACILITY NAME (1) Diablo Canyon Unit 1	DOCKET NUMBER (2) 0 5 0 0 0 2 7 5	PAGE (3) 1 OF 15
--	---	-----------------------------------

TITLE (4) **Engineered Safety Features Actuation System Outside Design Basis Due to High Energy Line Break Interaction With Solid State Protection System Circuits**

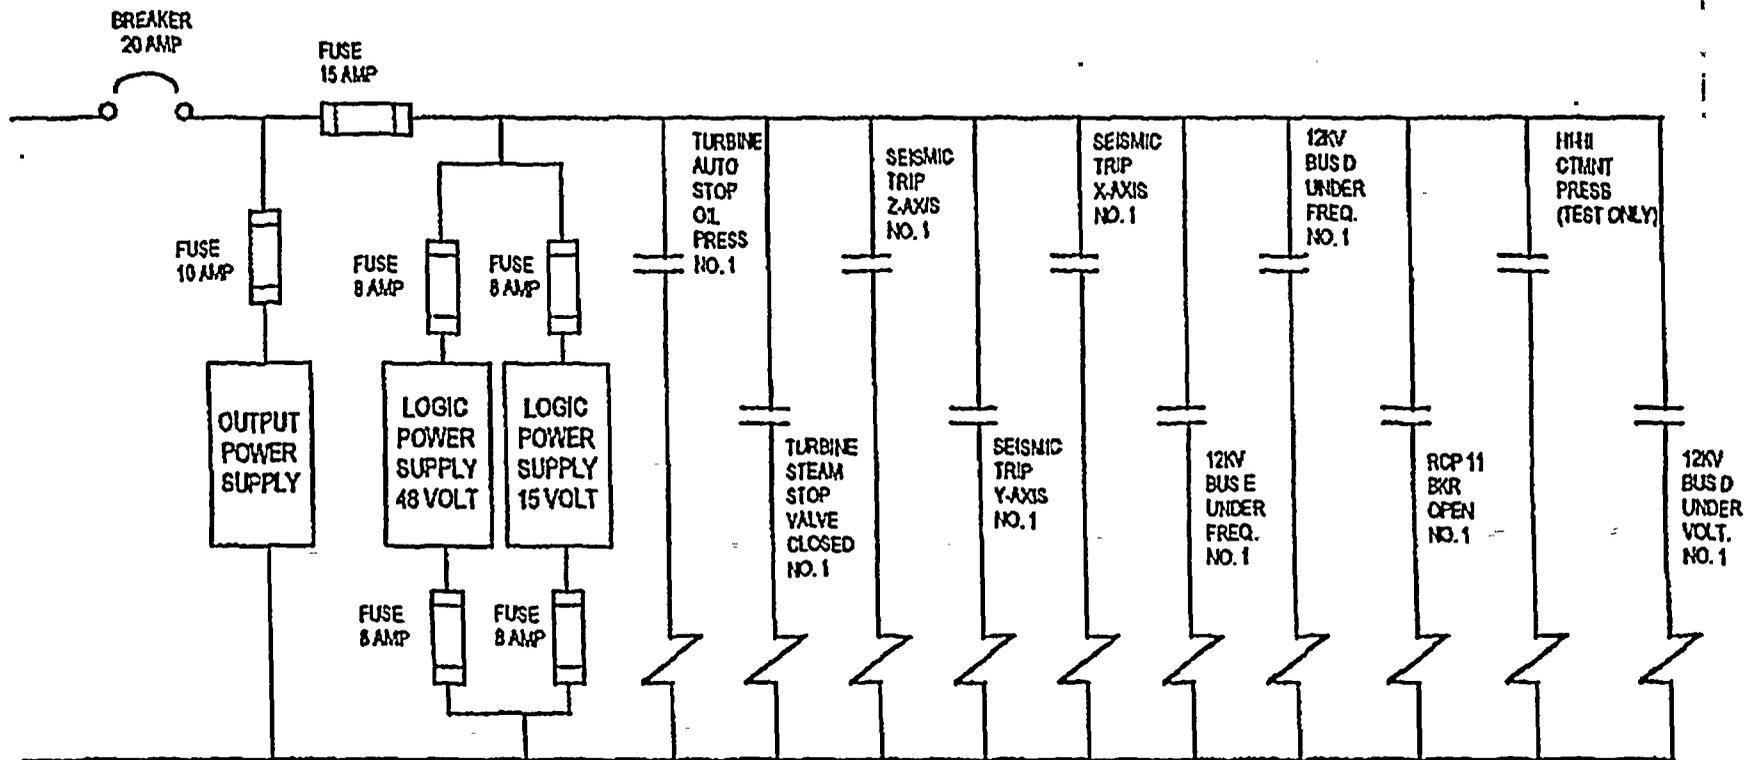
**SSPS, TRAIN A, CHANNEL 1
SIMPLIFIED SCHEMATIC DIAGRAM OF DIRECT CONTACT INPUTS
BEFORE DESIGN CHANGE**

On November 27, 1991, a nonconformance report (NCR) was issued to address the concern that formal documentation did not exist to demonstrate that a seismic event could not disable SSPS functions through the effects of the seismic event on certain non-safety grade SSPS direct contact inputs. Corrective actions for the NCR included a revised evaluation of IN 91-11, seismic analysis of the non-safety grade input devices and their enclosures, and an Updated Final Safety Analysis Report (UFSAR) change. Other non-seismic design basis accidents or events were not considered credible; however, a low priority followup (DCM open item) was assigned to investigate the potential seismic induced system interaction issue. Refer to Attachment 2, page 1, for a schematic representation of the affected inputs.
