LICENSEE EVENT REPORT (LER)

FACILITY NAME (1) Diablo Canyon Unit 1	DOCKET NUMBER (2) 0 5 0 0 0 2 7 5 1	PAGE (3) 1 OF 7
--	---	----------------------------------

TITLE (4) **Technical Specification 3.4.2.2 Not Met During Pressurizer Safety Valve Surveillance Testing Due to Random Setpoint Spread**

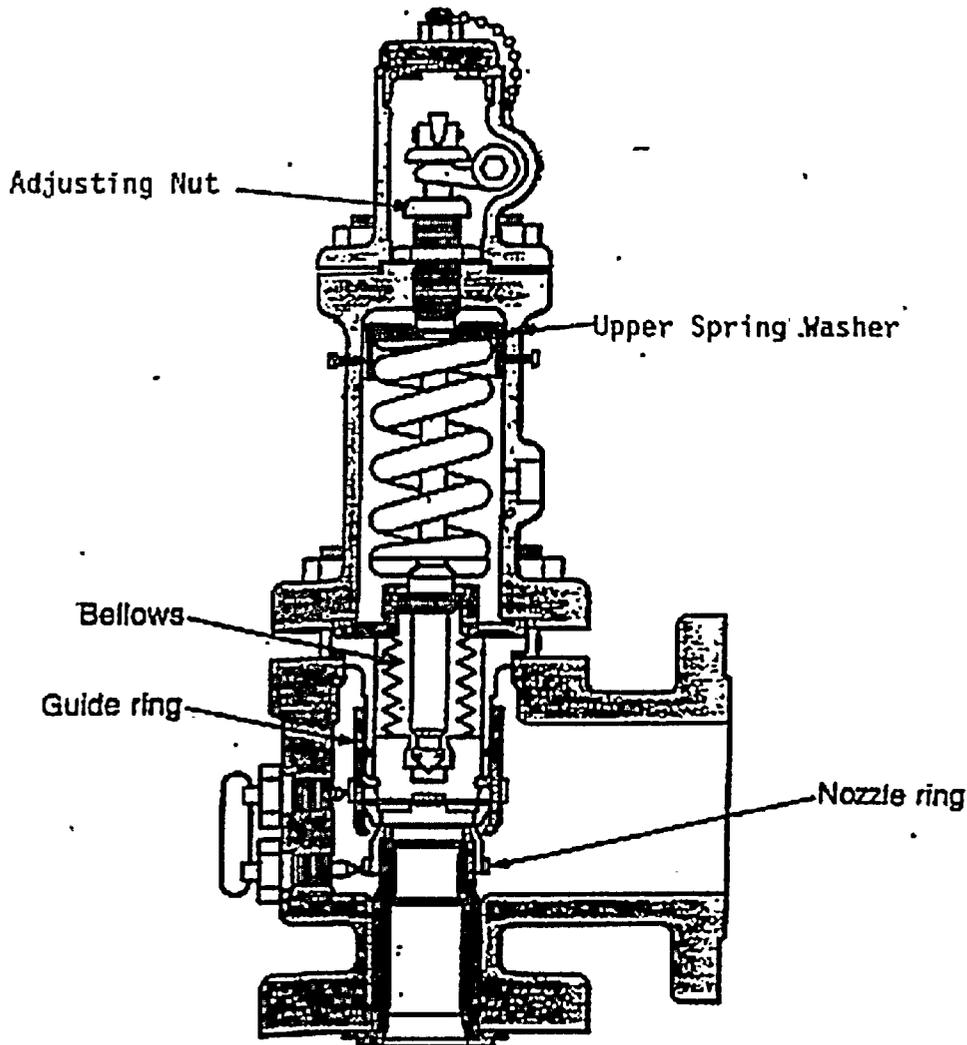
PG&E believes the large deviations in set pressure are a result of the interaction of the spring, the upper spring washer, and the nose of the adjusting bolt (see sketch, page 7) as they pivot. In a standard valve, the lower spring washer pivots around its seating surface on the lower spindle boss. The upper washer pivots in a similar manner, but it is seated against the rounded nose of the adjusting bolt. As the spring compresses, the forces compressing the spring are not evenly distributed on the washers. This is due to the machining of the spring coils at both ends of the spring to make them flat. This results in the first coil on either end being tapered. As the spring compresses, the forces are distributed around the washer in relation to the thickness of the coil. Consequently, more of the load is transferred to the thicker section of the spring resulting in the spring forces being biased and minute buckling of the spring. In addition, the rounded seating surfaces on both ends allows the spring to assume various shapes as it actuates.

A contributing cause of the measured random setpoint spread is the set pressure deviation characteristic of the valve due to minute movement of the upper spring washer. PG&E has found that a more rigidly restrained upper spring washer can reduce the setpoint deviation during controlled testing.

A prototype valve with a modified upper spring washer was developed and tested in order to reduce the minute buckling and pivoting that takes place in the standard valve arrangement. The valve with the modified washer was comparison tested to the standard valve. Testing was performed under identical environmental conditions for both valves. No adjustments were made to either valve type throughout the tests. The standard valve demonstrated a standard deviation (67 percent) of 22.5 psi. The magnitude of this value is nearly equal to the TS tolerance of 24.8 psi. The prototype valve demonstrated a standard deviation (67 percent) of 11.4 psi. PG&E has developed a design change package to implement the modified upper spring washer.

2. PG&E identified a design revision to the upper spring washer that, based upon preliminary testing, reduces the random setpoint variance of the valve by approximately 50 percent under controlled test conditions. Based upon discussions with the NRC staff, additional assurance that the PSV's performance is not altered by the design change was recommended. Due to the unavailability of a domestic facility with the capability to perform the recommended valve testing and acceptable performance demonstrated during recent testing, PG&E will not implement the modified design.
