LICENSEE EVENT REPORT (LER)

FACILITY NAME (1) Diablo Canyon Unit 2										DOCKET NUMBER (2) 0 5 0 0 0 3 2 3						PAGE (3) 1 OF 9		
TITLE (4) Manual Reactor Trip on Loss of Normal Feedwater Due to Unknown Condensate/Feedwater Transient																		
EVENT DATE (5)				LER NUMBER (6)				REPORT DATE (7)				OTHER FACILITIES INVOLVED (8)						
MON	DAY	YR	YR	SEQUENTIAL NUMBER				REVISION NUMBER				MON	DAY	YR	FACILITY NAME			
07	02	97	97	-	0	0	3	-	0	1	09	19	97					
OPERATING MODE (9)		THIS REPORT IS SUBMITTED PURSUANT TO THE REQUIREMENTS OF 10 CFR: (11)																
1		X		10 CFR		50.73(a)(2)(iv)												
POWER LEVEL (10)				OTHER														
1 0 0		(SPECIFY IN ABSTRACT BELOW AND IN TEXT, NRC FORM 368A)																
LICENSEE CONTACT FOR THIS LER (12)																		
Vickie A. Backman - Senior Regulatory Services Engineer														TELEPHONE NUMBER				
														AREA CODE		805		545-4289
COMPLETE ONE LINE FOR EACH COMPONENT FAILURE DESCRIBED IN THIS REPORT (13)

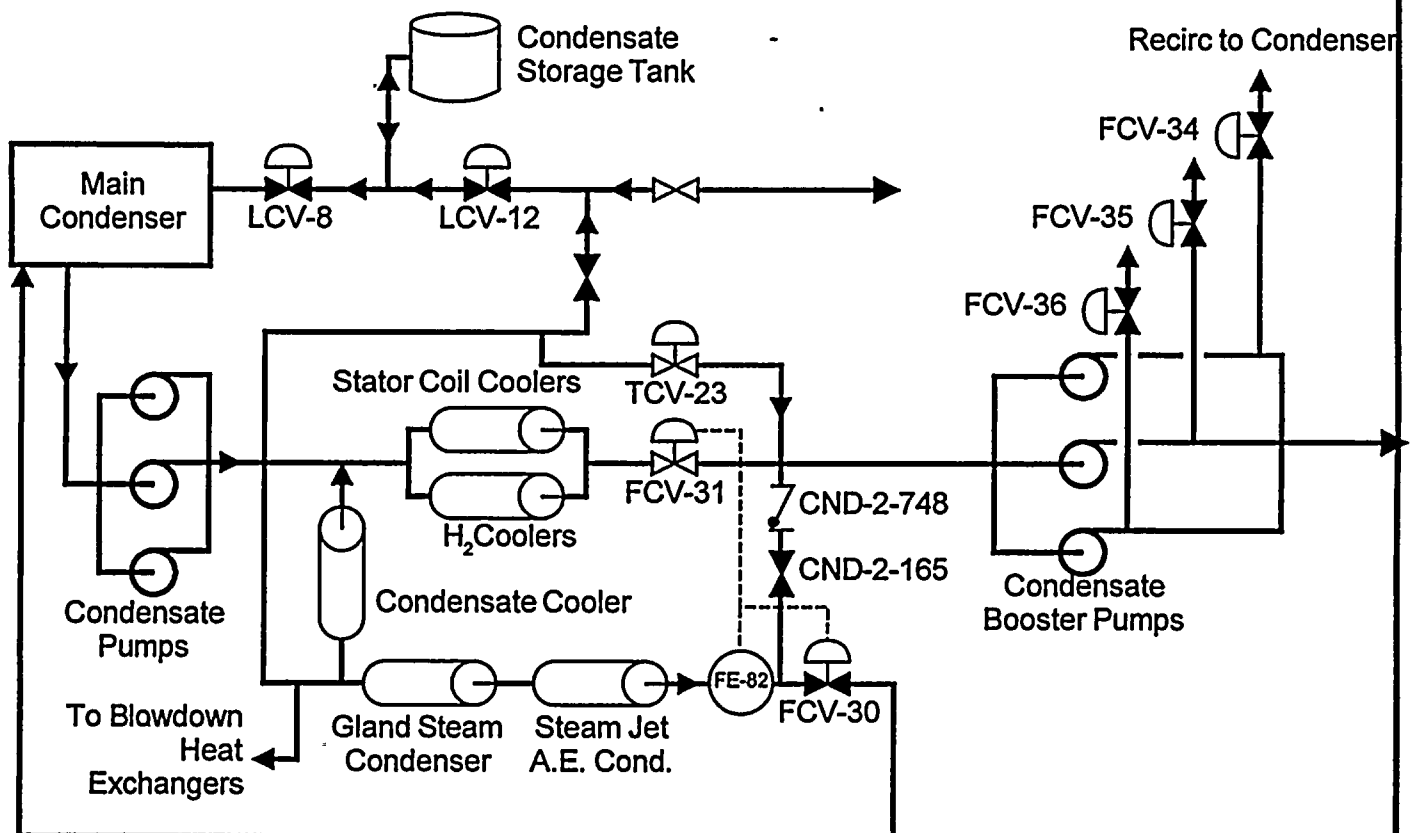
CONDENSATE SYSTEM

The condensate system [SD] provides suction to the MFWPs, as well as cooling to the main turbine generator (TG) coolers, the gland steam condenser (GSC), and steam jet air ejector (SJAЕ) condensers. A flow bypass line balances the system in response to the TG hydrogen cooling gas temperature, GSC and SJAЕ flow demand, and main feedwater (MFW) requirements (see attached "Condensate System" diagram).

Condensate pump discharge flow is distributed between the three parallel major flow paths and is controlled by three valves. The primary flow control is provided by a temperature control valve (TCV-23) in the bypass line, which reacts to TG hydrogen cooling gas temperature inputs. The secondary flow control is provided by a flow control valve (FCV-31) that responds to maintain a nearly constant GSC and SJAЕ condenser flow. The third valve (FCV-30) opens to maintain a minimum GSC and SJAЕ flow.
