LICENSEE EVENT REPORT (LER)

| FACILITY NAME (1) Diablo Canyon Unit 2 | DOCKET NUMBER (2) 0 5 0 0 0 3 2 3 | PAGE (3) 1 OF 10 |

TITLE (4)
Auxiliary-Saltwater System Was Outside its Design Basis Because 10 CFR 50, Appendix R, Requirements Were Not Met Due to Personnel Error

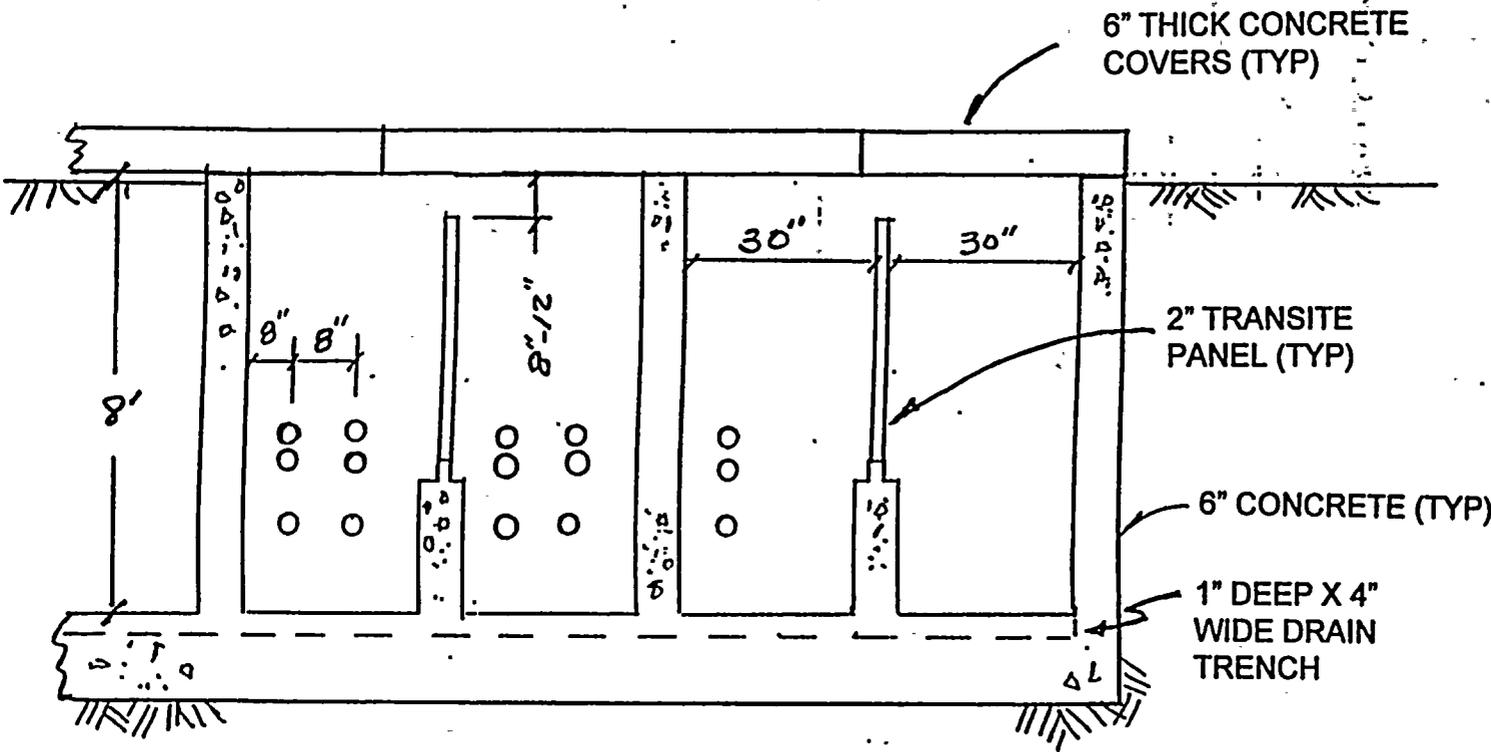
FIGURE 1

Two redundant trains of circuits associated with the Unit 2 ASW pumps (BI)(P) were found to be routed through the same pull boxes located outside of the DCPD protected area. The circuits routed through these pull boxes contain ASW 2-1 and 2-2 pump motor and exhaust fan E-102 and E-104 power cables, as well as ASW control cables. Each redundant set of cables is located in one half of the pull box separated by a 2 inch thick transite dividing panel. Each pull box is approximately 6 feet long, 5 1/2 feet wide, and 8 feet deep with the transite panel separating the pull boxes into compartments (See Figure 1). The electrical separation transite panel extends from side to side into the wall from the base of the box to within 12 inches of the pull box lid for BPO 33, and 8 inches from the pull box lid for BPO 43. The pull boxes contain a drainage gutter that penetrates both halves of the pull box and the two adjacent pull boxes. The pull box is separated from the two adjacent pull boxes by a 6 inch

concrete wall (3-hour rated fire barrier). The entire pull box is then provided with a 6 inch thick concrete lid which covers the entire opening.

SECTION - TYPICAL PULL BOX

1. PG&E will modify both pull boxes, BPOs 33 and 43, to bring them into compliance with 10 CFR 50, Appendix R, requirements.
2. PG&E will review other embedded pull boxes to ensure that all safe shutdown cabling is in compliance with 10 CFR 50, Appendix R.
