LICENSEE EVENT REPORT (LER)

FACILITY NAME (1) Diablo Canyon Unit 2	DOCKET NUMBER (2) 0 5 0 0 0 3 2 3	PAGE (3) 1 OF 10
--	---	----------------------------

TITLE (4)
Auxiliary-Saltwater System Was Outside its Design Basis Because 10 CFR 50, Appendix R, Requirements Were Not Met Due to Personnel Error

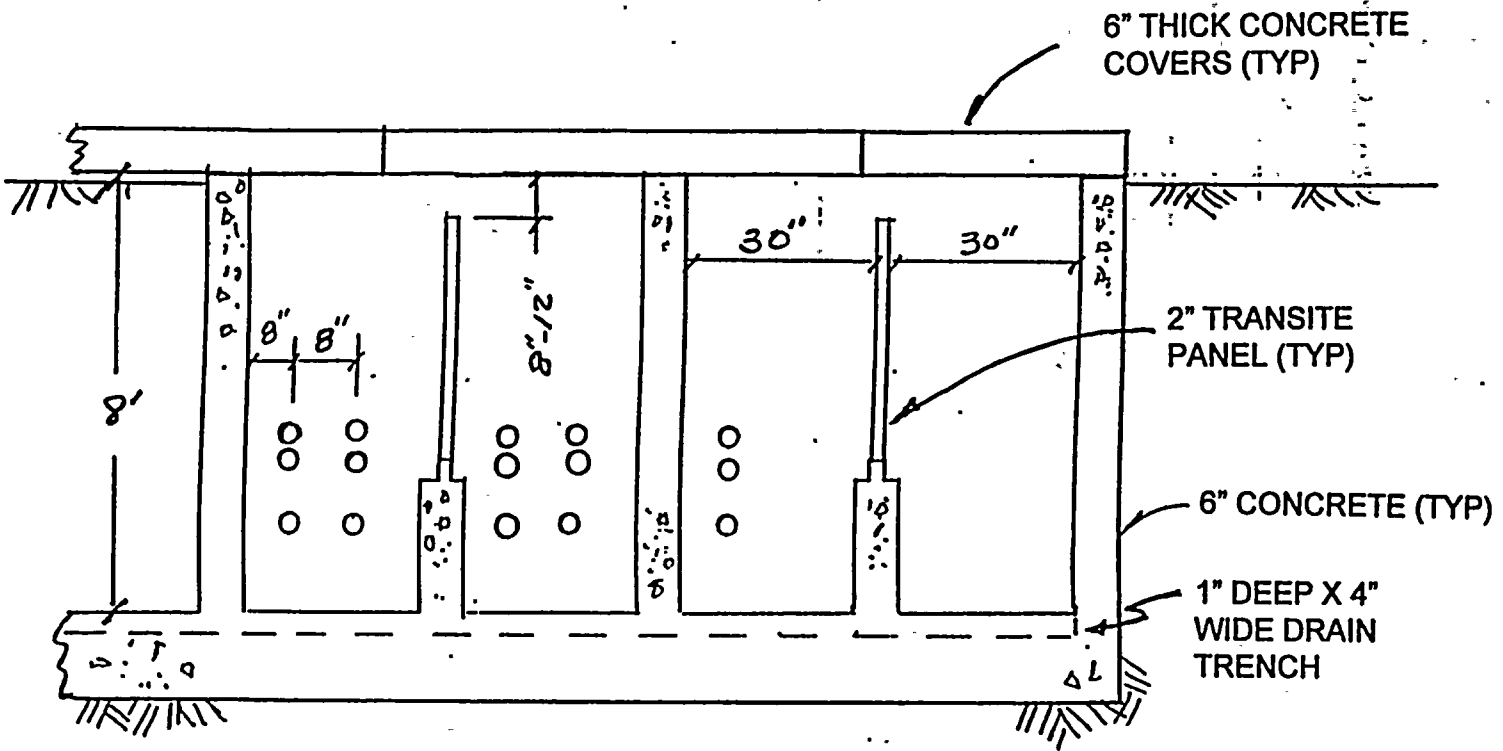
FIGURE 1

determined to be necessary to remove the pull box covers for a more detailed evaluation. The pull box covers were removed, and on October 17, 1997, at 1630 PDT, PG&E determined that ASW circuits routed through Unit 2 pull boxes BPO 33 and 43 were not entirely embedded from a fire protection standpoint, nor separated by qualified fire barrier material, and as such did not meet the requirements of 10.CFR 50, Appendix R, Section III.G.2. Thus the ASW system was outside its design basis. The circuits routed through pull boxes BPO 33 and 43 contain ASW 2-1 and 2-2 pump motor (BI)(MO) power and control cables and exhaust fan (BI)(FAN) E-102 and E-104 power cables (BI)(CBL4). A single fire in either of these pull boxes could result in the loss of both trains of ASW.

Two redundant trains of circuits associated with the Unit 2 ASW pumps (BI)(P) were found to be routed through the same pull boxes located outside of the DCPD protected area. The circuits routed through these pull boxes contain ASW 2-1 and 2-2 pump motor and exhaust fan E-102 and E-104 power cables, as well as ASW control cables. Each redundant set of cables is located in one half of the pull box separated by a 2 inch thick transite dividing panel. Each pull box is approximately 6 feet long, 5 1/2 feet wide, and 8 feet deep with the transite panel separating the pull boxes into compartments (See Figure 1). The electrical separation transite panel extends from side to side into the wall from the base of the box to within 12 inches of the pull box lid for BPO 33, and 8 inches from the pull box lid for BPO 43. The pull boxes contain a drainage gutter that penetrates both halves of the pull box and the two adjacent pull boxes. The pull box is separated from the two adjacent pull boxes by a 6 inch

concrete wall (3-hour rated fire barrier). The entire pull box is then provided with a 6 inch thick concrete lid which covers the entire opening.

1. PG&E will modify both pull boxes, BPOs 33 and 43, to bring them into compliance with 10 CFR 50, Appendix R, requirements.
2. PG&E will review other embedded pull boxes to ensure that all safe shutdown cabling is in compliance with 10 CFR 50, Appendix R.
