SUBJECT: LER 94-006-01: on 940624, determined that throttled component cooling water flow rate to CCP skids may not have been high enough to maintain post-accident CCP operability. Caused by human error. Calculations revised. W/950615 ltr.

Docket No. 50-275, OL-DPR-80
Docket No. 50-323, OL-DPR-82
Diablo Canyon Units 1 and 2
Licensee Event Report 1-94-006-01
Centrifugal Charging Pump Outside Design Basis Due to Throttling of
Component Cooling Water to Subcomponents

LICENSEE EVENT REPORT (LER) TEXT CONTINUATION

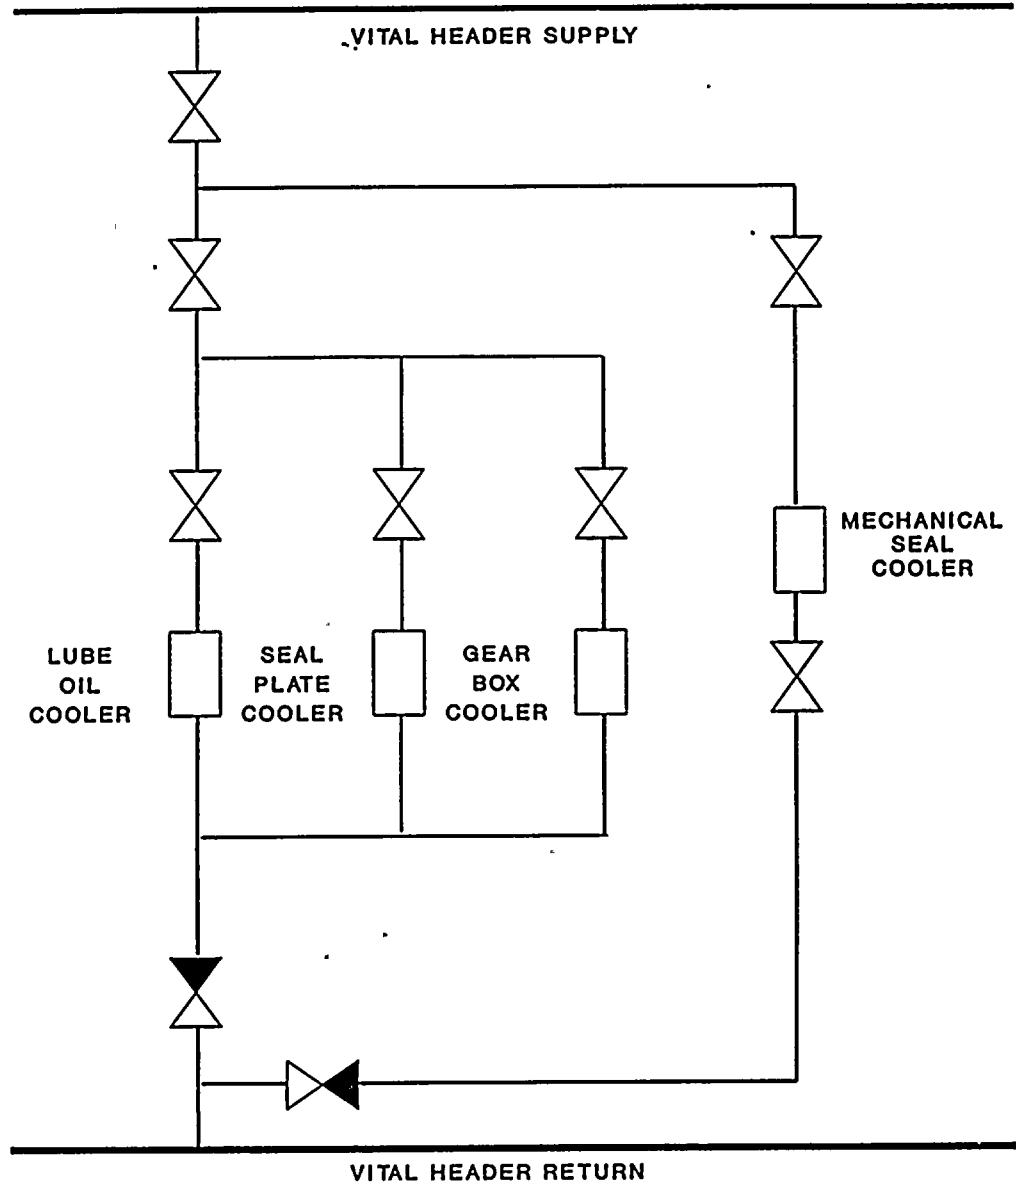
Figure 1

plate heat exchangers have no minimum flow requirement. A header provides CCW flow to the CCP skid, and a common discharge header throttle valve exists downstream of the lube oil heat exchanger (see Figure 1).

The immediate cause of this event was the throttling of CCW flow to the CCP skid subcomponent heat exchangers.

The root cause of this event was human error, in that there was an inadequate understanding of design basis. The PG&E start-up testing organization did not understand that acceptable cooling for normal CCP operation (using the throttling valves) would not provide adequate cooling flow for post-accident operation conditions.

TYPICAL COMPONENT COOLING WATER SCHEMATIC FOR THE CENTRIFUGAL CHARGING PUMP SKID

1. The throttle valve downstream of the CCP lube oil cooler on each skid was fully opened and sealed in position pending further investigation.
