SUBJECT: Forwards revised request for relief for non-welded repair
using ASME Code Case N-523 of main Unit 2 SG instrumentation
piping connection.

PG&E Letter DCL-95-216

Docket No. 50-323, OL-DPR-82
Diablo Canyon Unit 2
Request for Relief for a Temporary Repair of the Unit 2 Main Steam Generator
Instrumentation Piping Connection Utilizing ASME Code Case N-523

**REQUEST FOR RELIEF FOR A TEMPORARY REPAIR OF UNIT 2 MAIN
STEAM GENERATOR INSTRUMENTATION PIPING CONNECTION UTILIZING
ASME CODE CASE N-523**

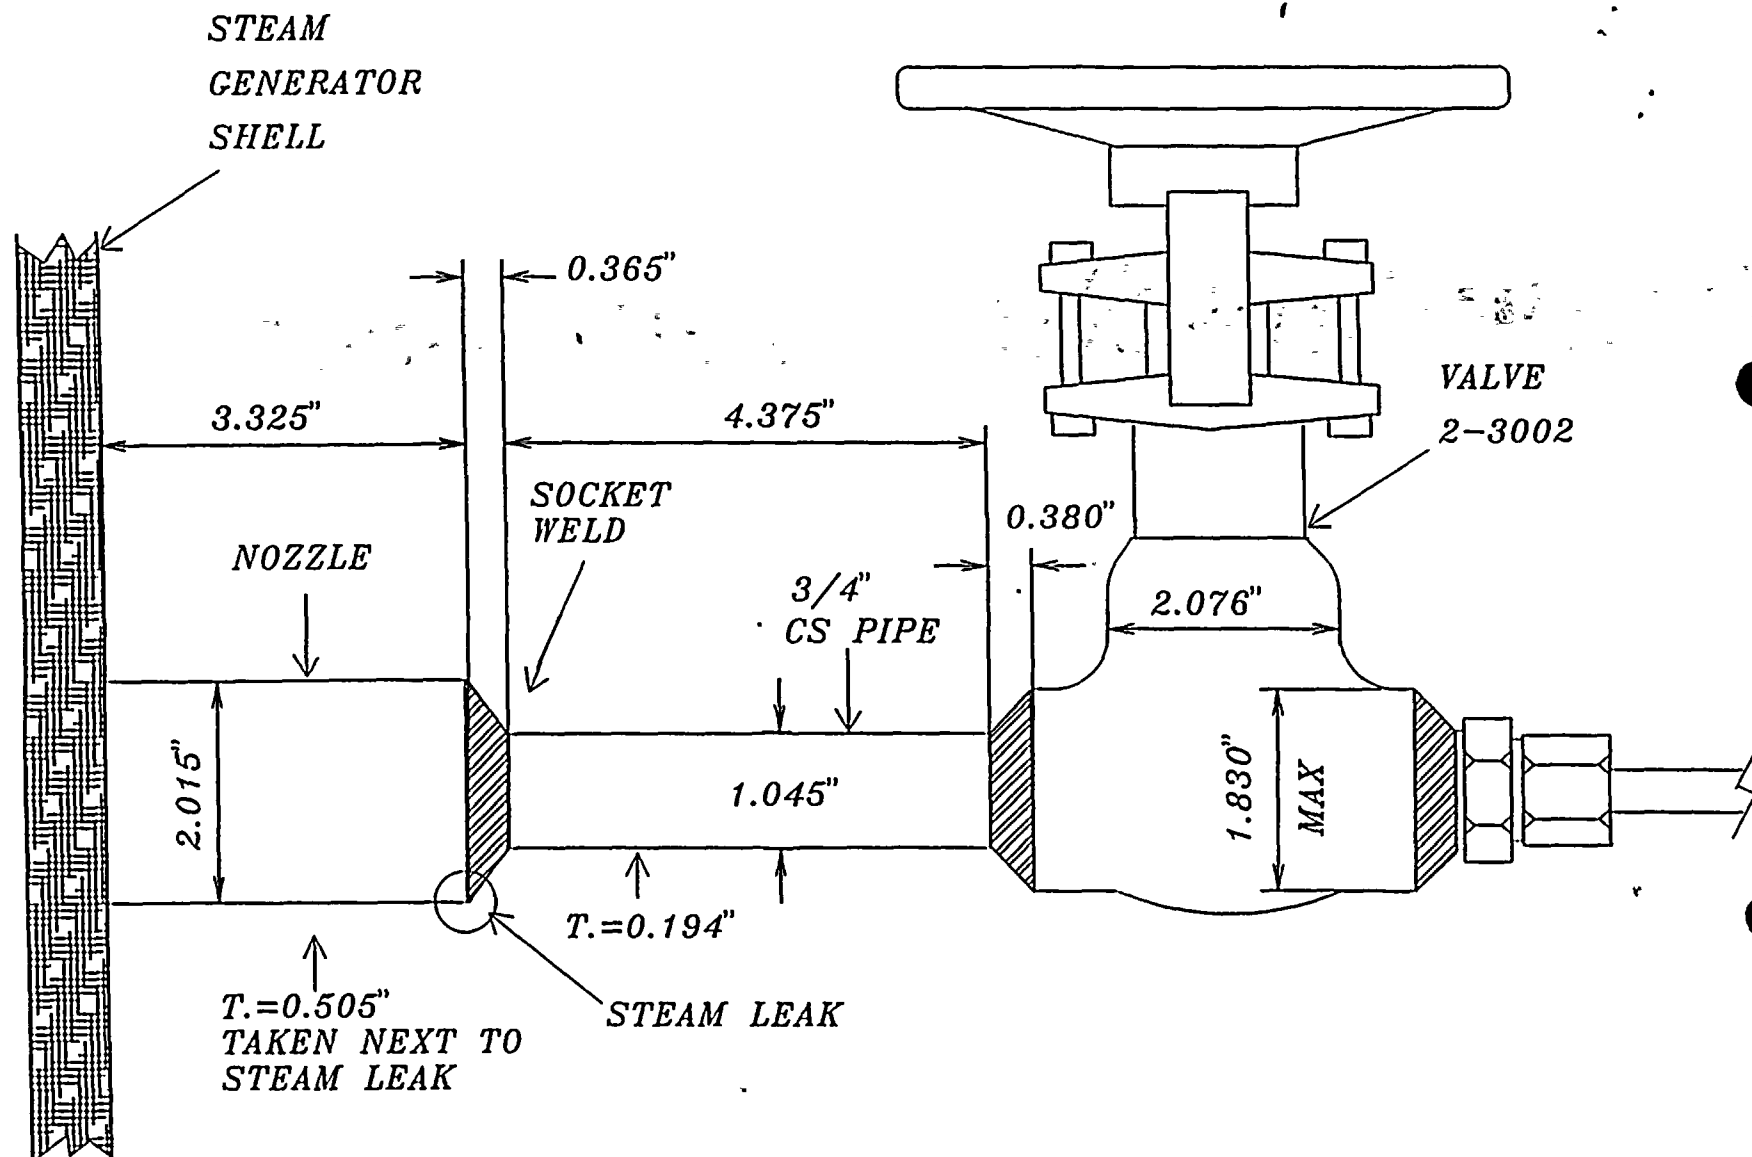
AR# A0377877

The flaw is at the toe of the socket weld of the 3/4 inch pipe to the SG 2-3 nozzle. It appears to be a pinhole type leak based upon a visual inspection. There is no evidence of any linearity to the leak opening. The flaw is believed to have originated in the inner diameter of the pipe. The flaw is believed to be due to the result of a very localized weld defect present since initial construction that recently progressed through the remaining weld material.

DCPP 2 STEAM GENERATOR LEVEL INDICATOR
 "STEAM LEAK 9-8-95

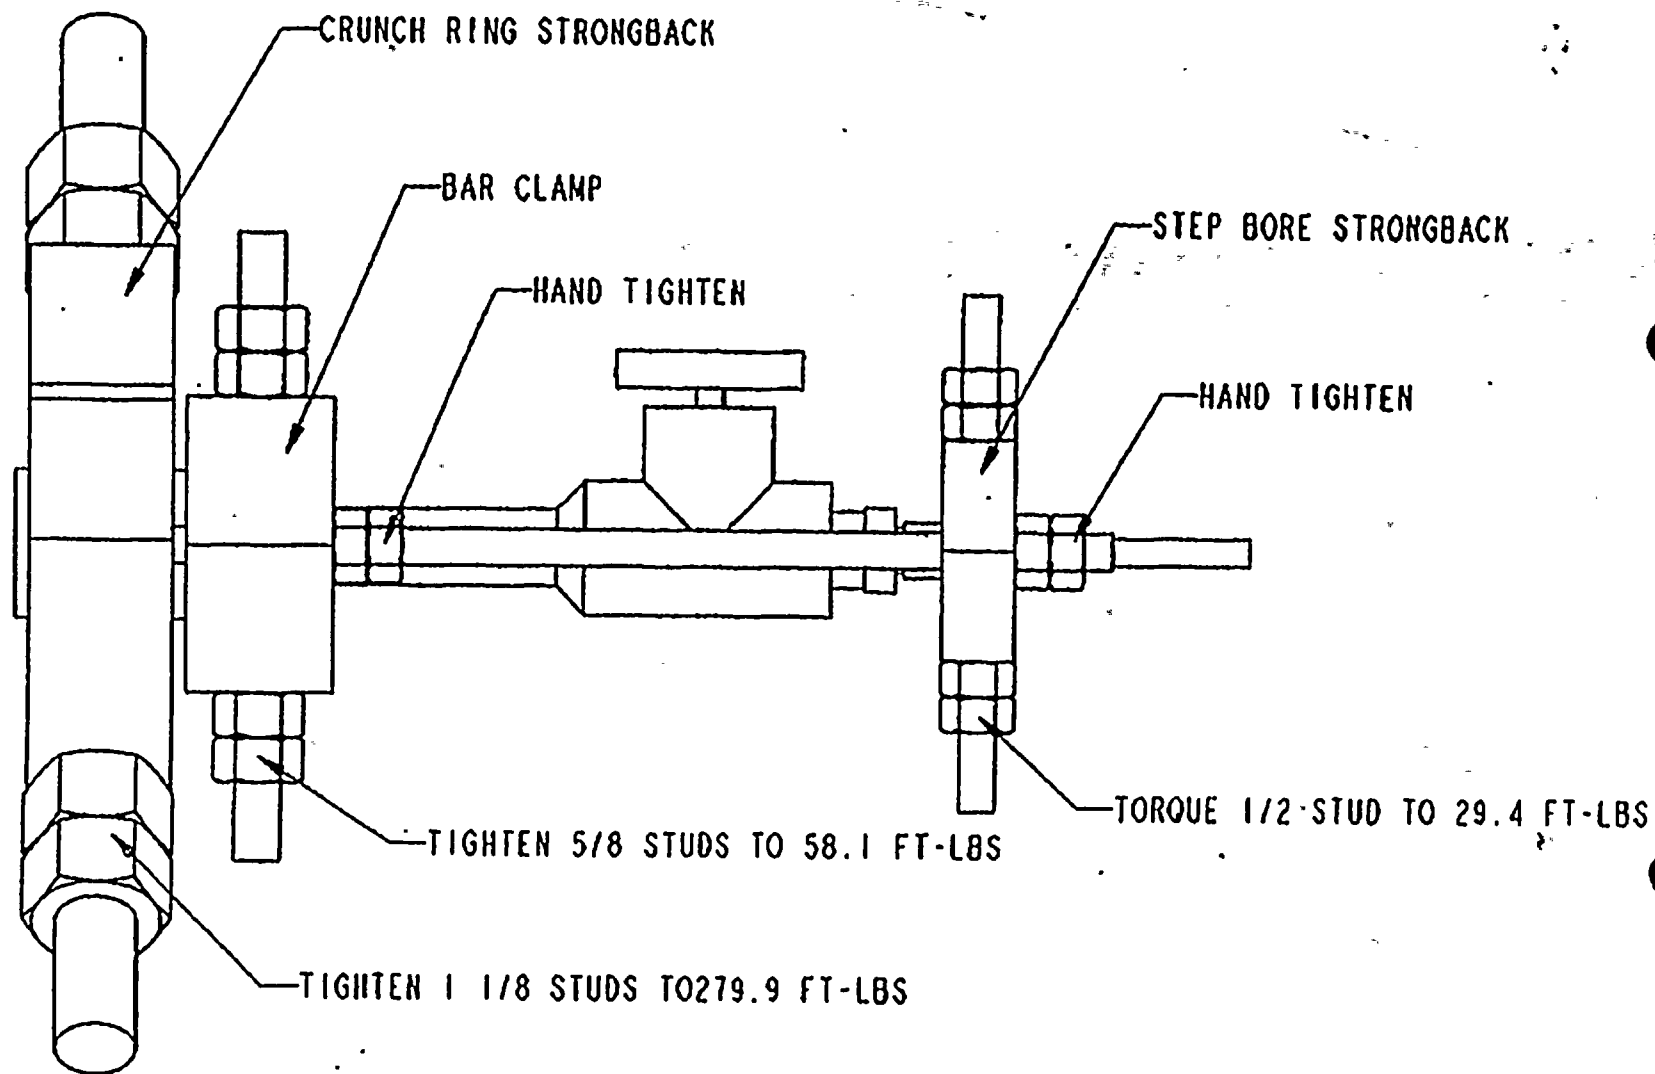
MAXIMUM INJECTION PRESSURE 2122 PSI + STATIC
A/R #A0377877
EQUIP #LT-536 & 537

An engineered mechanical clamp, designed to meet the load requirements of the piping, was installed September 25, 1995, consistent with the requirements of Code Case N-523 and verbal NRC approval of DCL-95-201, dated September 21, 1995. The clamp design with its associated strongback is shown in Attachment 2.

The clamp is designed for the line design condition of 1415 psig at 600 degrees F and sealant injection pressure of 2122 psig, which is 1.5 times the design pressure (1415 psig).
