SUBJECT: LER 95-009-02: on 940928, TS 3.4.2.1 & 3.4.2.2 were not met during pressurizer code safety valve surveillance testing due to random setpoint spread. Reset Unit 1 PSVs to required tolerance using STP-M-77.W/951107 ltr.

Docket No. 50-275, OL-DPR-80
Diablo Canyon Unit 1
Licensee Event Report 1-94-009-02
Technical Specification 3.4.2.1 and 3.4.2.2 Not Met During Pressurizer Safety
Valve Surveillance Testing Due to Random Setpoint Spread

TITLE (4) **Technical Specification 3.4.2.1 And 3.4.2.2 Not Met During Pressurizer Code Safety Valve Surveillance Testing Due to Random Setpoint Spread**

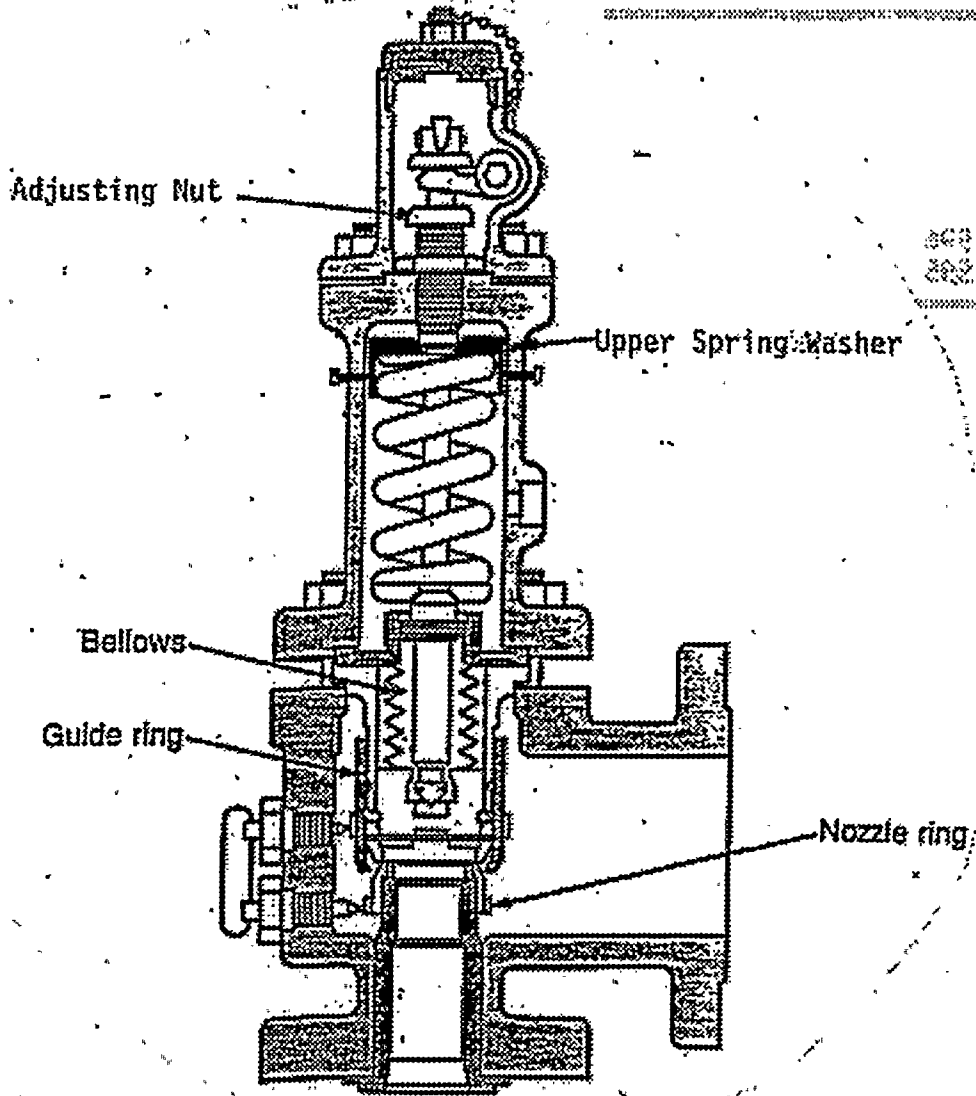
The large deviations in set pressure are a result of the interaction of the spring, the upper spring washer, and the nose of the adjusting bolt (see sketch, page 6) as they pivot. In a standard valve, the lower spring washer pivots around its seating surface on the lower spindle boss. The upper washer pivots in a similar manner, but it is seated against the rounded nose of the adjusting bolt. As the spring compresses, the forces compressing the spring are not evenly distributed on the washers. This is due to the machining of the spring coils at both ends of the spring to make them flat. This results in the first coil on either end being tapered. As the spring compresses, the forces are distributed around the washer in relation to the thickness of the coil. Consequently, more of the load is transferred to the thicker section of the spring resulting in the spring forces being biased and minute buckling of the spring. In addition, the rounded seating surfaces on both ends allows the spring to assume various shapes as it actuates.

A contributing cause of the measured random setpoint spread is the set pressure deviation characteristic of the valve. PG&E has found that a more rigidly restrained upper spring washer can reduce the setpoint deviation during controlled testing.

A prototype valve with a modified upper spring washer was developed and tested in order to reduce the minute buckling and pivoting that takes place in the standard valve arrangement. The valve with the modified washer was comparison tested to the standard Crosby valve. Testing was performed under identical environmental conditions for both valves. No adjustments were made to either valve type throughout the tests. The standard Crosby valve demonstrated a standard deviation (67 percent) of 22.5 psi. The magnitude of this value is nearly equal to the TS tolerance of 24.8 psi. The prototype Crosby valve demonstrated a standard deviation (67 percent) of 11.4 psi.
