PG&E Letter DCL-96-072

Docket No. 50-275, OL-DPR-80
Docket No. 50-323, OL-DPR-82
Diablo Canyon Units 1 and 2
Licensee Event Report 1-85-043-00
Technical Specification 3.3.2, Table 3.3-3, Action 18, Not Met When
Containment Purge Valves Were Opened Without a Valid Current Slave Relay
Test Due to an Inadequate Procedure

TITLE (4) **Technical Specification 3.3.2, Table 3.3-3, Action 18, Not Met When Containment Purge Valves Were Opened Without a Valid Current Slave Relay Test Due to an Inadequate Procedure**

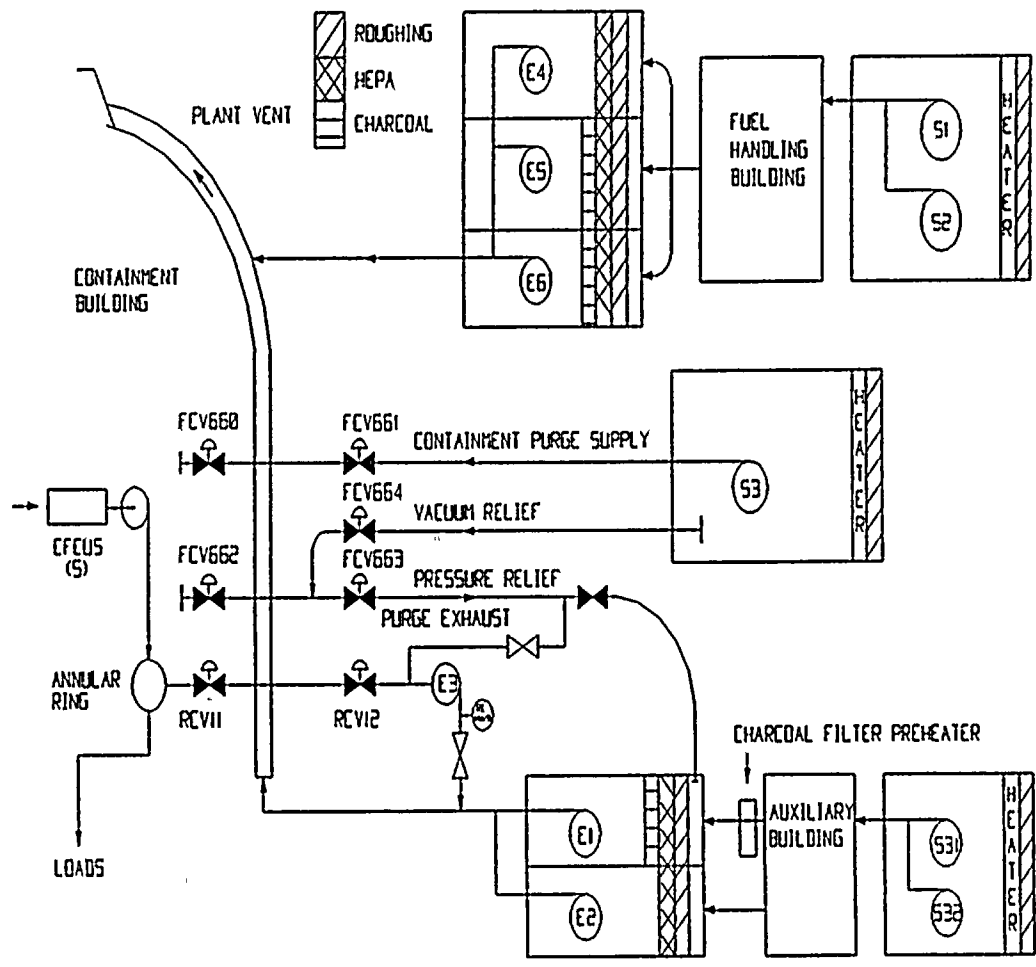
FIGURE 1
Containment Purge and Relief Valves

The containment purge supply and exhaust system (VA) consists of two 48 inch (one purge and one exhaust) and one 12 inch (vacuum relief and exhaust) penetrations between containment and the Auxiliary Building ventilation system (VF) (see Figure 1). There are seven valves (VA)(V) in this system, all of which close automatically when a containment ventilation isolation (CVI) signal (JE) is generated. The valves are divided into two groups, with the three valves inside containment associated with CVI train A and the four valves outside containment associated with CVI train B. The trains and their associated relays make up the two channels of CVI required by TS Table 3.3-3.
