RE: LQD 2015-2016 Annual Inspection Report, Uranium One, Willow Creek ISR Project, Permit No. 478

IN SITU MINE INSPECTION REPORT

Permit Number: PT0478	Permittee: URANIUM ONE USA INC
Inspection Date: 10/18/2016	Inspector(s): Luke McMahan
Report Date: 12/1/2016	Participant(s): Scott Schierman, Kevin Filbert
Last Inspection: 12/29/2015	Current Bond: \$21,672,638
Inspection Reason(s): Annual	Field Conditions: Clear, calm, dry ~60°
	Approval Date: 4/18/1978

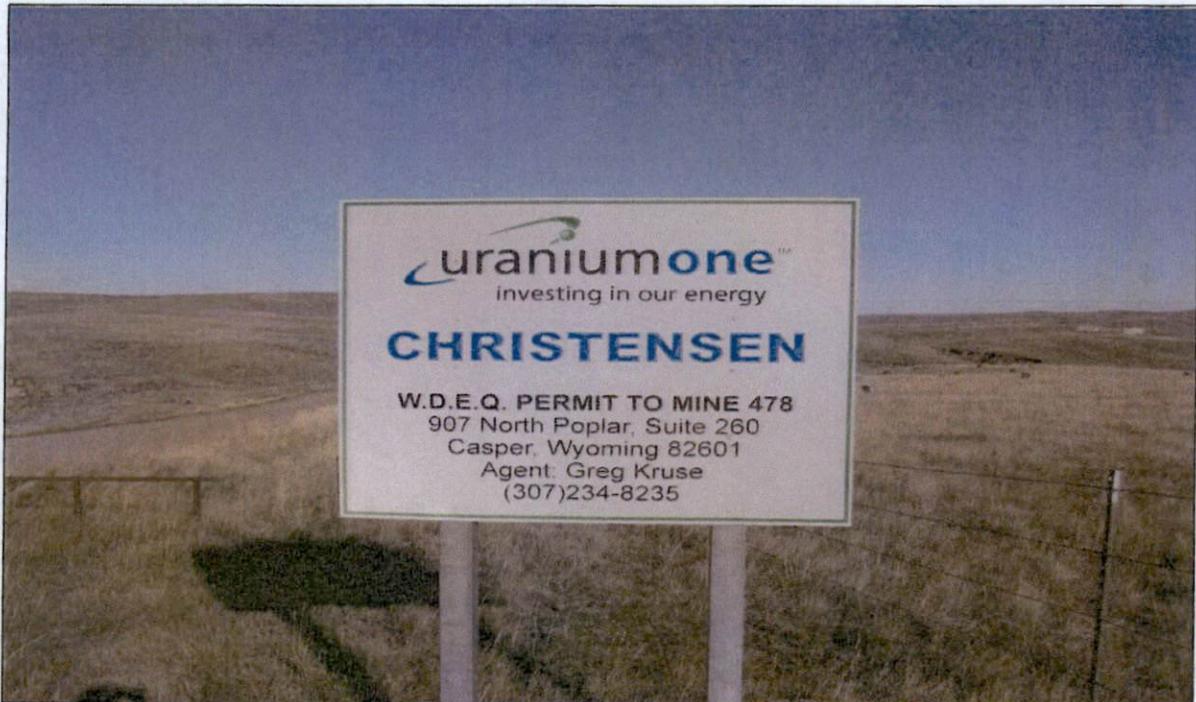
<ul style="list-style-type: none"> • Signs 	Yes
<p>The permit signs for Irigaray and Christensen Ranch have been updated with the current agent (Photos #1 & #11).</p>	
<ul style="list-style-type: none"> • Topsoil Stockpiles 	Yes
<p>All topsoil stockpiles viewed were stable, well vegetated and posted with a topsoil identification sign (Photo #9).</p>	
<ul style="list-style-type: none"> • Vegetation 	Yes
<p>Areas of interim vegetation (MU8 & MU10) were observed. Interim vegetation in Module 8-4/5 of Mine Unit 8 continues to be sparse, however erosion control efforts are preventing significant erosion at this time. Interim vegetation in Mine Unit 10 appears to be established (Photo #10).</p>	
Well Field Development	N/A
<ul style="list-style-type: none"> • Drilling Activity 	Yes
<p>Pilot holes in Mine Unit 10B (Modules 10-7 & 10-8) remain temporarily capped (Photo #10). The Mine continues to monitor and report the absence or presence of water in the open portion of a select number of temporarily capped pilot holes. Uranium One has provided LQD with information demonstrating that the plug gel in the pilot holes remains approximately 50 feet above the shallow groundwater in the area. As of this inspection, monitoring of these pilot holes has not identified groundwater in the open portion above the plug gel in the boreholes.</p>

Photo #1: Christensen Ranch Facility/Permit sign.

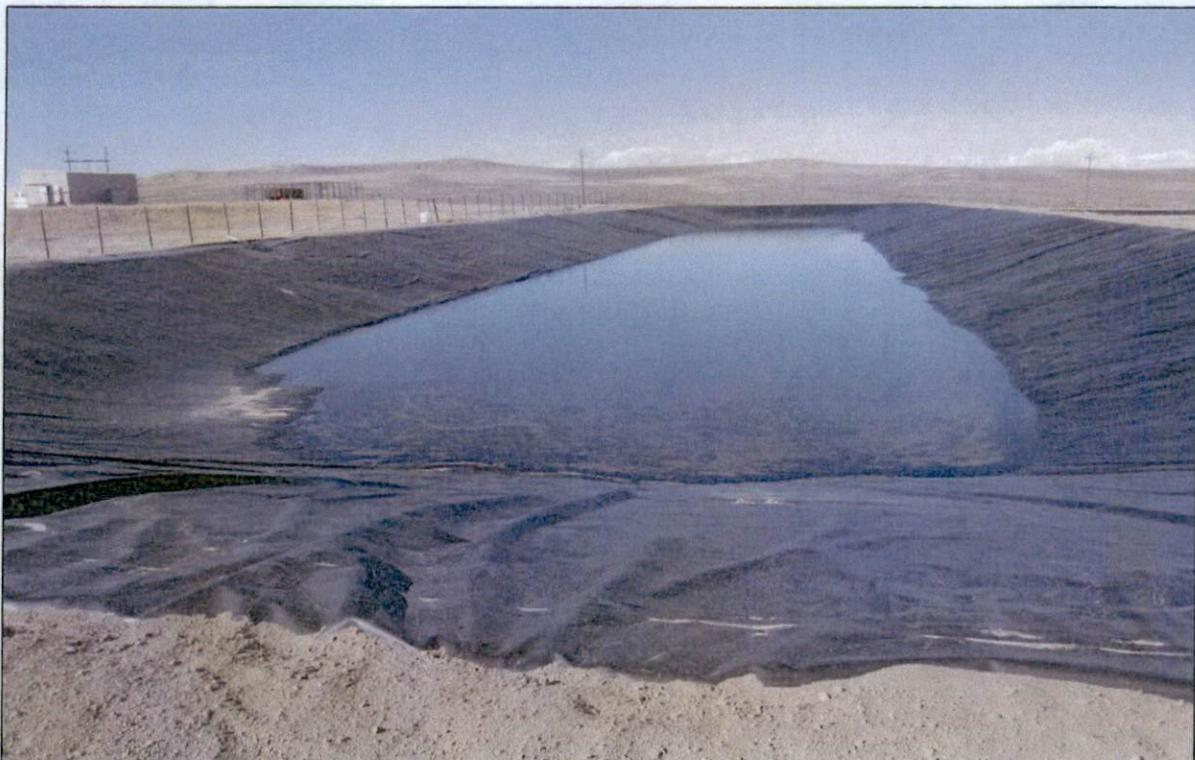
Inspection Topic	In Compliance
General	N/A
<ul style="list-style-type: none"> • Ponds 	Yes
<p>Installation of the new liner (36 mil) for CR Pond 2 was completed in October 2016 (Photo #2). Uranium One performed a visual inspection of the old liner and patched holes identified during the visual inspection. The new liner system (which included geofabric between the old and new liner) was then installed over the old liner. No issues were noted with the installation of the new liner. As indicated in the Annual Report, the CR Permeate Pond was taken out of service in November of 2015 due to a crack identified on the east embankment. Repair work for the crack in the east embankment of the Permeate Pond had been completed and the area seeded (Photos #3 & #4). There was no change in the Permeate Pond design or capacity as a result of this repair. No issues were noted with the repaired embankment. At the time of the inspection, the Mine was working to locate a leak in Irigaray Pond D. Enough water was left in the pond to cover the sludge and keep it from drying out (Photo #14). The Mine was also pumping out the leak detection system while progressing with plans to locate and repair the leak. Irigaray Facility Ponds RA & RB were also viewed during the inspection. Both ponds were observed to be retaining water and no issues were noted with the liners or embankments (Photo #13).</p>

Photo #2: Completed installation of new liner in CR Pond #2.

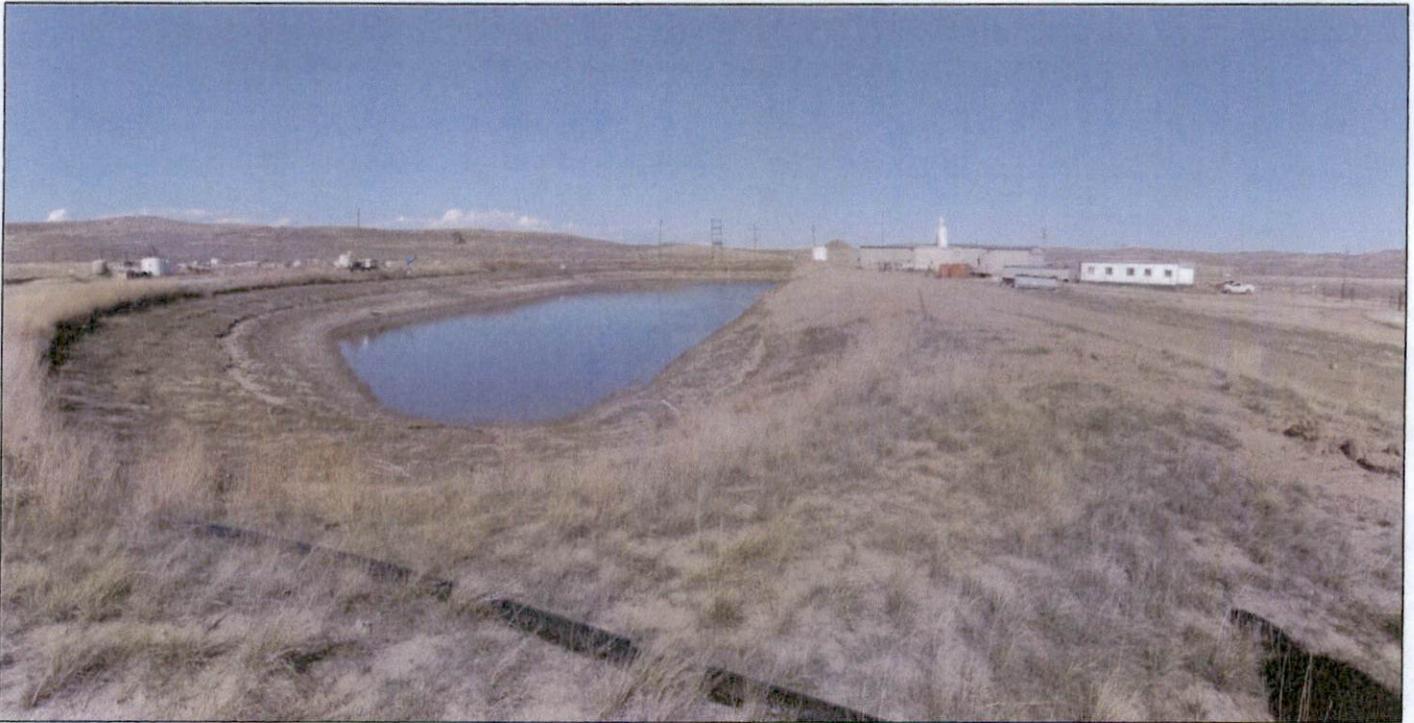
Photo #3: View of CR Permeate Pond, CR Satellite Facility in background of photo.

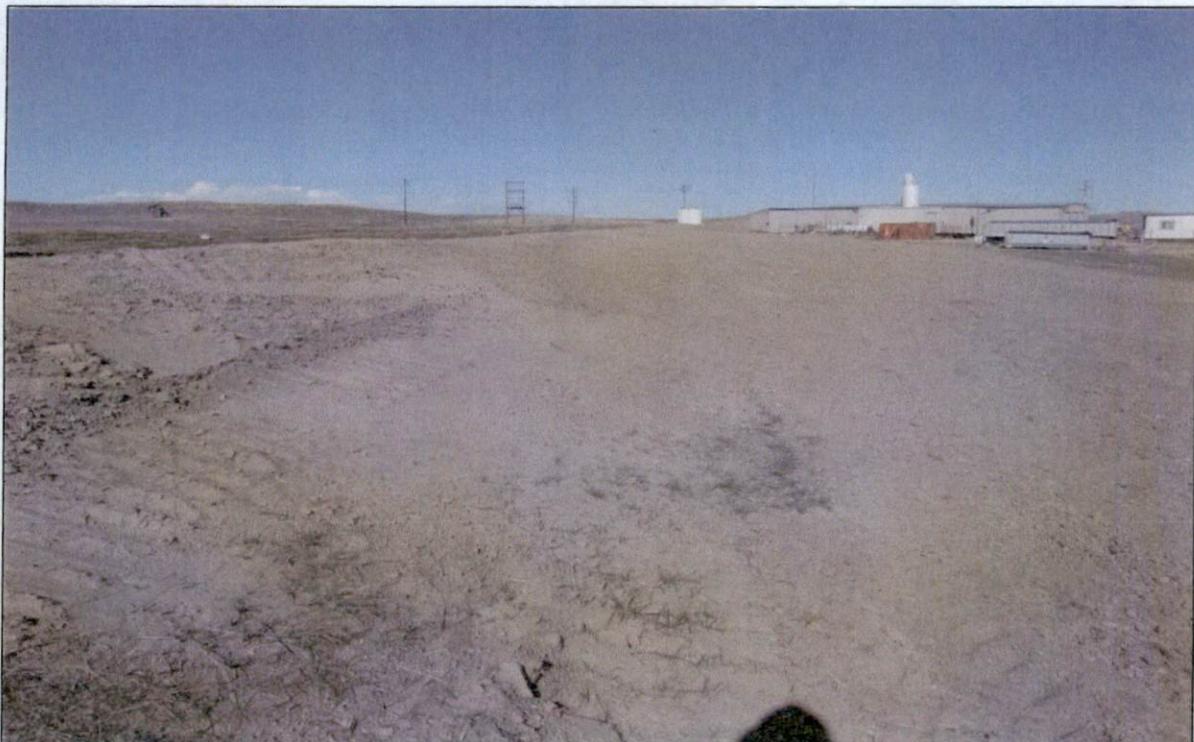
Photo #4: View of completed embankment repair along east side of CR Permeate Pond.

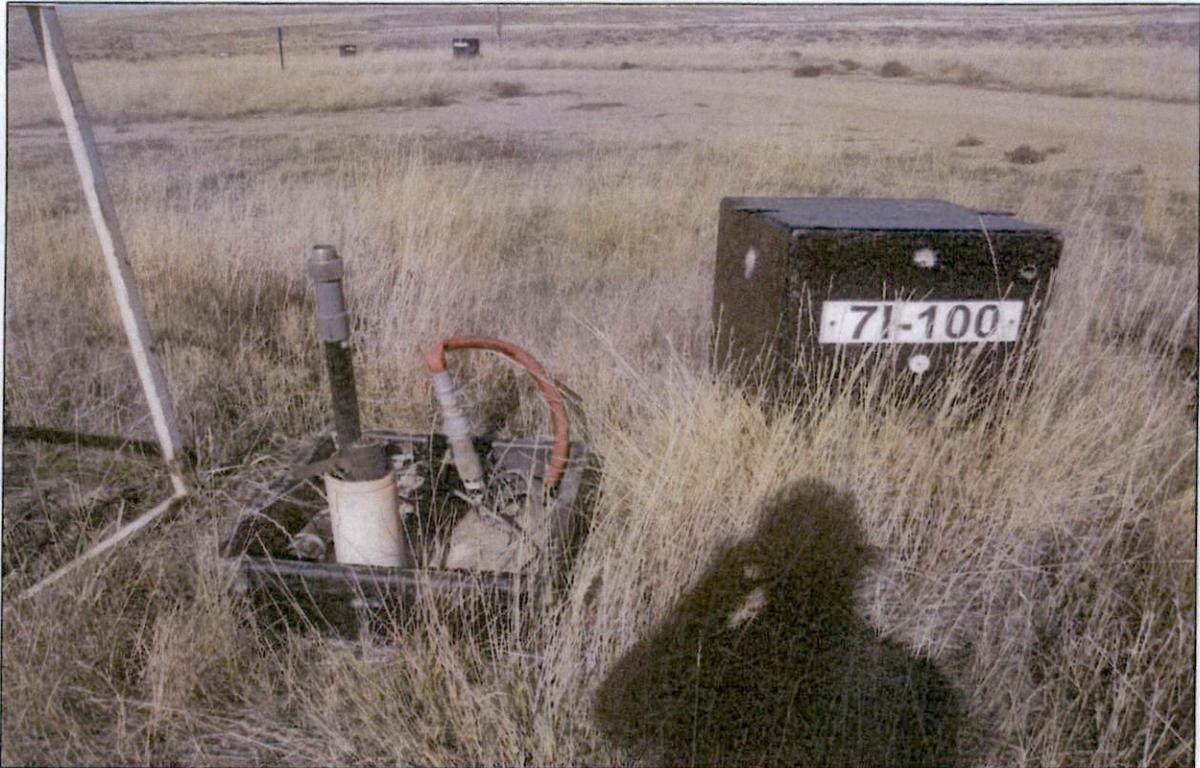
Photo #5: View of injection well converted to recovery well, stinger removed, pump installed.

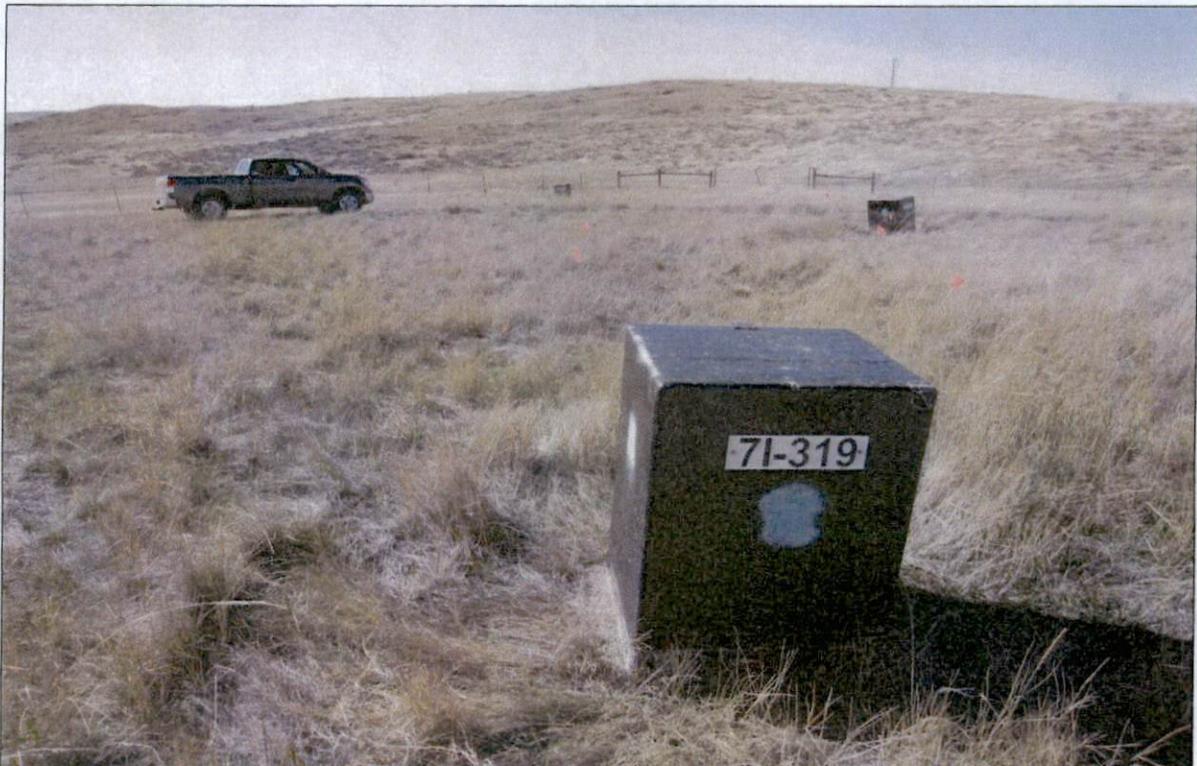
Photo #6: View of Mine Unit 7 (Mod 7-4) Injection Well 71-319 fluid spill, spill area flagged.

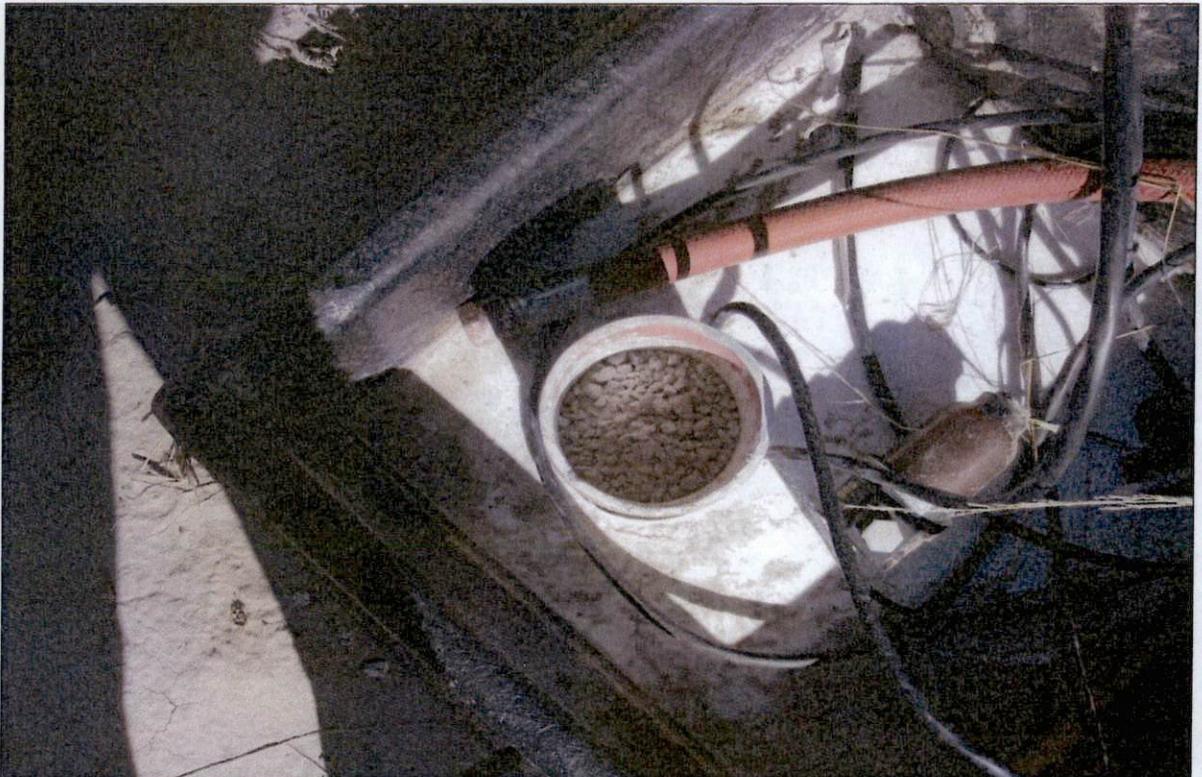
Inspection Topic	In Compliance
<ul style="list-style-type: none"> Class 3 Wells <p>Wells that have failed MIT have been plugged, and plugging operations continue for additional wells that have failed MIT (Photos #7 & #8). Wells that have passed MIT are marked on the well box with green paint. Wells that have failed MIT are marked on the well box with red paint. Select wells that have failed MIT have been converted to recovery wells by pulling the stinger installing a pump (Photo #5). Converted wells 7I-100 and 7I-116 were viewed.</p>	Yes
<ul style="list-style-type: none"> MITs <p>MIT operations were active at the time of the inspection. Equipment associated with conducting the testing was observed on-site in Mine Unit 8. However, an MIT was not being performed while on-site in Mine Unit 8 and therefore an MIT was not viewed during the inspection.</p>	Yes
<ul style="list-style-type: none"> Spills <p>Two spill areas were viewed during the inspection. One spill was from the MU7-4 header house which was discovered on October 17, 2016 and the other was from MU7-5 injection well 7I-319 which occurred on October 11, 2016 (Photo #6). LQD was notified of the MU7-5 injection well spill prior to the inspection on October 12, 2016. The LQD inspector was notified of the MU7-4 header house spill during the inspection. No visible erosion or impact to the vegetation was observed while viewing the spill locations.</p>	Yes

Photo #8: View of bentonite chips at surface in plugged well 71-94.

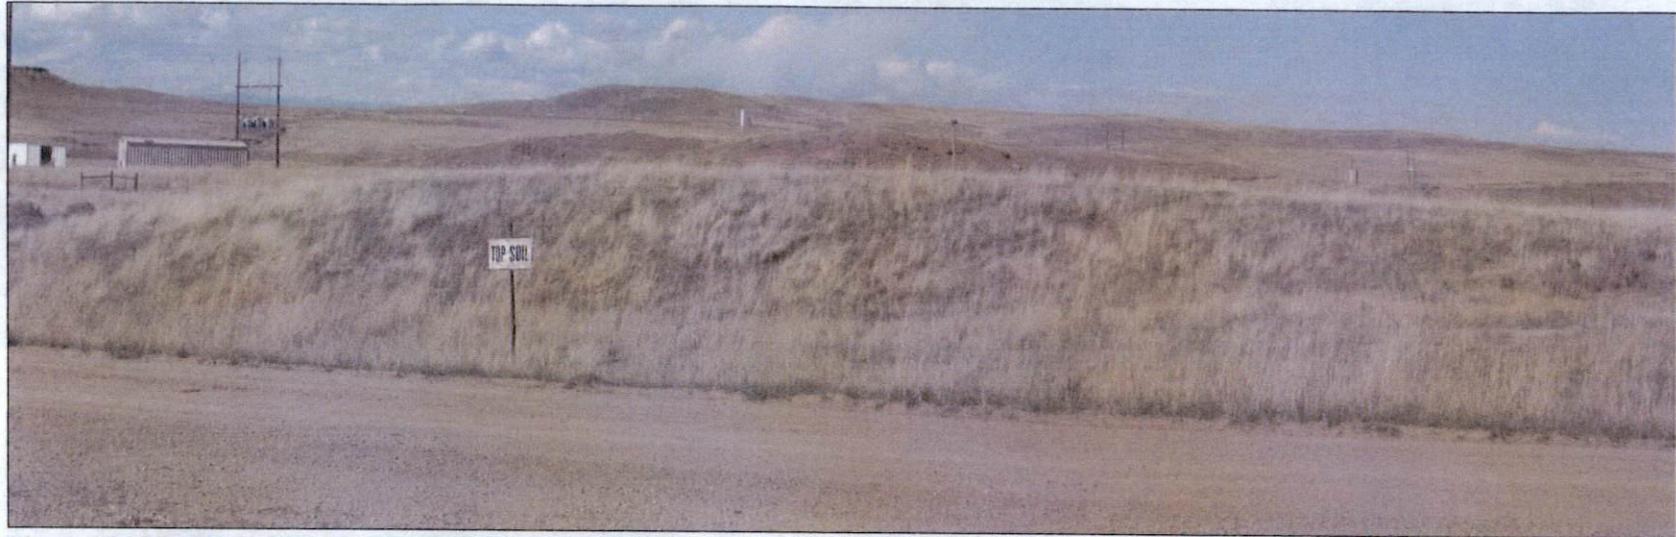
Photo #9: View of Mine Unit 7 Topsoil Stockpile #14, typical of stockpiles viewed with signage and vegetative erosion control.

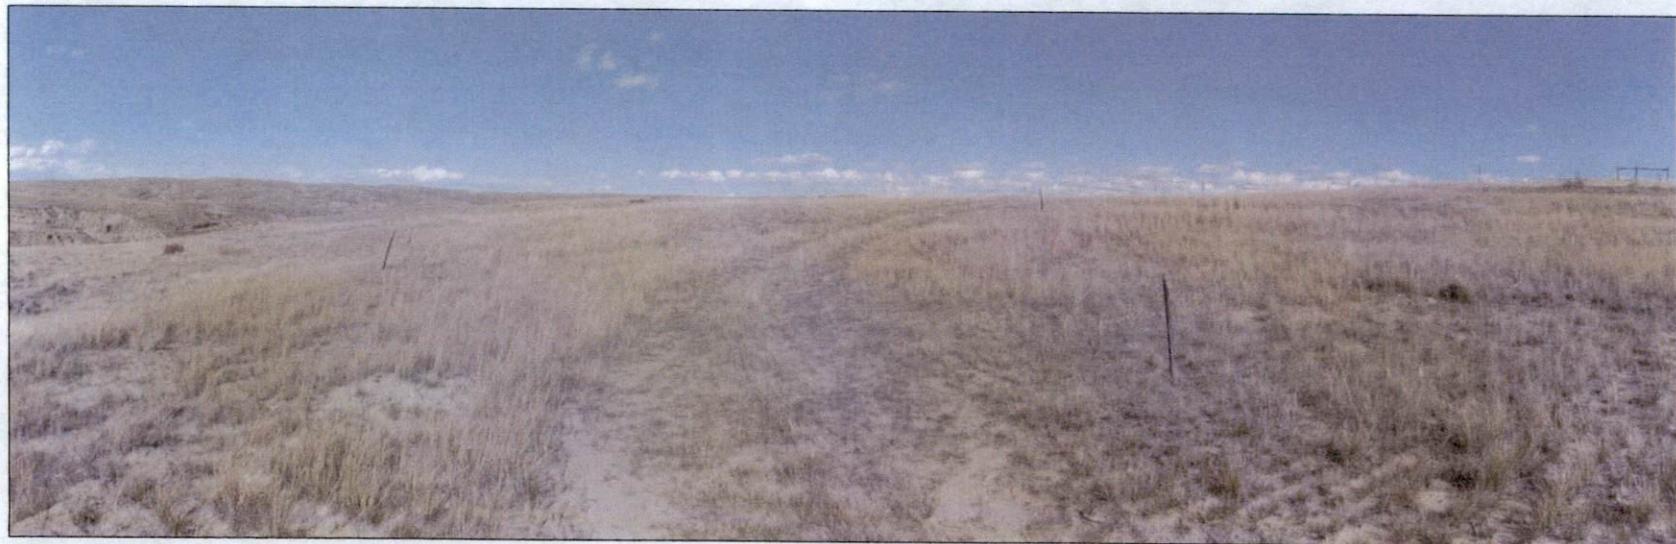
Photo #10: View of Mine Unit 10B, temporarily capped pilot-hole markings and interim vegetation.

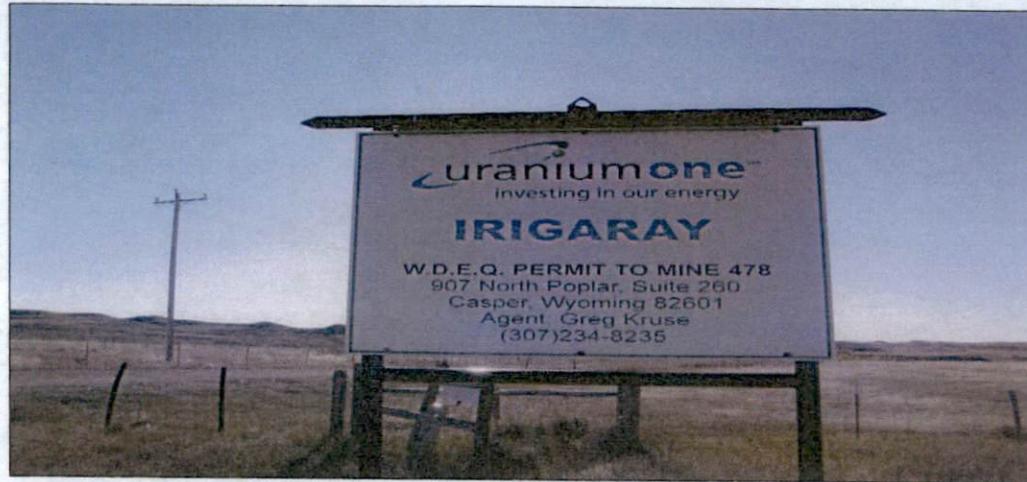
Photo #11: View of Irigaray Facility/Permit sign.

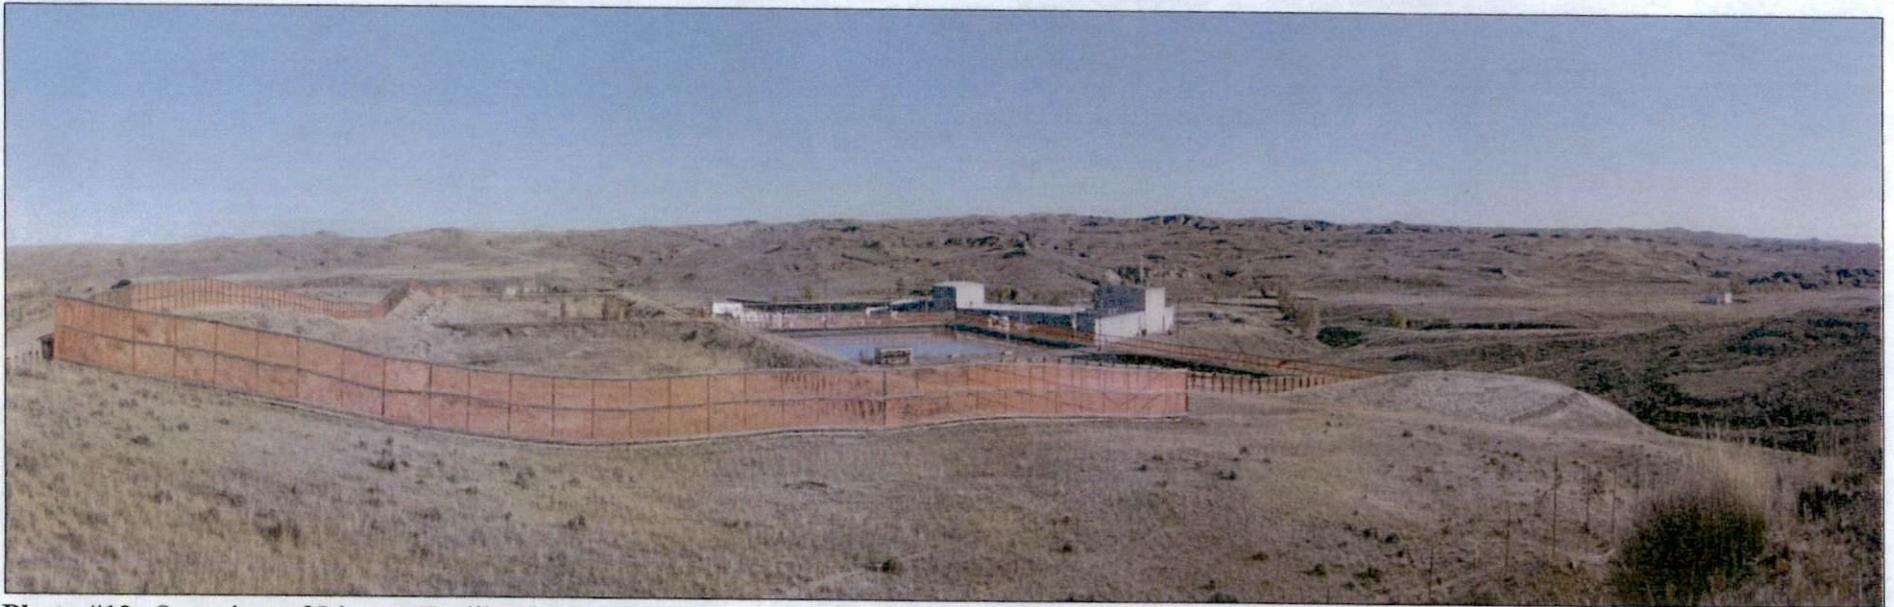
Photo #12: Overview of Irigaray Facility, looking NNE.

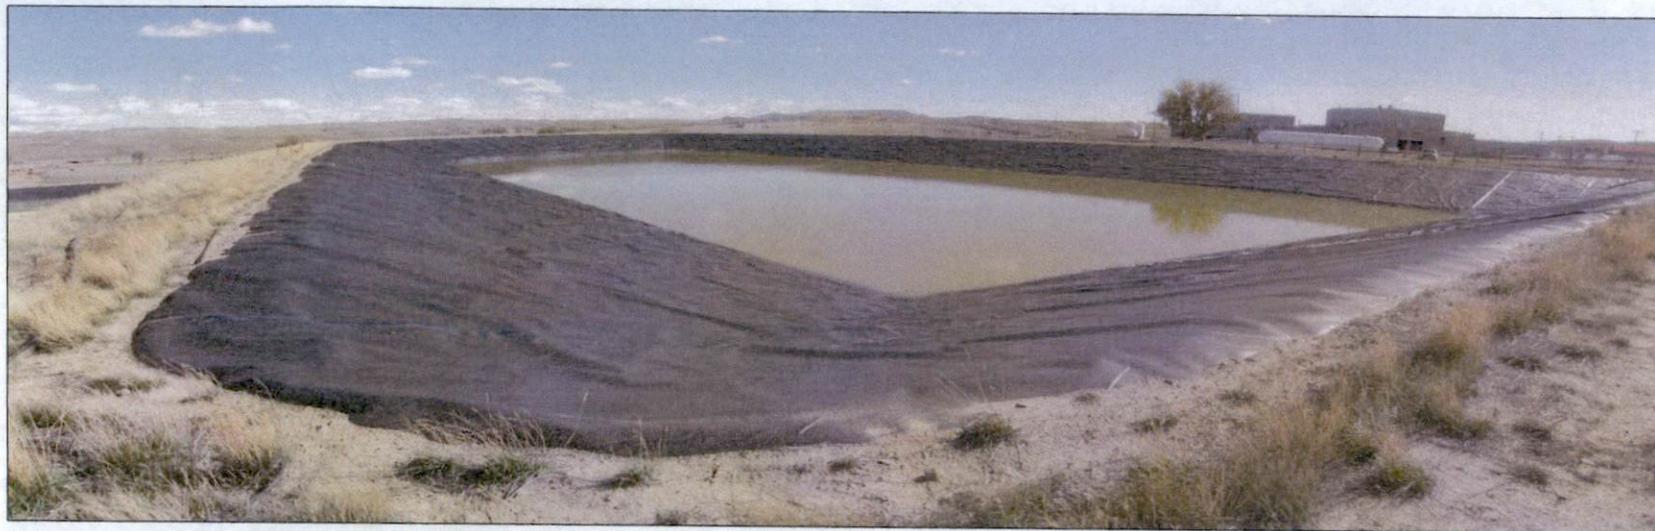
Photo #13: View of Irigaray Facility Pond RA, from NW corner of pond.

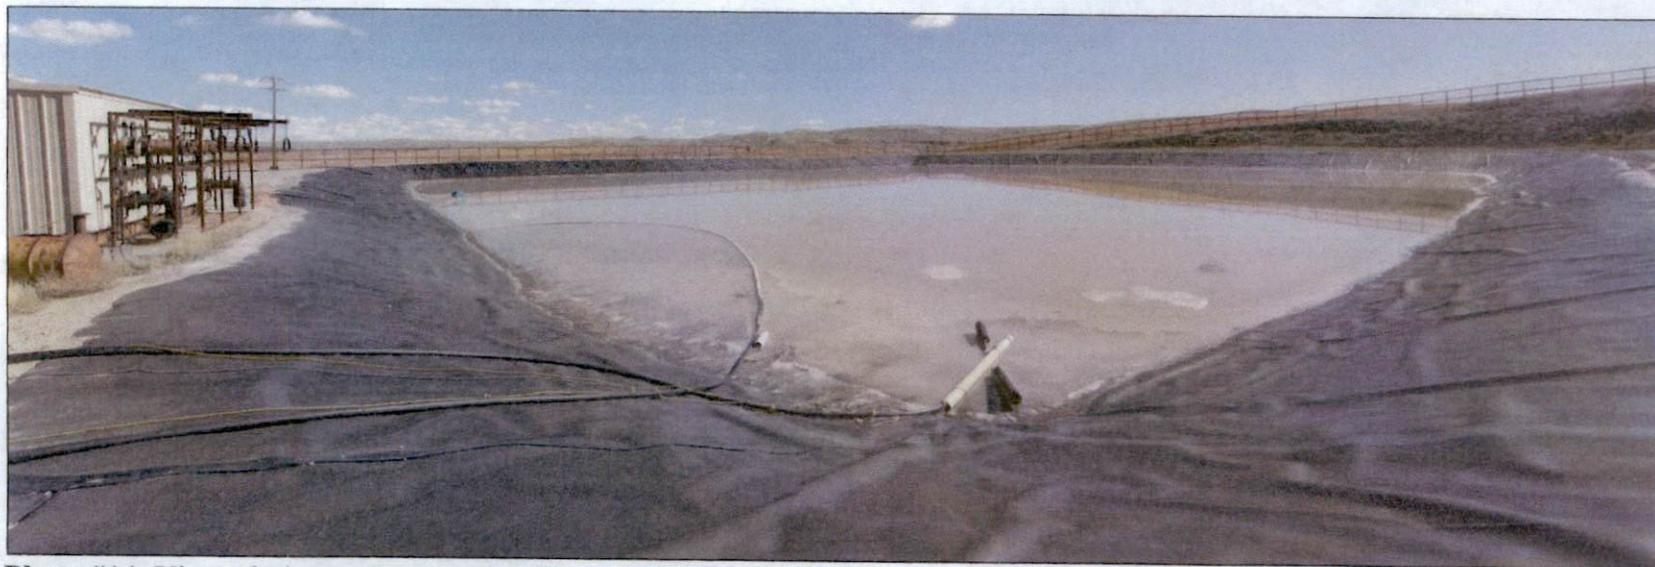
Photo #14: View of Irigaray Facility Pond D, from NW corner of pond.
