RE: 10 CFR 71.95(a)(3) report for CoC number USA/9187/B(U)-96

QSA Global, Inc. is making a report under 10 CFR 71.95(a)(3) concerning the Model 865 Type B packages (CoC 9187).

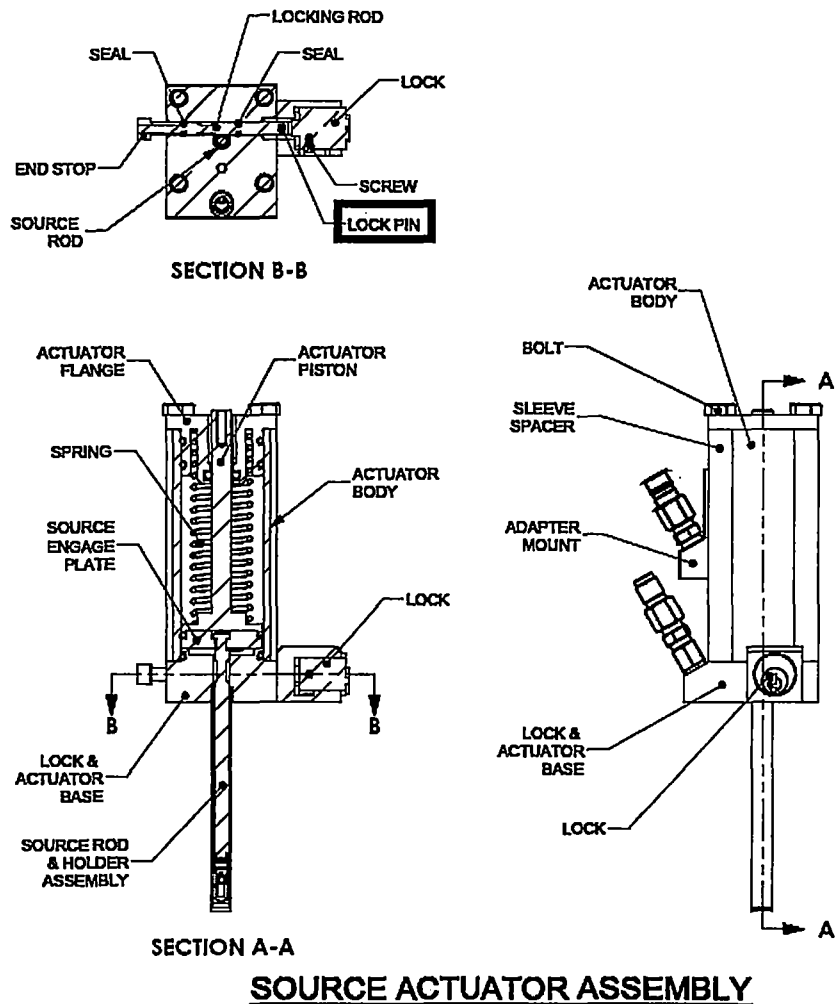
SOURCE ACTUATOR ASSEMBLY

The exploded view of the actuator assembly shown on sheet 4 of drawing R86590 Revision J does not show the pin connecting the plunger lock to the locking rod. The pin has always been present in all Model 865 transport packages and all Model 865 Type-B test specimens. The pin is needed to unlock the source from the shield, but is NOT needed to lock the source into the fully shielded position in the package. See figure below for pin location:

The pin material is 300 series stainless steel and is fully compatible with all adjacent component materials. The presence or absence of the lock connecting pin does not adversely affect the safety and integrity of the Model 865 transport package and does not create a substantial safety hazard under 10 CFR Part 21.
