QSA GLOBAL

RE: 10 CFR 71.95(a)(3) report for CoC number USA/9187/B(U)-96

QSA Global, Inc. is making a report under 10 CFR 71.95(a)(3) concerning the Model 865 Type B packages (CoC 9187).

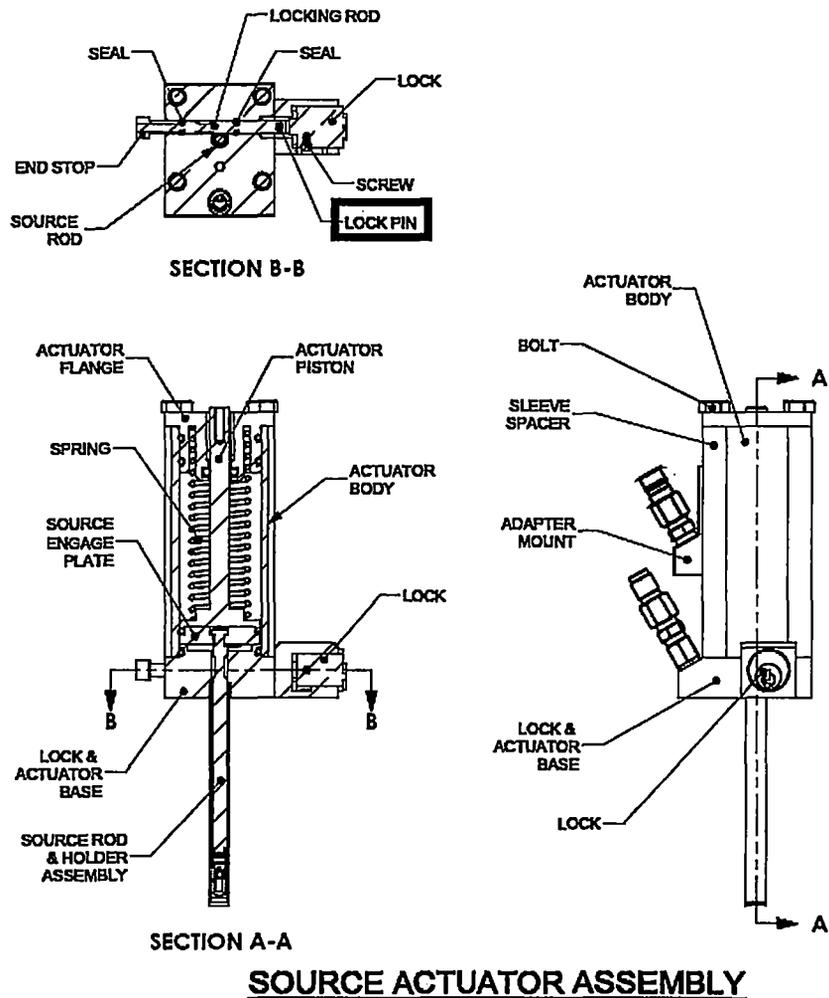
SOURCE ACTUATOR ASSEMBLY

The exploded view of the actuator assembly shown on sheet 4 of drawing R86590 Revision J does not show the pin connecting the plunger lock to the locking rod. The pin has always been present in all Model 865 transport packages and all Model 865 Type-B test specimens. The pin is needed to unlock the source from the shield, but is NOT needed to lock the source into the fully shielded position in the package. See figure below for pin location:

The pin material is 300 series stainless steel and is fully compatible with all adjacent component materials. The presence or absence of the lock connecting pin does not adversely affect the safety and integrity of the Model 865 transport package and does not create a substantial safety hazard under 10 CFR Part 21.
