LOST CREEK ISR, LLC

December 30, 2016

**Re: Notification of Release – HH1-5 (Report 24)
Lost Creek ISR Project Permit #788**

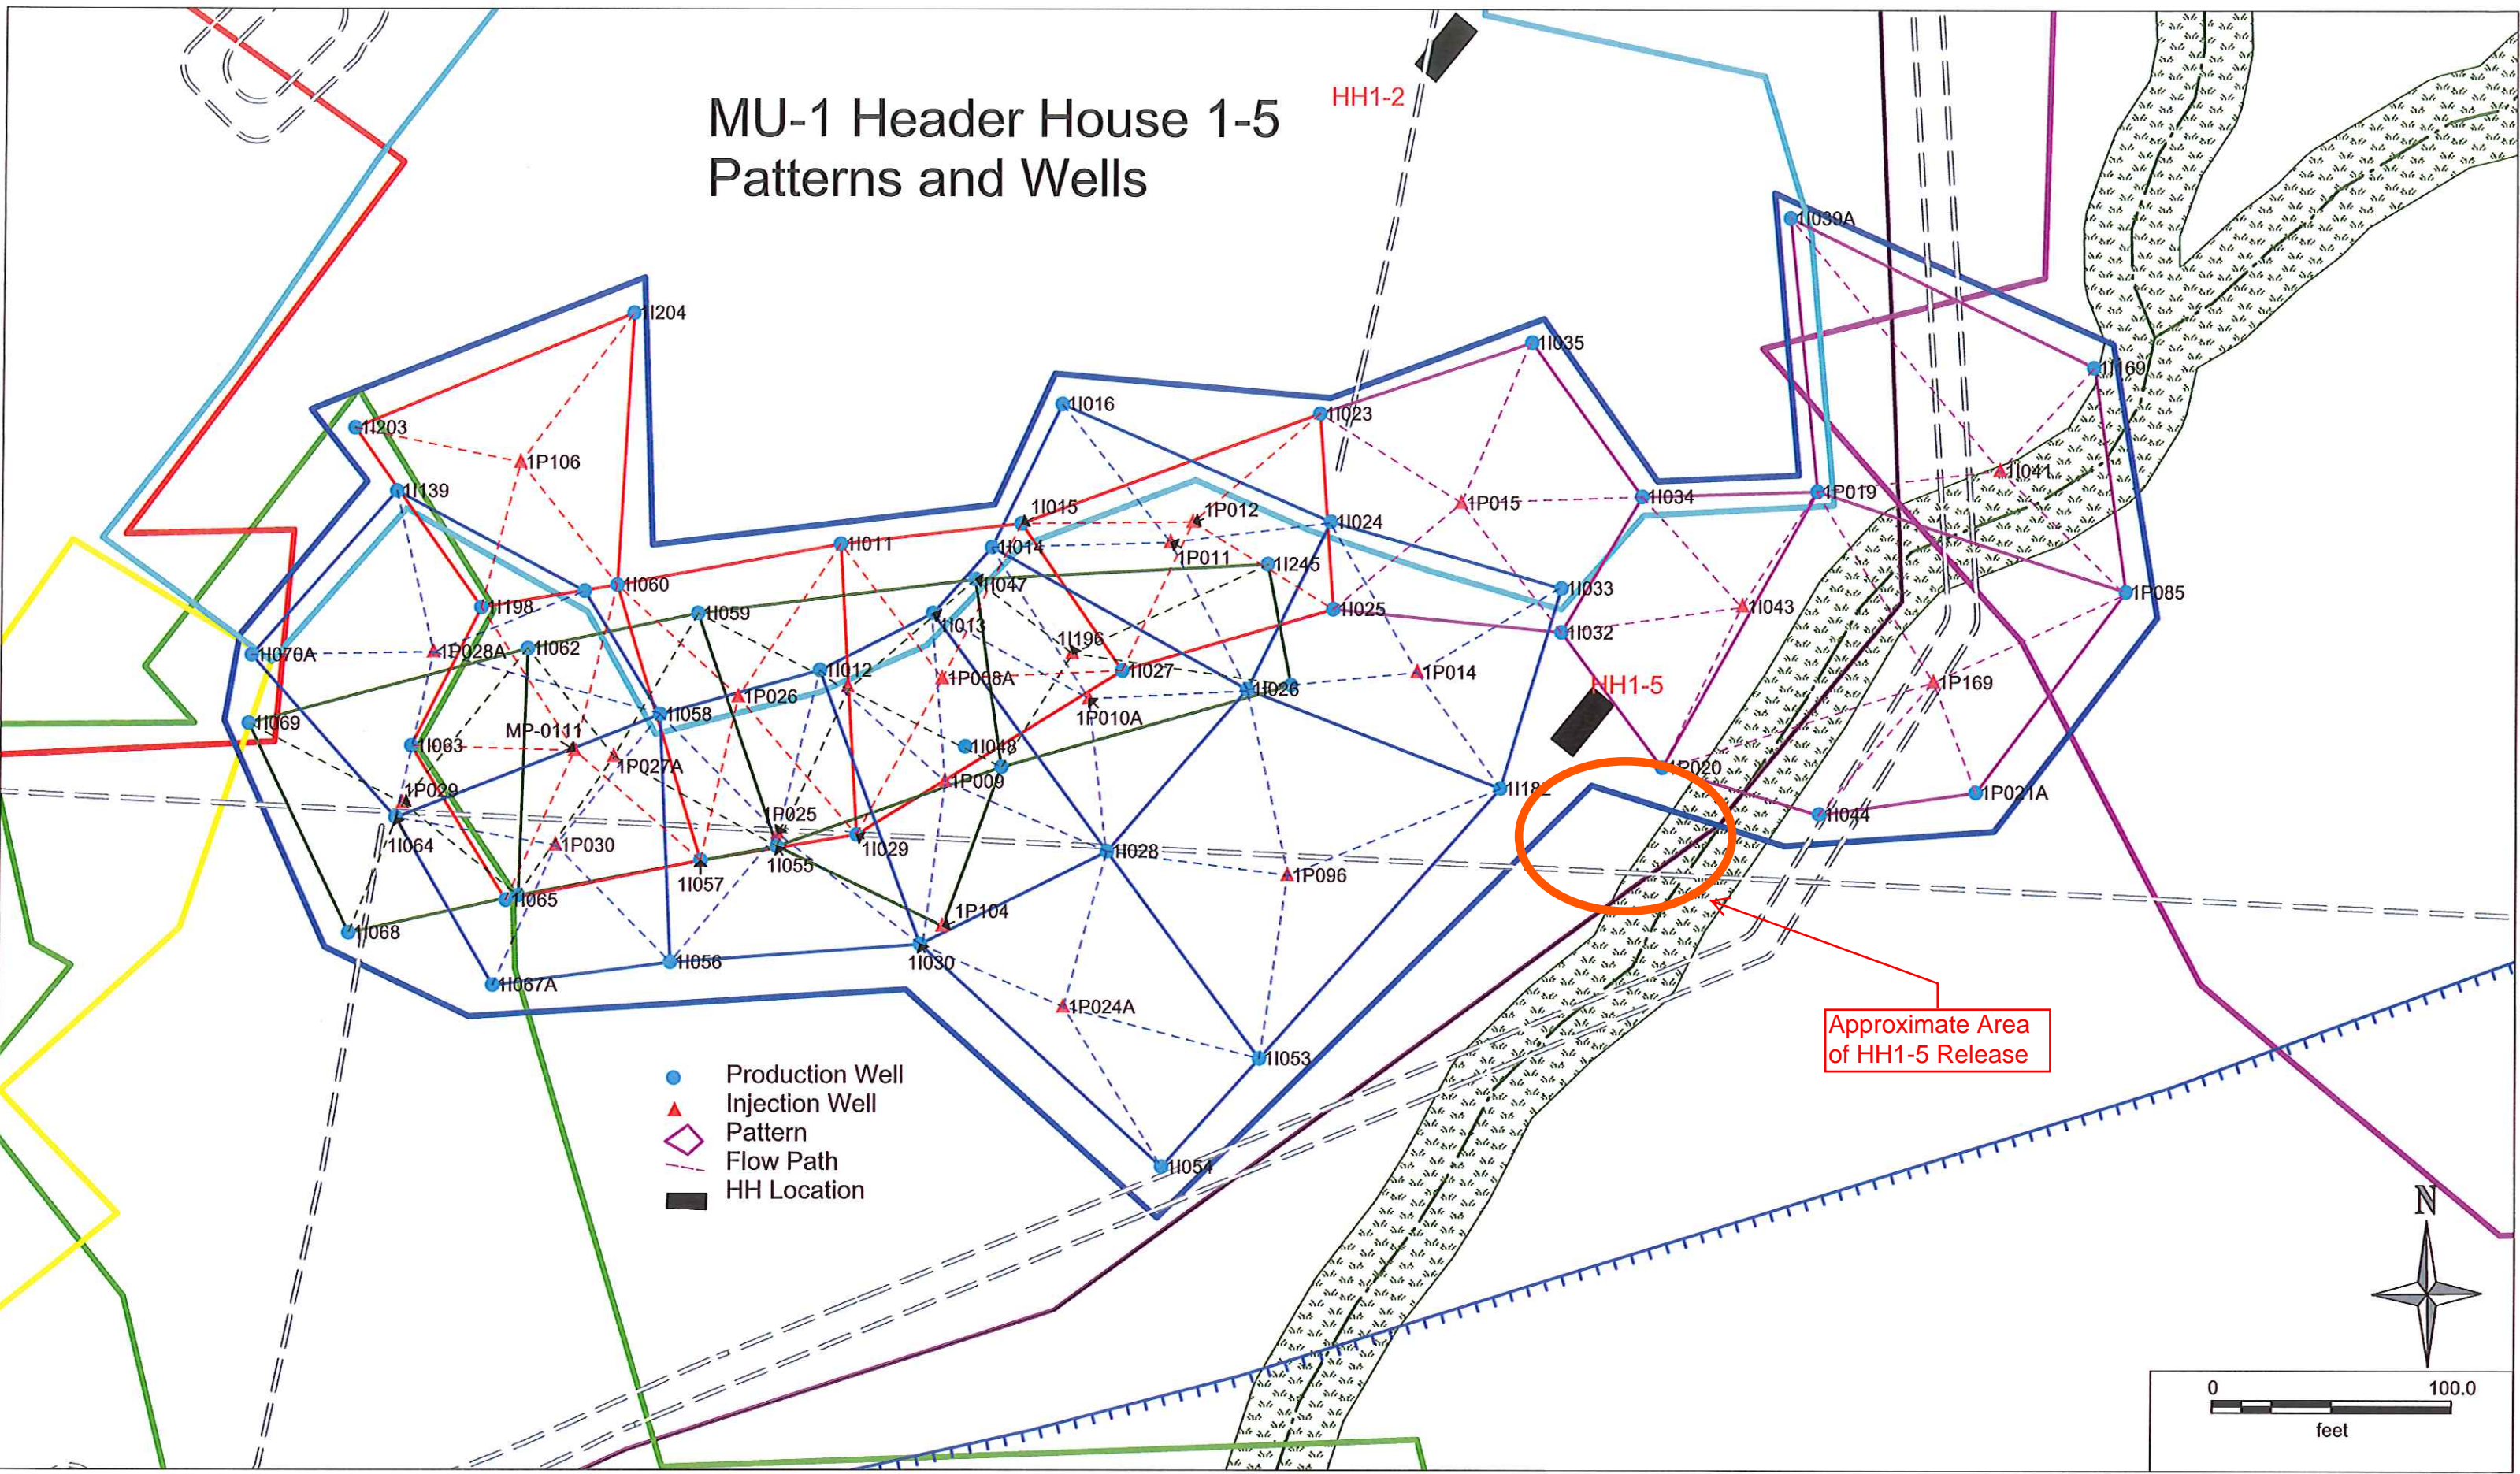
MU-1 Header House 1-5 Patterns and Wells

In accordance with Wyoming Department of Environmental Quality Land Quality Division (WDEQ-LQD) regulation, Lost Creek ISR, LLC ("LCI") hereby provides a written report detailing a release of injection fluid that was reportable to WDEQ. Using the spill report webpage, LCI notified WDEQ-Water Quality Division (WQD) of the spill on December 27, 2016 (Incident ID 161227-1048). Additionally, LCI notified WDEQ-LQD (Brian Wood) and NRC (John Saxton) of the release via email on the same day it was reported to the WQD. Notifications were delayed due to many personnel on leave for the holiday break. The release volume was initially estimated at approximately 582 gallons based on the area affected by the release. The release occurred from within Header House 1-5 (HH1-5) at T25N R92W Section 19 NW of NE qtr-qtr and is shown on the Figure attached. A small portion of the release entered the dry ephemeral drainage just to the south of HH1-5.

Approximate Area
of HH1-5 Release
