Part 21 (PAR)

PART 21 - ISSUES IDENTIFIED WITH THE ENTERPRISE DIESEL ENGINE SUBCOVER

Report No. 10CFR21-0114  
Rev. 0: 12/28/16

COMPONENT: Subcover Assembly, P/N 1A-7846

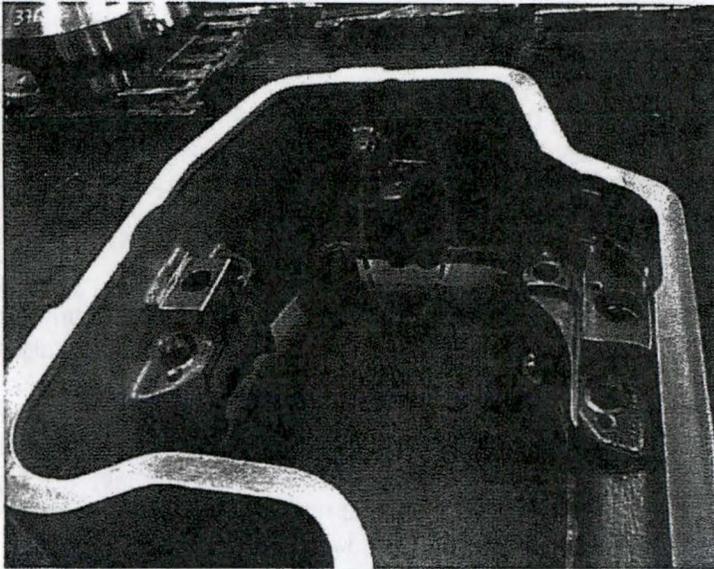
**Item #1:**

**Photo 1: Visual Depiction of Inadequately Drilled Bolt Hole**

The issue regarding the inadequately drilled bolt hole would be detected during installation since it would prevent the bolt from passing through the hole. Therefore, it is determined this issue would have no impact on operability since the cover could not be installed with an incompletely drilled bolt hole.

- a) Inspect for the bolt hole (item #1). If rework is necessary, drill through to a diameter of 13/16".
- b) For the incomplete machining of the rocker arm pedestal (item #2), first remove the installed dowel which has 0.000" to 0.001" clearance. Then machine a 2" radius relief at the affected area. All other dimensions such as pedestal height shall remain unchanged.

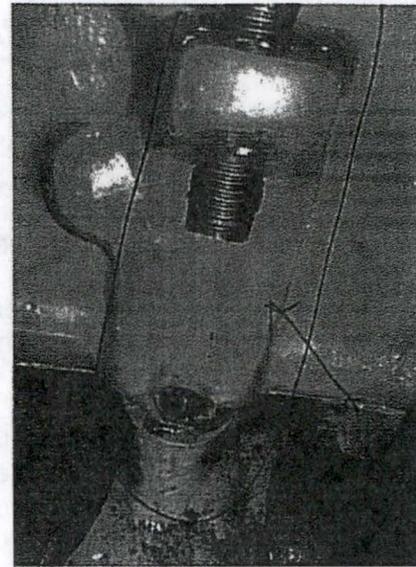
**Photo 2: Attempted Bolt Install**

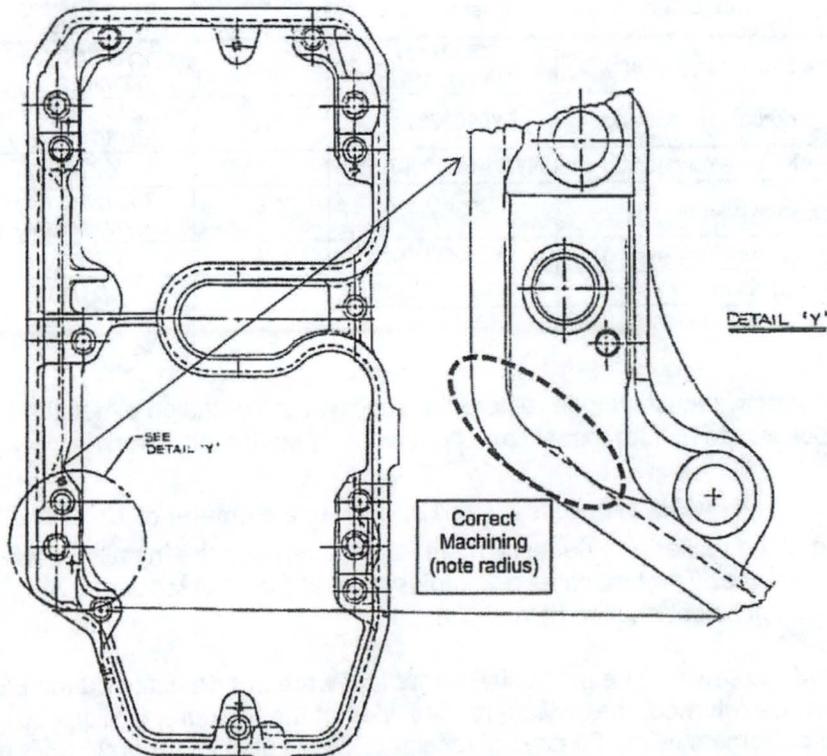
**Item #2:**

**Figure 2: Ideal Pedestal Machining**

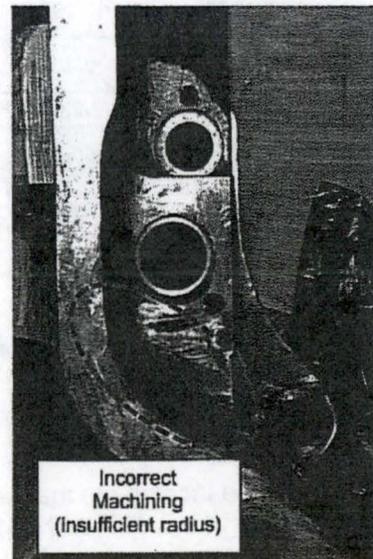
**Photo 3: Actual Machining**

With regard to the incompletely machined pedestal, there is the potential that a customer could install the rocker arm shaft without detecting this issue. In this situation, the shaft will partially fit on the pedestal and the bolt will thread into subcover; however, the shaft will not seat fully on the pedestal. This prevents full contact with the pedestal and inhibits adequate preload throughout the bolted joint. If a customer were to install the rocker arm shaft (with mating rocker arms, pushrods, etc) onto the engine without realizing this issue, operability and durability of the engine would be compromised. This could present a substantial safety hazard.

The root cause analysis determined the cause to be machining errors that were not detected during ESI's dedication activities. As subcovers are returned, they will be re-machined at the vendor's facility, inspected by ESI, and returned to customers within 60 days of receipt. ESI will also incorporate revisions to the dedication report prior to the supply of any new or reworked subcovers to further clarify the inspection of these features during the dedication process, thereby preventing reoccurrence.
