**LOST CREEK ISR, LLC**

**Re: Notification of Release – 11365 (Report 25)  
Lost Creek ISR Project Permit #788**

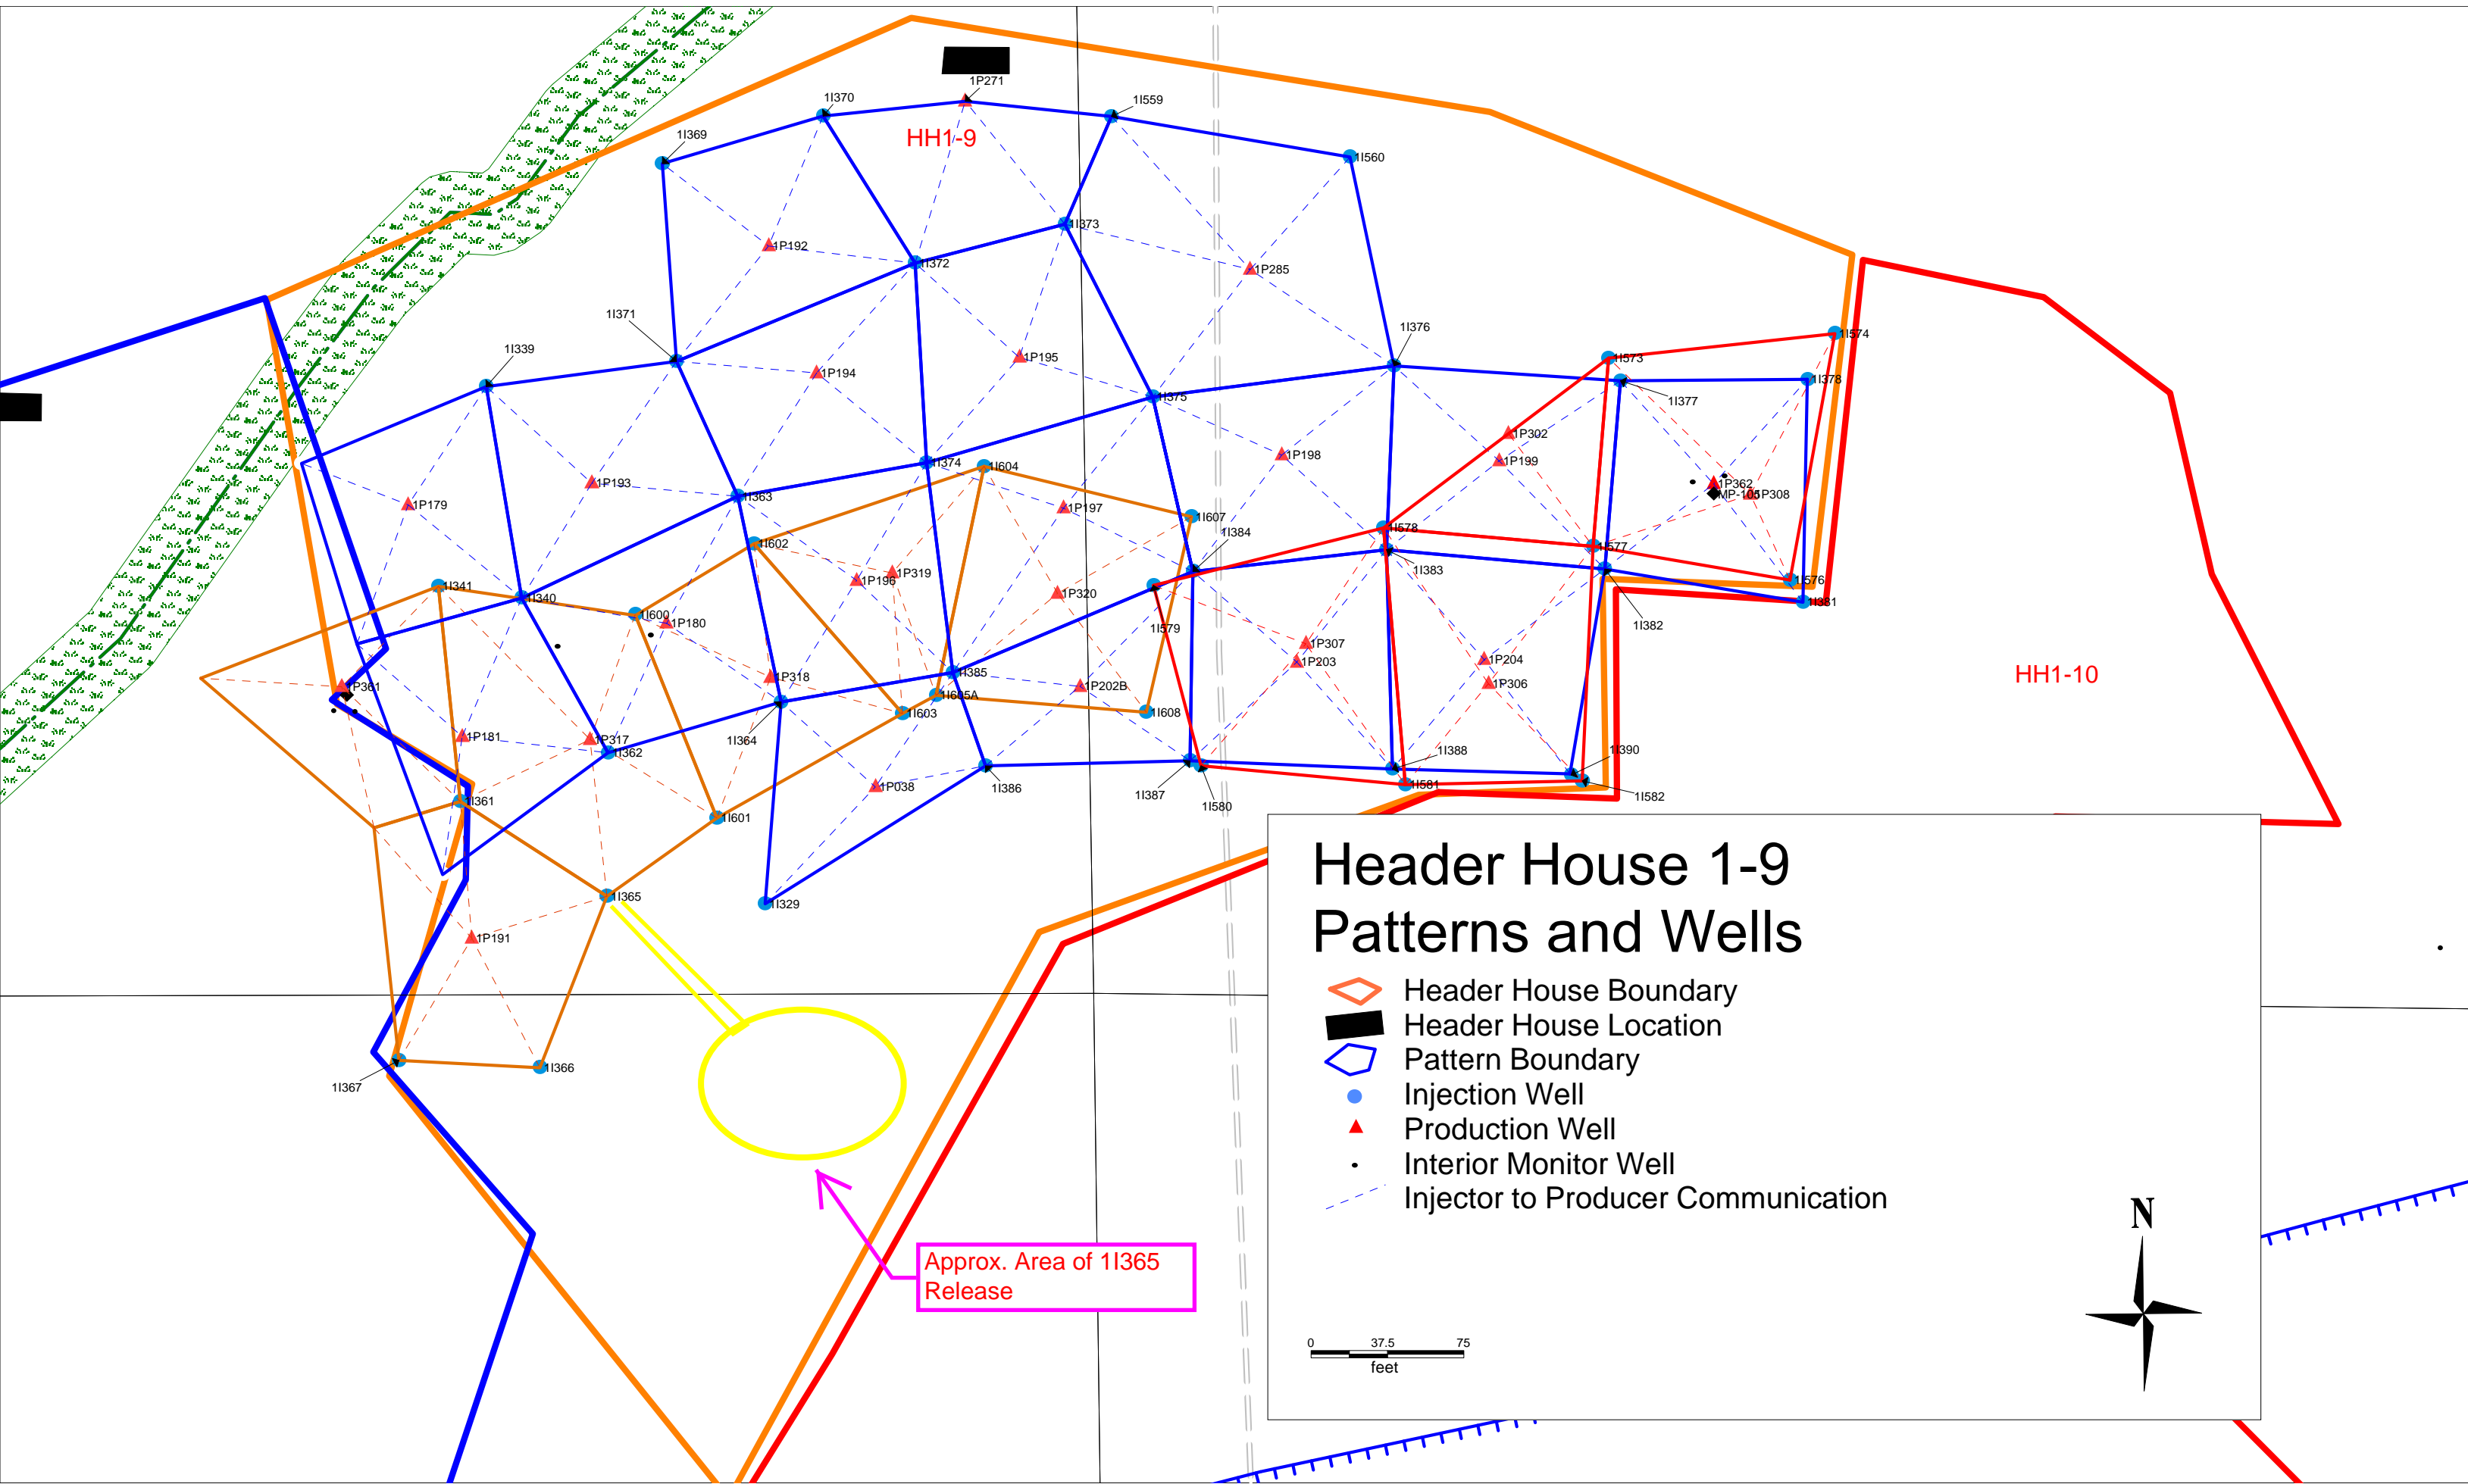
# Header House 1-9 Patterns and Wells

In accordance with Wyoming Department of Environmental Quality Land Quality Division (WDEQ-LQD) regulation, Lost Creek ISR, LLC ("LCI") hereby provides a written report detailing a release of injection fluid that was reportable to WDEQ. Using the spill report webpage, LCI notified WDEQ-Water Quality Division (WQD) of the spill on January 9, 2017 (Incident ID 170109-1520). Additionally, LCI notified WDEQ-LQD (Brian Wood) and NRC (John Saxton) of the release via email on the same day it was reported to the WQD. The release volume was initially estimated at approximately 3,654 gallons based on the area affected by the release. The release originated from injection well 11365 at T25N R92W Section 18 SE of SE qtr-qtr and is shown on the **Figure** attached. The release did not enter any drainage.

The release was discovered by a wellfield operator on January 9, 2017 at approximately 0930 hrs. The majority of the release was under snow cover and had not been spotted until enough fluid surfaced. The source of the release was an injection vent that had frozen and broken due to the extremely cold weather. The insulation jacket was properly on the well head at the time. The leak detection in the well cover had malfunctioned and did not alert operators of the leak. Concentration of uranium (as U3O8) in the injection stream at HH1-9 on the day of the release was approximately 1.3 ppm.

Approx. Area of 11365 Release

The immediate action to stop the flow at 11365 was to shut off the well at the header house. The vent was replaced with a "pop-off" but the well will remain off and tagged out until the leak detection system is repaired and tested.

- Vents are being shut off to prevent freeze damage and wells are manually vented during the rest of the cold season
- The leak detections sensors for all of the injection wells are being tested
- Replacement of the old style vents with pressure "pop-offs" is continuing until all vents have been replaced
- A more routine leak detection testing plan is being developed
