LOST CREEK ISR, LLC

January 16, 2017

Re: Notification of Release – 1I365 (Report 25) Lost Creek ISR Project Permit #788

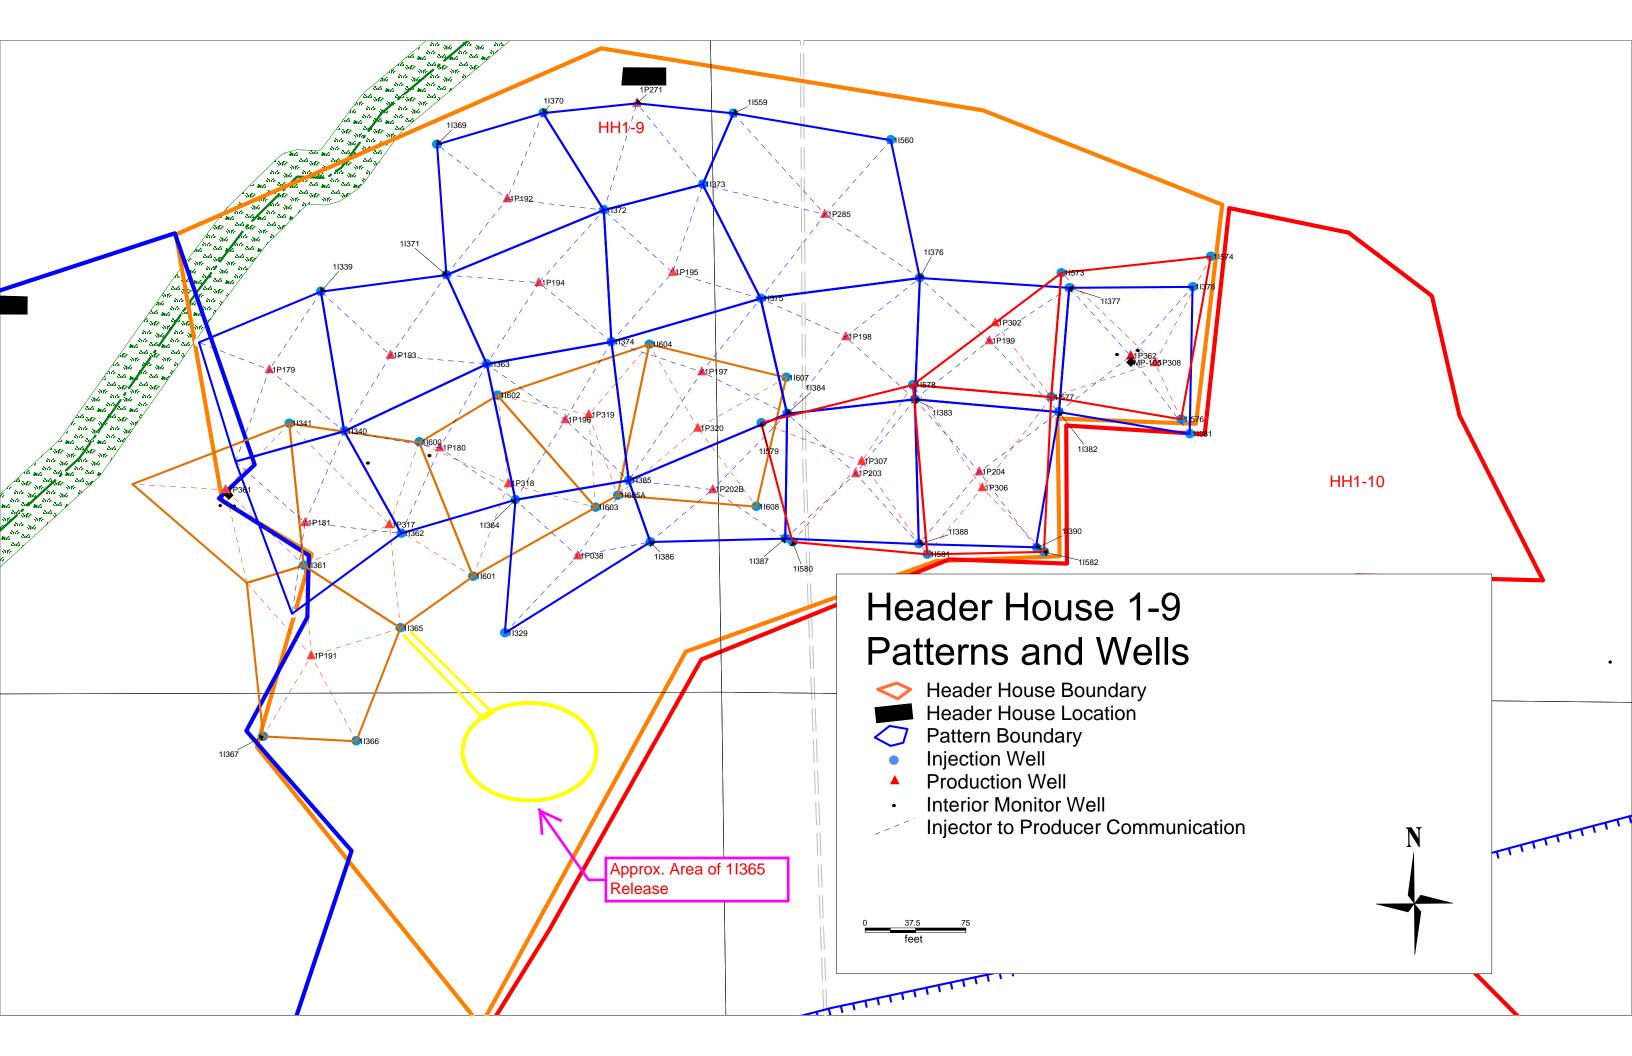
Attachments: Figure: HH1-9 Patterns and Wells

In accordance with Wyoming Department of Environmental Quality Land Quality Division (WDEQ-LQD) regulation, Lost Creek ISR, LLC ("LCI") hereby provides a written report detailing a release of injection fluid that was reportable to WDEQ. Using the spill report webpage, LCI notified WDEQ-Water Quality Division (WQD) of the spill on January 9, 2017 (Incident ID 170109-1520). Additionally, LCI notified WDEQ-LQD (Brian Wood) and NRC (John Saxton) of the release via email on the same day it was reported to the WQD. The release volume was initially estimated at approximately 3,654 gallons based on the area affected by the release. The release originated from injection well 1l365 at T25N R92W Section 18 SE of SE qtr-qtr and is shown on the **Figure** attached. The release did not enter any drainage.

The release was discovered by a wellfield operator on January 9, 2017 at approximately 0930 hrs. The majority of the release was under snow cover and had not been spotted until enough fluid surfaced. The source of the release was an injection vent that had frozen and broken due to the extremely cold weather. The insulation jacket was properly on the well head at the time. The leak detection in the well cover had malfunctioned and did not alert operators of the leak. Concentration of uranium (as U3O8) in the injection stream at HH1-9 on the day of the release was approximately 1.3 ppm.

The immediate action to stop the flow at 1I365 was to shut off the well at the header house. The vent was replaced with a "pop-off" but the well will remain off and tagged out until the leak detection system is repaired and tested.

- Vents are being shut off to prevent freeze damage and wells are manually vented during the rest of the cold season
- · The leak detections sensors for all of the injection wells are being tested
- Replacement of the old style vents with pressure "pop-offs" is continuing until all vents have been replaced
- A more routine leak detection testing plan is being developed
