**UNITED STATES
NUCLEAR REGULATORY COMMISSION**
REGION IV
1600 E. LAMAR BLVD.
ARLINGTON, TX 76011-4511

**SUBJECT: ARKANSAS NUCLEAR ONE – NRC INSPECTION REPORT 05000368/2016011
AND PRELIMINARY WHITE FINDING**

.1 Unit 2 Emergency Diesel Generator A Bearing Failure

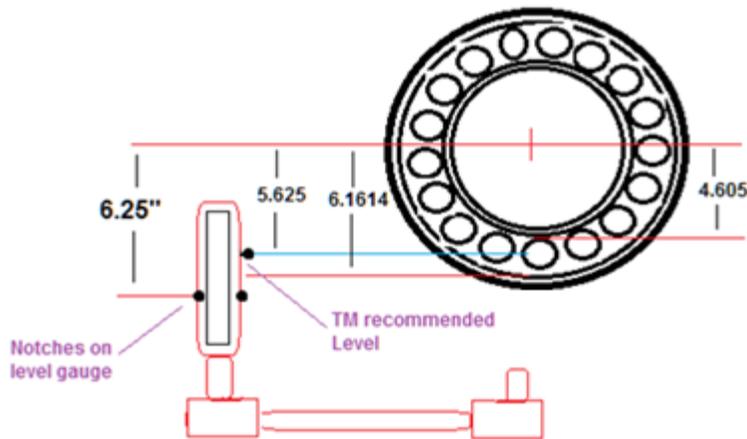
During a causal investigation for the lack of lubrication, the licensee identified that the oil level scribe mark on the sight glass was below the minimum level necessary to provide proper oil lubrication to the bearing. The licensee concluded that on November 11, 2014, while performing Work Order 356569, maintenance personnel had removed and inadvertently inverted the sight glass, which caused the scribe mark to be below the bottom of the bearing rollers (see diagram below). With the sight glass inverted, the scribe mark was 3/8-inch lower than if it was in the correct orientation. Post-failure measurements identified that the scribe mark was 5/8-inch below the correct position. The licensee concluded that adequate oil was initially provided following the sight glass reinstallation. Evidence to support this included multiple successful surveillance tests with no increase in vibrations, including a 24-hour surveillance on January 12, 2015, and having an oil sample from the bearing on June 22, 2016, with no indications of abnormal wear.

On June 22, 2016, maintenance personnel changed the oil in the inboard generator bearing after taking an oil sample in accordance with Work Order 52656389. Maintenance personnel documented leaving the oil level within the procedural limits relative to the scribe mark. Vibrations and system performance were normal during the post-maintenance runs and surveillance tests on June 26, 2016. The licensee determined that the inboard generator bearing had not been leaking oil between the oil change on June 22, 2016, and the September 16, 2016, surveillance failure.

The licensee concluded that the oil in the inboard generator bearing heated up slowly during the 24-hour surveillance. After 14 hours, enough oil had vaporized within the bearing casing that the liquid oil level became inadequate to lubricate the bearing, resulting in bearing failure. Therefore, the inspectors concluded that the emergency diesel generator could have failed approximately 14 hours after the start of a postulated event between June 26, 2016, and September 16, 2016.

The licensee documented the issue in Condition Report CR-ANO-2-2016-03307. The licensee replaced the damaged parts, machined the shaft and installed a sleeve, and raised the sight glass scribe mark to the correct level for adequate lubrication to the bearing. This violation is being treated as an apparent violation pending a final significance determination. AV 05000368/2016011-01 "Failure to Ensure Adequate Lubrication for Emergency Diesel Generator Bearing."

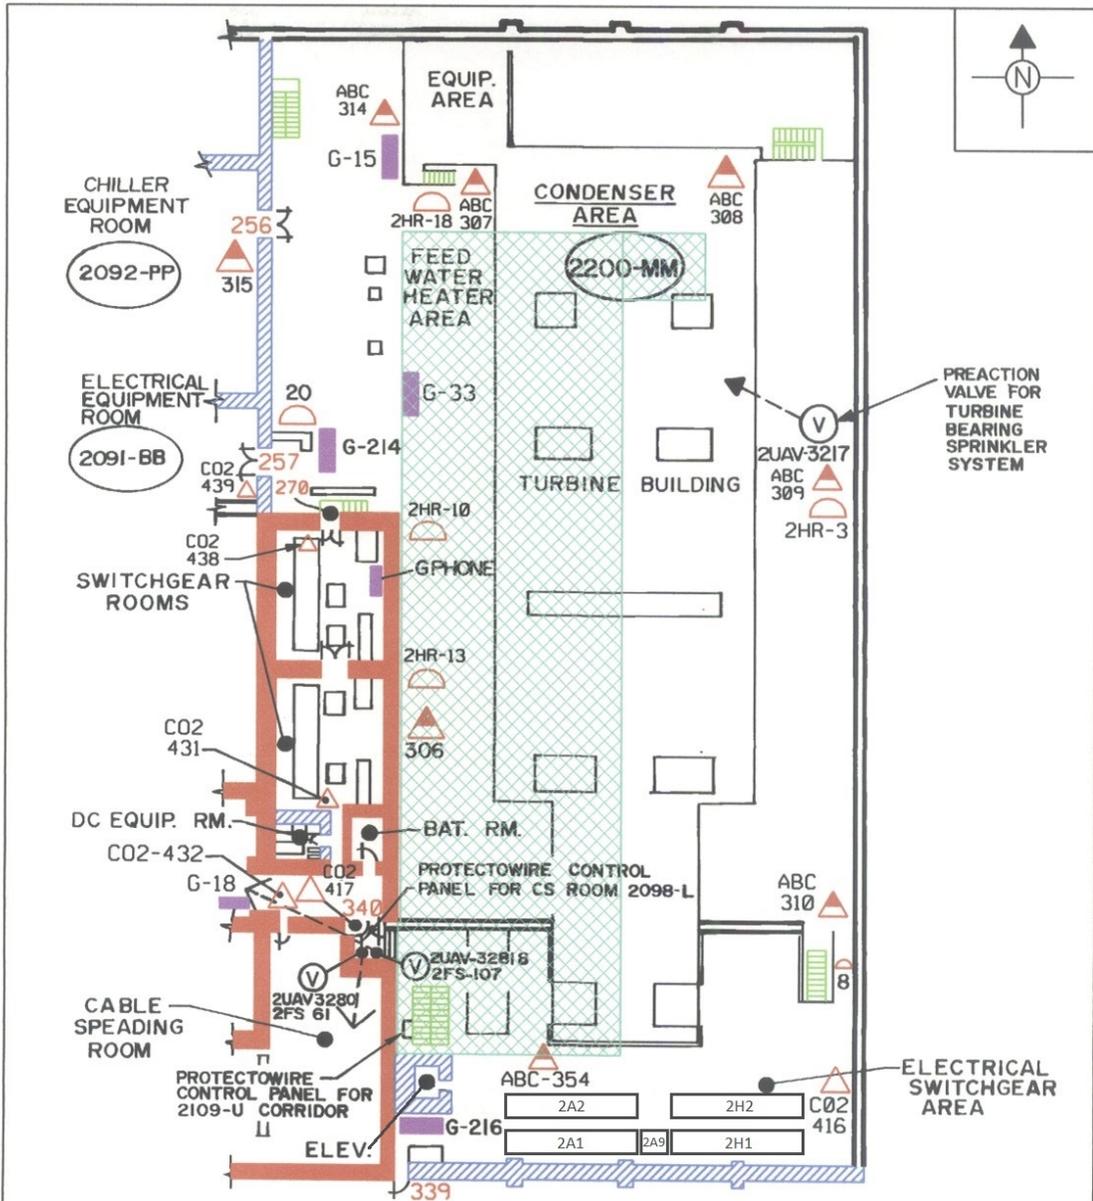
AREA: B	ELEV: 368'-0"	ZONE: 2200-MM		
ARKANSAS NUCLEAR ONE UNIT 2 RUSSELLVILLE, ARKANSAS

As shown in the following figure (taken from the ANO Unit 2 pre-fire plans and enhanced for emphasis), the simplified modelling assumed a fire in switchgear 2A1 would always affect switchgear 2A2 because of their close proximity to each other (6 feet apart). Likewise a fire in switchgear 2A2 would always affect switchgear 2A1. The same spatial relationship and fire

Walkway between 2A1/2A2 and 2H1/2H2 is 6 feet wide.
Space between 2A9 and 2A1/2H1 is 6 inches wide.
