Subject: 10CFR21 Reporting of Defects and Non-Compliance -
Engine Systems, Inc. Report No. 10CFR21-0114, Rev. 0

Report No. 10CFR21-0114

COMPONENT: Subcover Assembly, P/N 1A-7846

SYSTEM: Emergency Diesel Generator

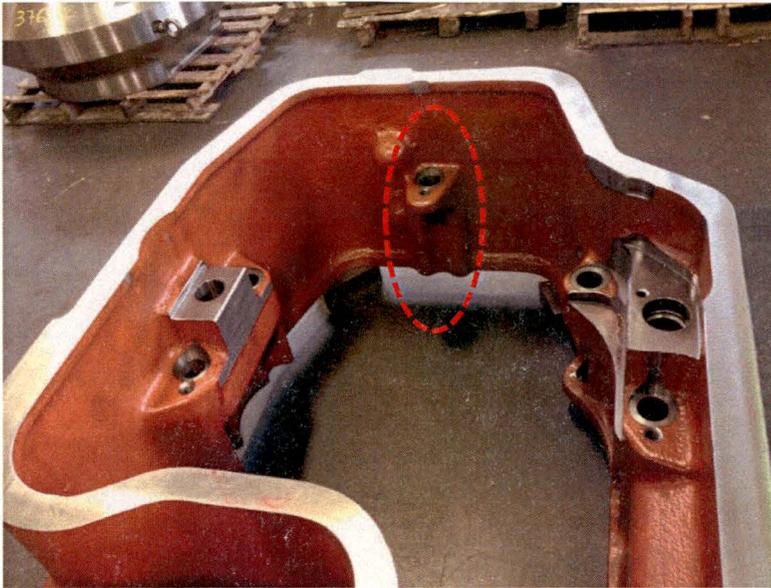
Photo 1: Visual Depiction of Inadequately Drilled Bolt Hole

The issue regarding the inadequately drilled bolt hole would be detected during installation since it would prevent the bolt from passing through the hole. Therefore, it is determined this issue would have no impact on operability since the cover could not be installed with an incompletely drilled bolt hole.

- a) Inspect for the bolt hole (item #1). If rework is necessary, drill through to a diameter of 13/16".
- b) For the incomplete machining of the rocker arm pedestal (item #2), first remove the installed dowel which has 0.000" to 0.001" clearance. Then machine a 2" radius relief at the affected area. All other dimensions such as pedestal height shall remain unchanged.

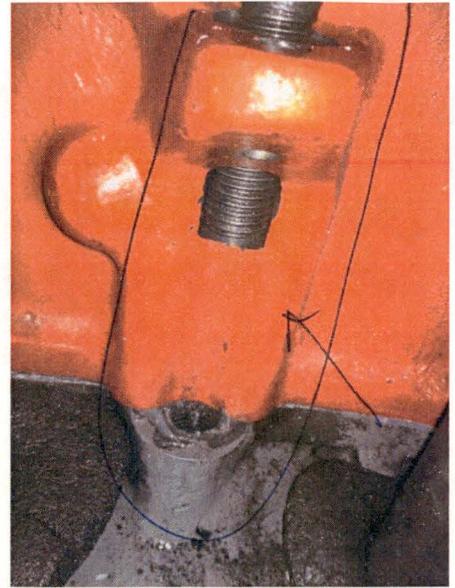
Photo 2: Attempted Bolt Install

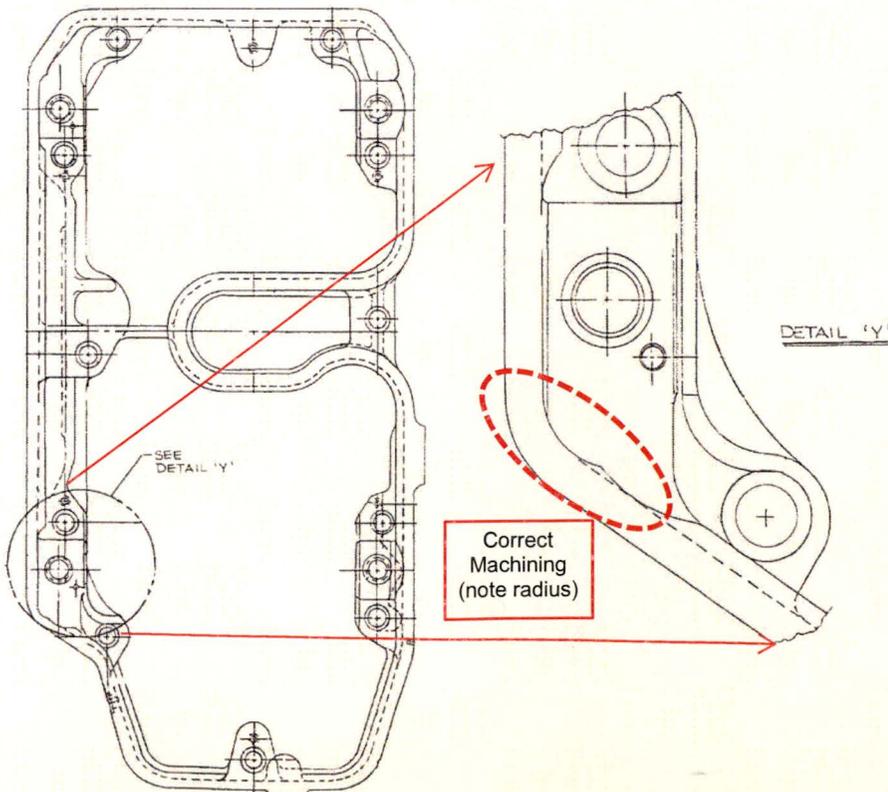
Figure 2: Ideal Pedestal Machining

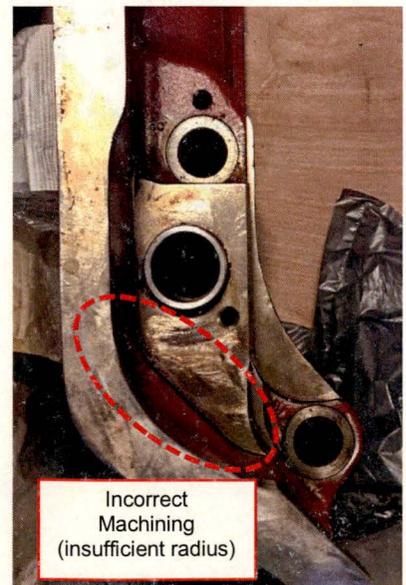
Photo 3: Actual Machining

With regard to the incompletely machined pedestal, there is the potential that a customer could install the rocker arm shaft without detecting this issue. In this situation, the shaft will partially fit on the pedestal and the bolt will thread into subcover; however, the shaft will not seat fully on the pedestal. This prevents full contact with the pedestal and inhibits adequate preload throughout the bolted joint. If a customer were to install the rocker arm shaft (with mating rocker arms, pushrods, etc) onto the engine without realizing this issue, operability and durability of the engine would be compromised. This could present a substantial safety hazard.
