PLANT NAME: NINE MILE POINT #1

Re: Nine Mile Point Unit 1
Docket 50-220
DPR-63

Laboratory Examination of Cracked 6" Type 304 Pipe
From Nine Mile Point Cleanup System.

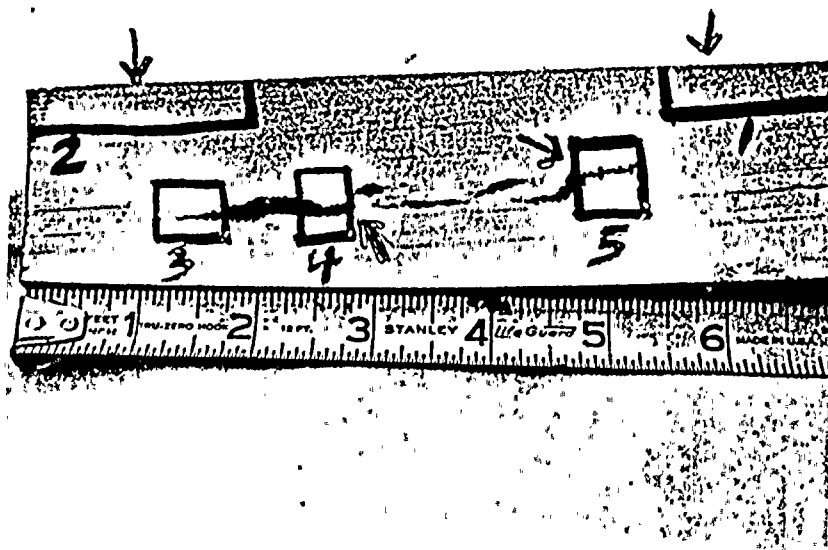
Figures 3 and 4 show the outer and inner surfaces after penetrant examination. The cracking appears much more severe on the inside surface, indicating that the cracks initiated on the inside of the pipe. Sections were cut for metallographic examination from the locations marked on Figure 4. The main crack was about 3" long on the outside and 4" long on the inside.

Figure 4. - Pipe Inside, Penetrant Examined and Section Locations.

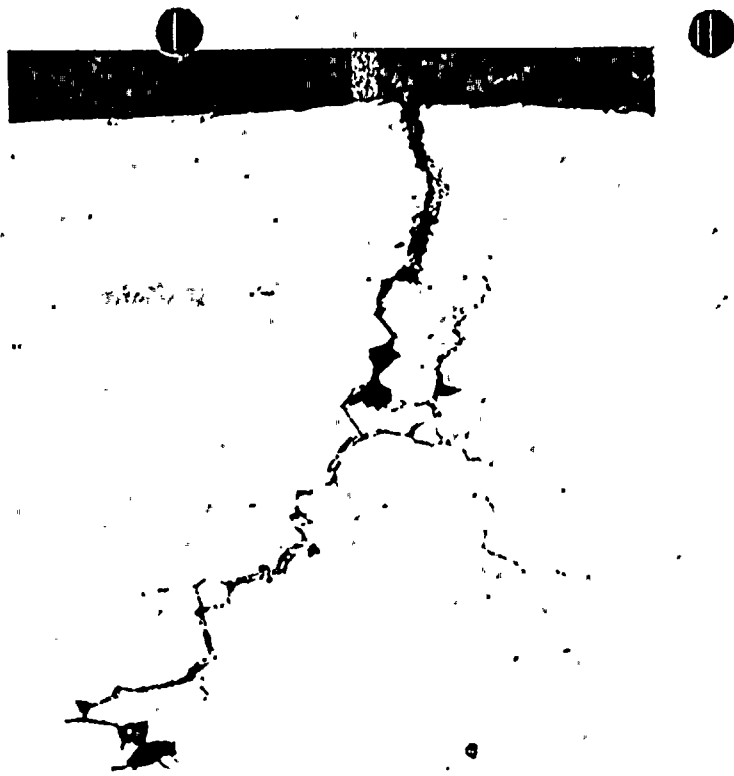
The cracks initiated in the heavily cold worked surface in a transgranular mode. Propagation changed to an intergranular mode below the cold worked surface. Figures 7 and 8 illustrate a typical crack from this section. The cracks were filled with oxides over most of their lengths.

Figure 7. - As Polished 100X
Typical Crack, Section 1

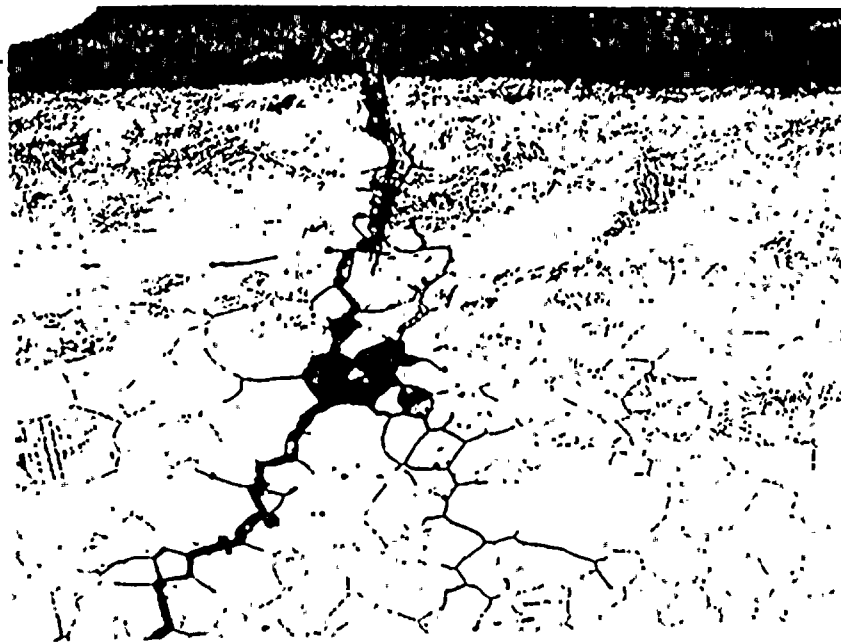
Figure 8. - Etched, Electrolytic Oxalic Acid 100X
Typical Crack, Section 1.

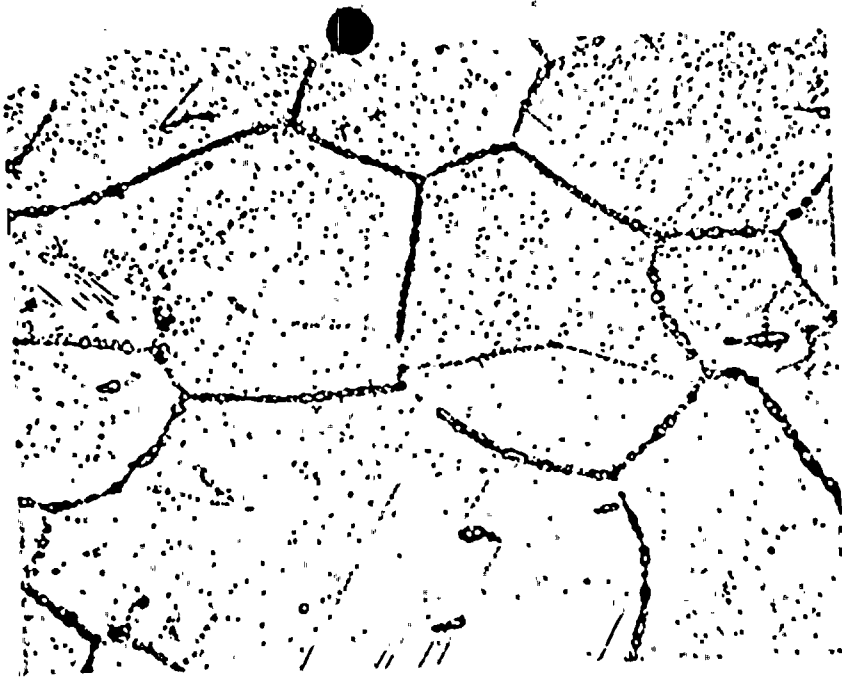
The microstructure (except for the cold worked surface) consisted of equiaxed grains of austenite with an A.S.T.M. grain size of 5 to 6. There was significant carbide precipitation around grain boundaries, as shown in Figure 9.

The combination of a cold-worked sensitized material is known to be susceptible to stress corrosion cracking, and this is considered to be the most probable mechanism. The reason for carbide precipitation is not known. The A.S.T.M. specification requires all Type 304 pipe to be solution annealed.

Figure 9. - Section 1 500X
Grain Boundary Carbide Precipitates

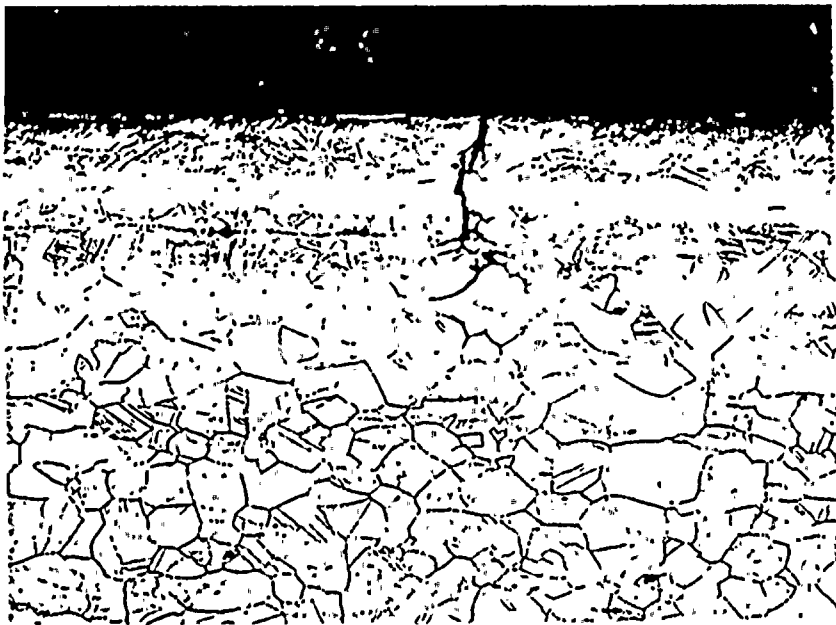
This section was examined for comparison purposes with Section 1. Only one crack was found, shown in Figure 10. It is clearly transgranular in the cold worked surface area, and has started to propagate in an intergranular mode.

Figure 10. - Etched, Electrolytic Oxalic Acid. 100X
Typical Crack, Section 2

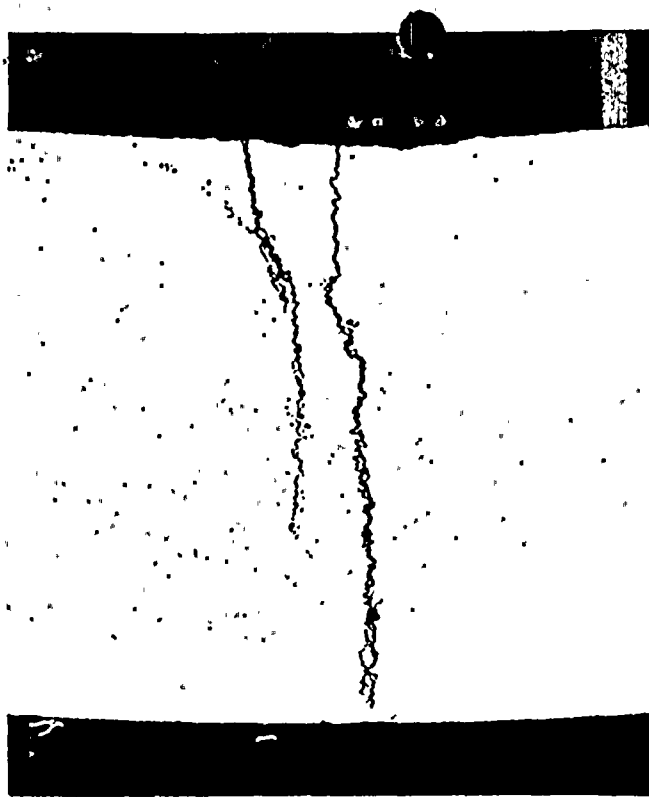
The inside surface before and after penetrant examination is shown in Figures 13 and 14. The polished section is shown in Figure 15. In this plane, one crack had almost penetrated the wall. The microstructure and crack morphology were similar to the other sections.

Figure 15. - As Polished
Section 5 Cracks

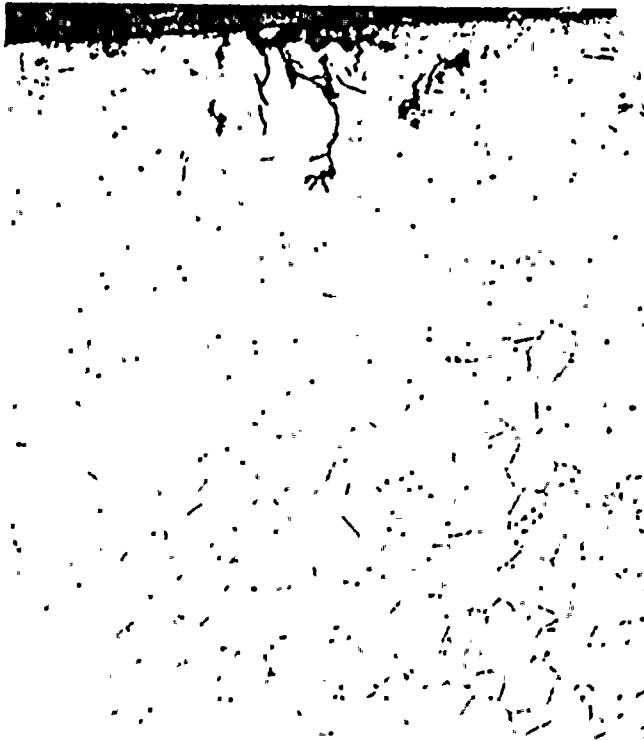
One shallow crack was found on the outside surface of this section, which does not appear to be associated with the pipe leak. This is shown in Figure 16. It is less than .010" in depth, and is primarily transgranular. While the exact mechanism of this crack can not be determined, similar cracks in the past have been attributed to chloride contamination stress corrosion. This would most likely have occurred during the fabrication or construction period.

Figure 16. - Etched, Electrolytic Oxalic Acid 100X
Section 5, Crack on Outside Surface.
