Docket No. 50-220

ELECTRICAL CONNECTOR ASSEMBLIES

IE Bulletin 77-05A

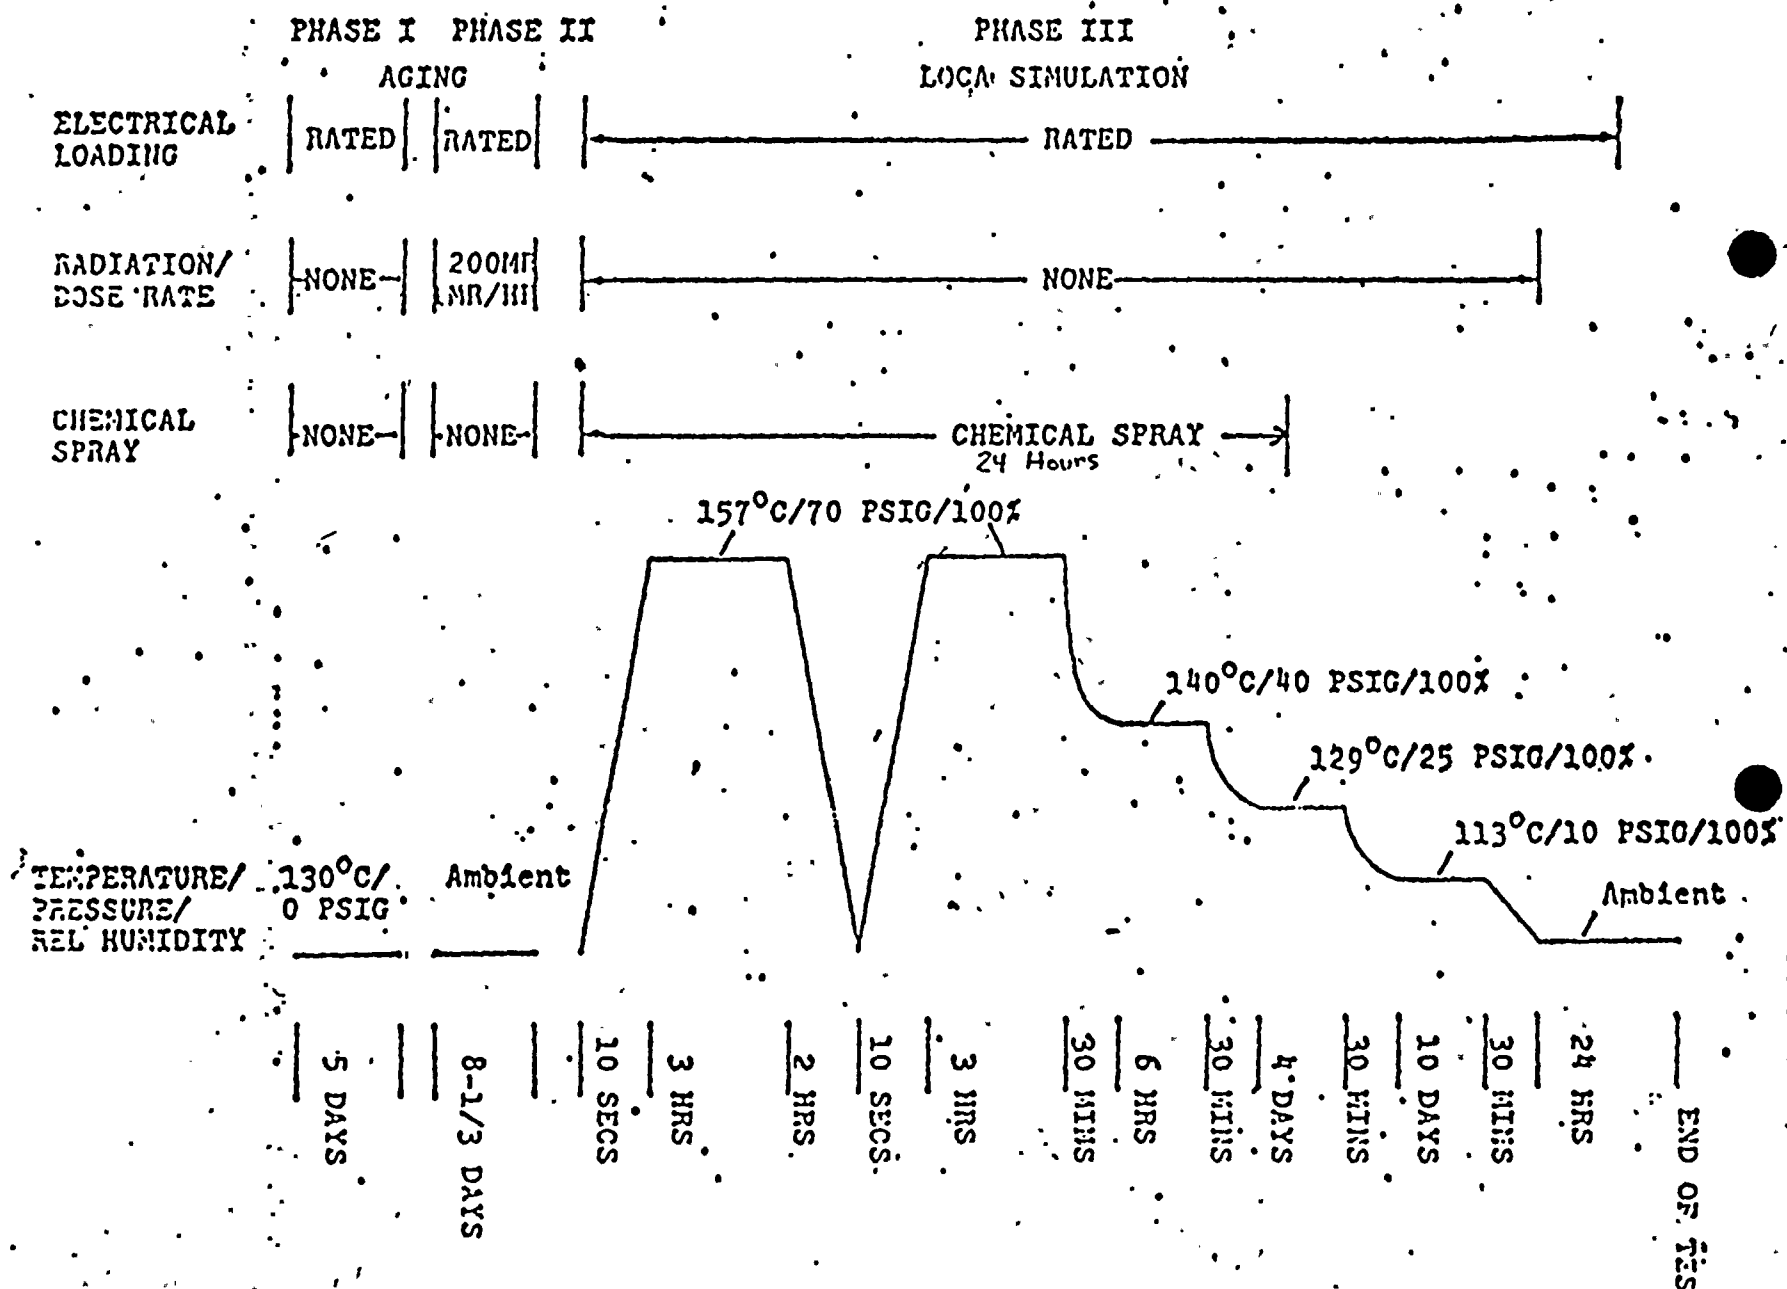
Figure 1

The three tests performed by Sandia were composed of two sequential and one simultaneous exposure to LOCA environments. In each case the equipment was exposed to radiation and thermal aging prior to operating under the simulated LOCA conditions. Figures 1 and 2 describe the test profiles for sequential and simultaneous tests respectively (Sandia tests were designed to study synergistic effects). Each of the tests satisfy the intent of IEEE 323-1974. The assemblies were electrically loaded to 20 amperes and 600 volts at the start of the tests. Insulation resistance and capacitance measurements were recorded during the tests to indicate damage.

SEQUENTIAL TEST PROFILE

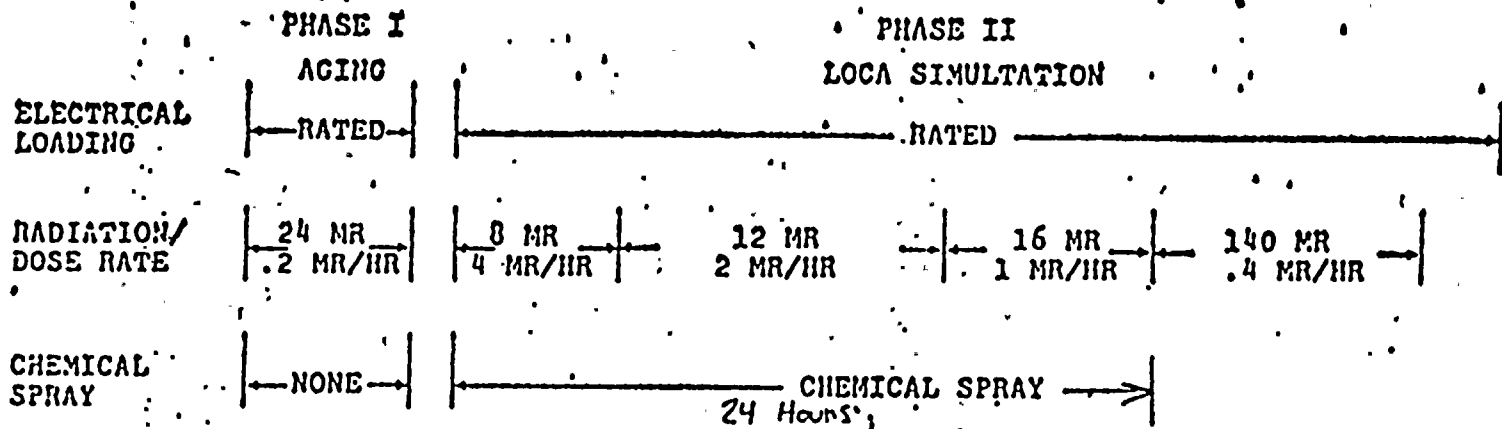
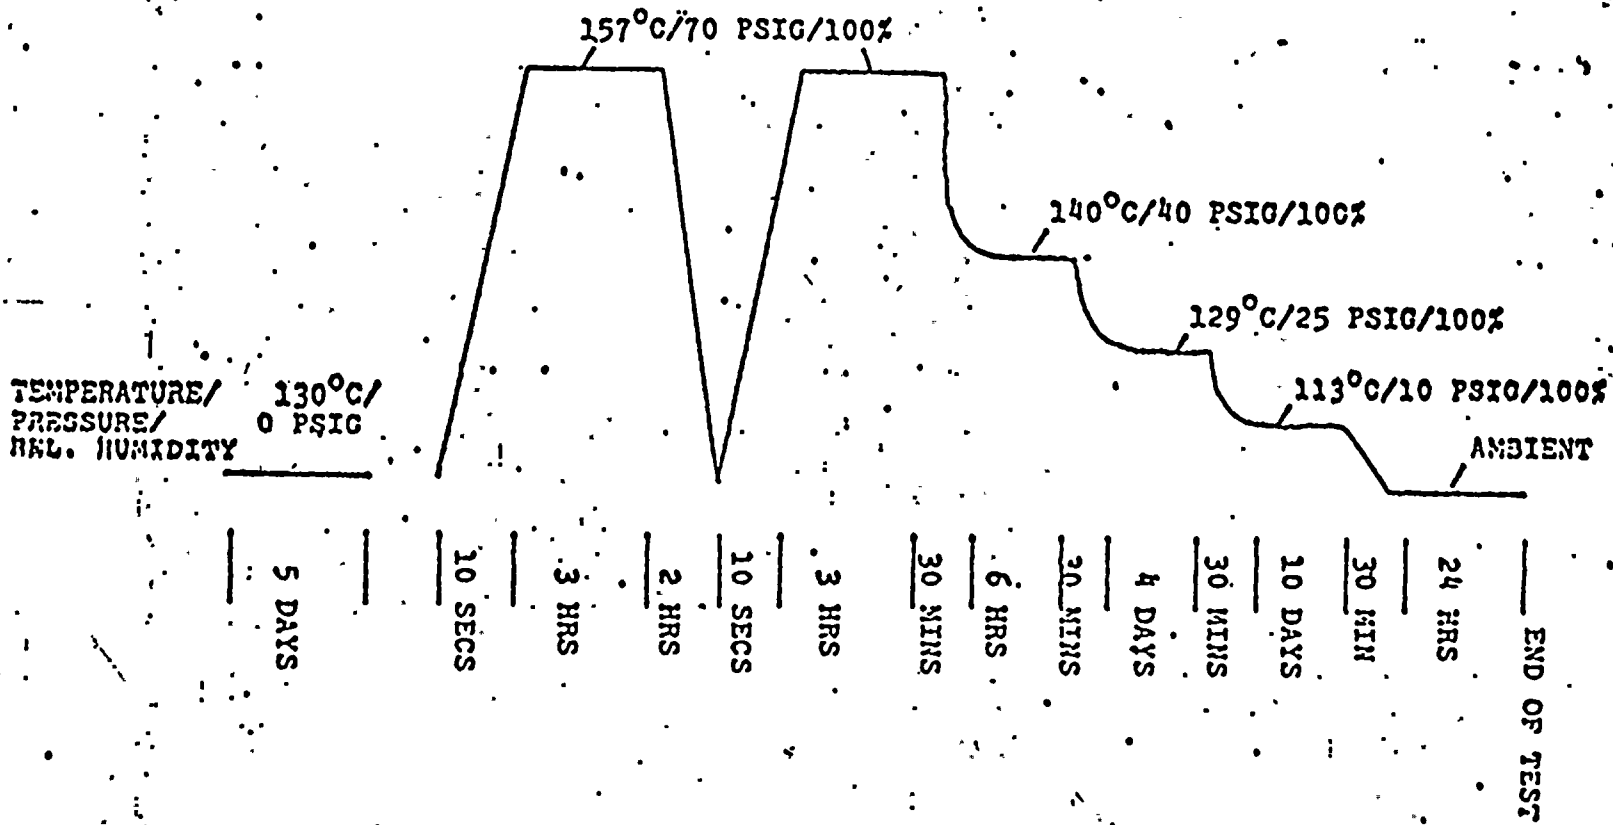
Figure 2

SIMULTANEOUS TEST PROFILE
