DESCRIPTION:  
Ltr reporting an incident on 6-2-72, regarding a problem with the electromatic relief valves & trans the following:

ENCLOSURES:  
Consolidated Electromatic Relief Valve  
6"- Type 1525-VX (Drawing)

PLANT NAMES: Nine Mile Point

Re: Provisional Operating License: DPR-17  
Docket No.: 50-220

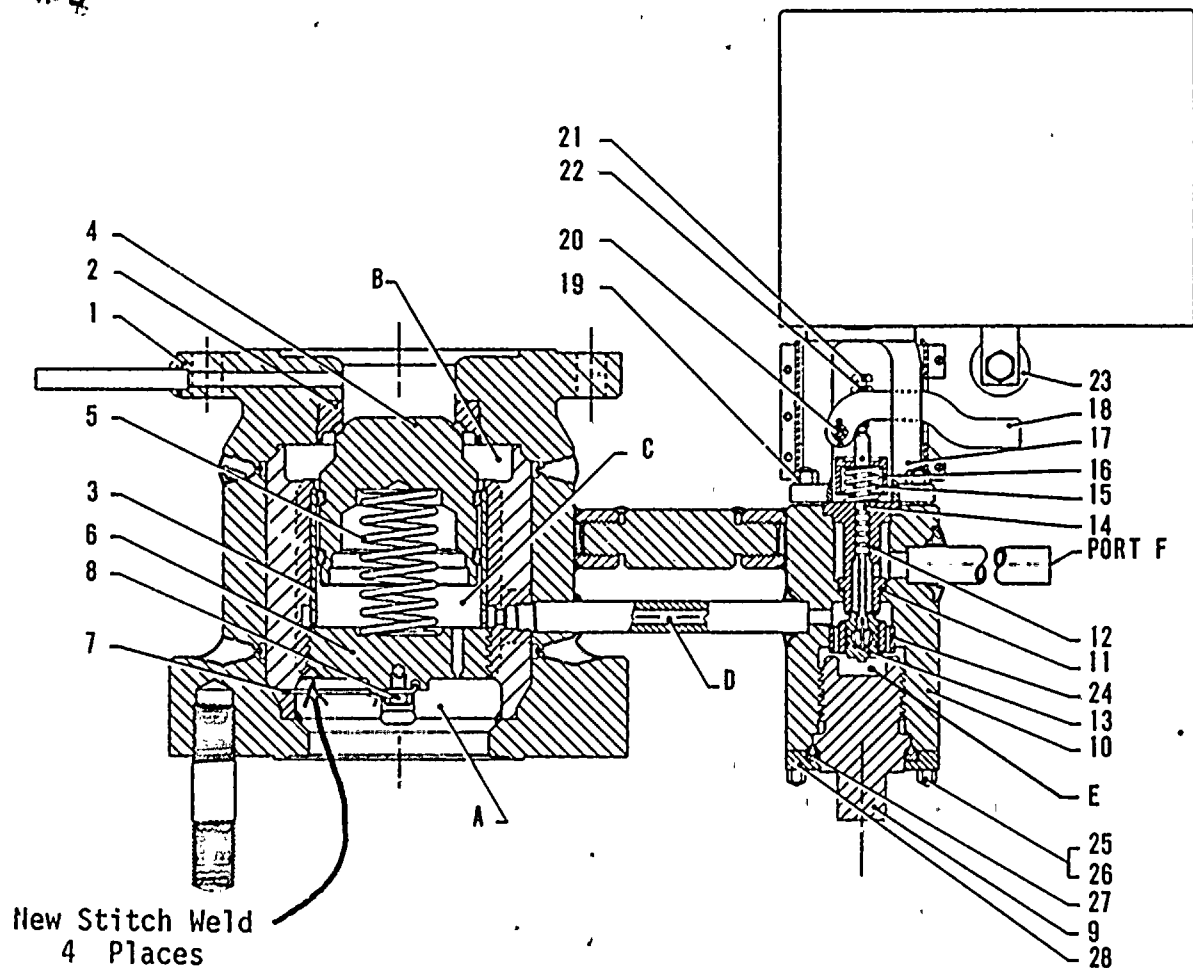
## CONSOLIDATED ELECTROMATIC RELIEF VALVE

On one valve, the locking screw, Part #8 on enclosed drawing, had become unscrewed allowing lock retainer Plate #7 to fall free (both parts were recovered in the turbine stop valve strainer basket). This permitted the disc retainer, Part #6, to completely back-out falling to the bottom of the valve body. In this condition, it would be impossible to bleed enough steam from Chamber "C" to open the valve as it would be wide open to Chamber "A" and would not have the benefit of the restricting orifice in the retainer plate.

One other valve was found with the locking screw, Part #8, backed out 1/16" but the lock retainer plate and disc retainer had not moved, therefore the valve was operable. Tie-wires holding the locking screws were broken on all six valves.

Repair was effected to all six valves by removing the locking screw, Part #8, and lock retainer plate, Part #7. In their place, four 1/4" V grooves, 1" long, were cut in the joint between the disc retainer and the valve body insert. These were stitch welded together. Future maintenance may be accomplished by grinding out the stitch weld. In this manner, there can be no loose parts on the valves to drop into the steam lines and dependability of valve operation is increased.
