102-07431-MLL/RAC
February 10, 2017

Subject: **Palo Verde Nuclear Generating Station (PVNGS) Unit 3**
Docket No. STN 50-530 / License No. NPF 74
Licensee Event Report 2016-002-00

4. TITLE
Emergency Diesel Generator Failure Resulting in a Condition Prohibited by Technical Specifications

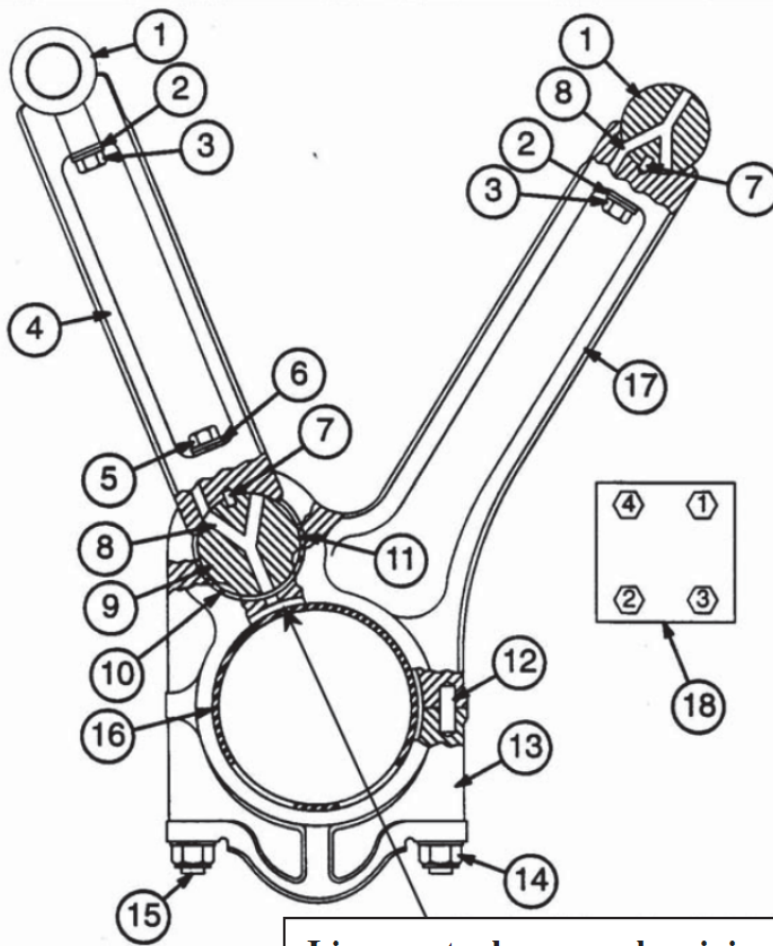
Attachment 1
Figure of the Connecting Rod Configuration

The preliminary cause analysis indicates that the 3B DG master connecting rod failed due to high cycle fatigue caused by misalignment of the crankshaft bore introduced by a previous failure that occurred in 1986. The failure mechanisms that caused the 1986 and 2016 3B DG failures are not present in any other PVNGS DG.

The direct cause of this event was high cycle fatigue of the #9 master rod ligament. The preliminary cause analysis determined the 3B DG had a misaligned crankshaft bore that resulted from a previous failure of the 3B DG that occurred in 1986. The misalignment of the crankshaft bore resulted in sufficient cyclic stresses at the #9 master rod ligament to initiate and propagate a fatigue crack. Refer to Attachment 1 for a figure of the master rod configuration and the location of the ligament crack.

Ligament where crack originated

The damaged equipment has been repaired or replaced, and the misalignment of the crankshaft bore has been corrected by precision line boring, which restored the crankshaft bearing alignment to within manufacturer specifications. However, additional analytical work is in progress to validate the preliminary conclusions of the cause investigation team.
