UNITED STATES
 NUCLEAR REGULATORY COMMISSION
 REGION I
 631 PARK AVENUE
 KING OF PRUSSIA, PENNSYLVANIA 19406

Docket No. 50-410

IE Bulletin No. 78-12A
Date: November 24, 1978
Page 1 of 2

ATYPICAL WELD MATERIAL IN REACTOR PRESSURE VESSEL WELDS

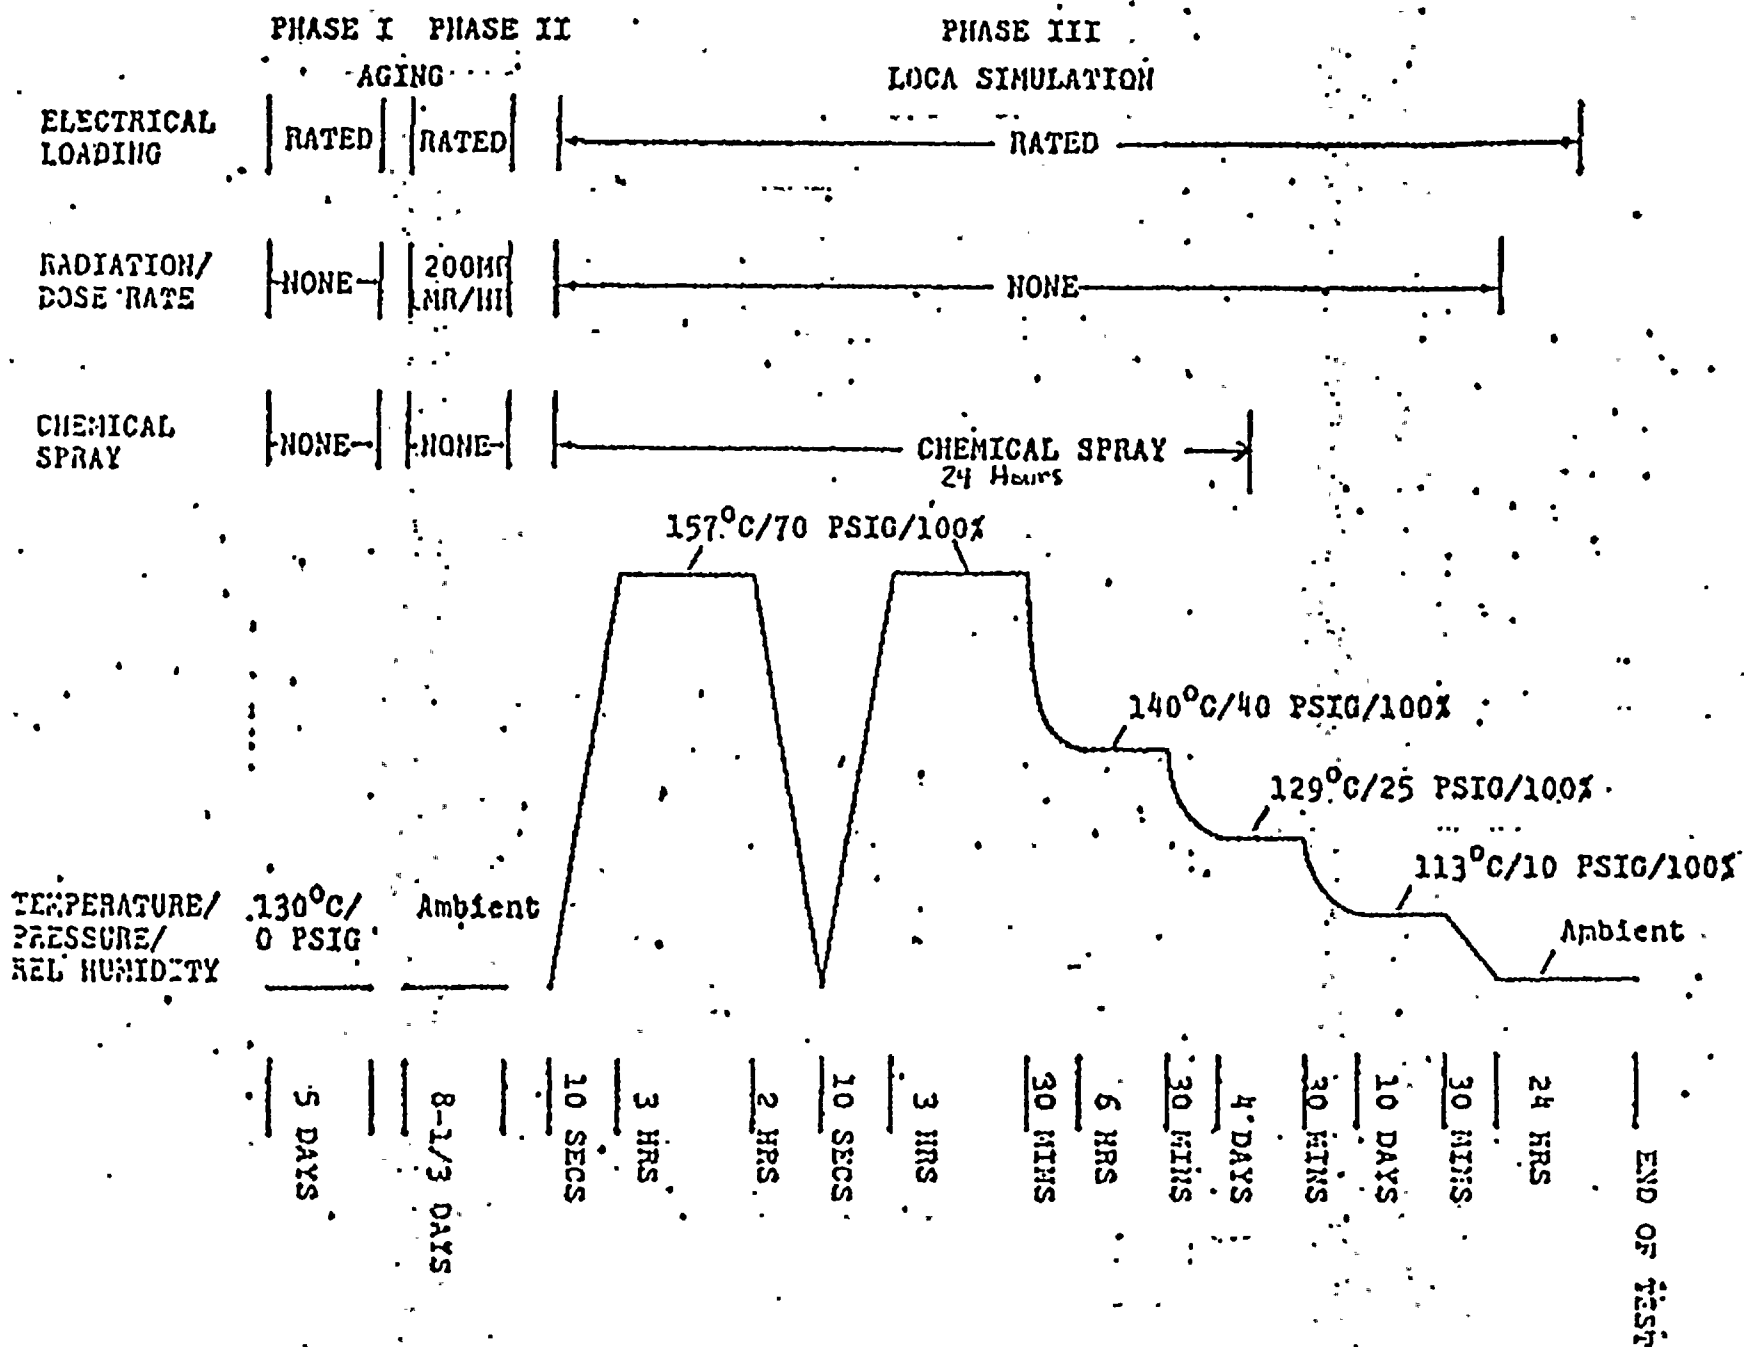
Figure 1

SEQUENTIAL TEST PROFILE

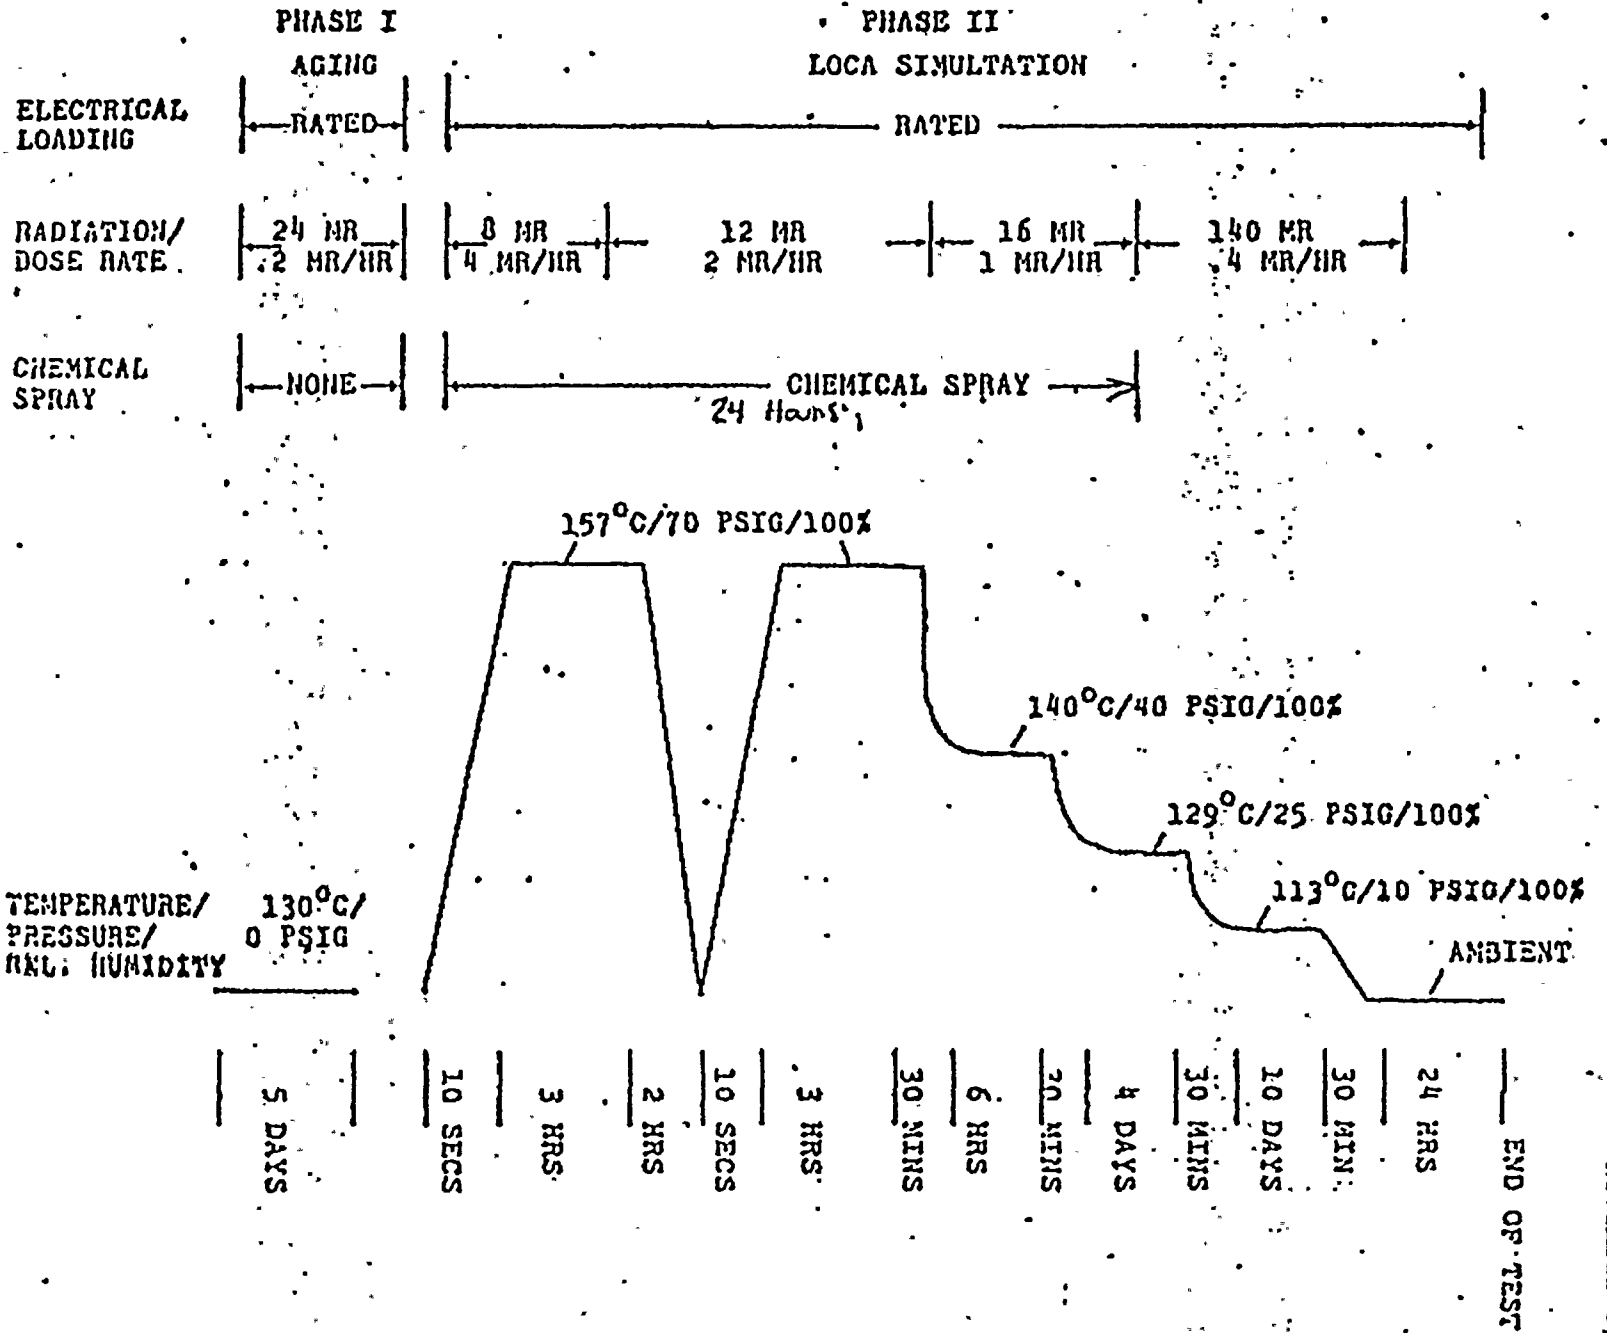
Figure 2

SIMULTANEOUS TEST PROFILE
