SUBJECT: FOLLOWUP ON NOTIFICATIONS OF 780621 & 781122 RE POTENTIALLY *10 CFR 50.55(e)*
 REPORTABLE DEFICIENCIES IN CADWELD SLEEVES ON CONTAINMENT
 LINER KNUCKLE PLATE.FORWARDS DESCRIPTION, ANALYSIS &
 CORRECTIVE ACITON.

Re: Nine Mile Point Unit 2
Docket No. 50-410

I. INTRODUCTION

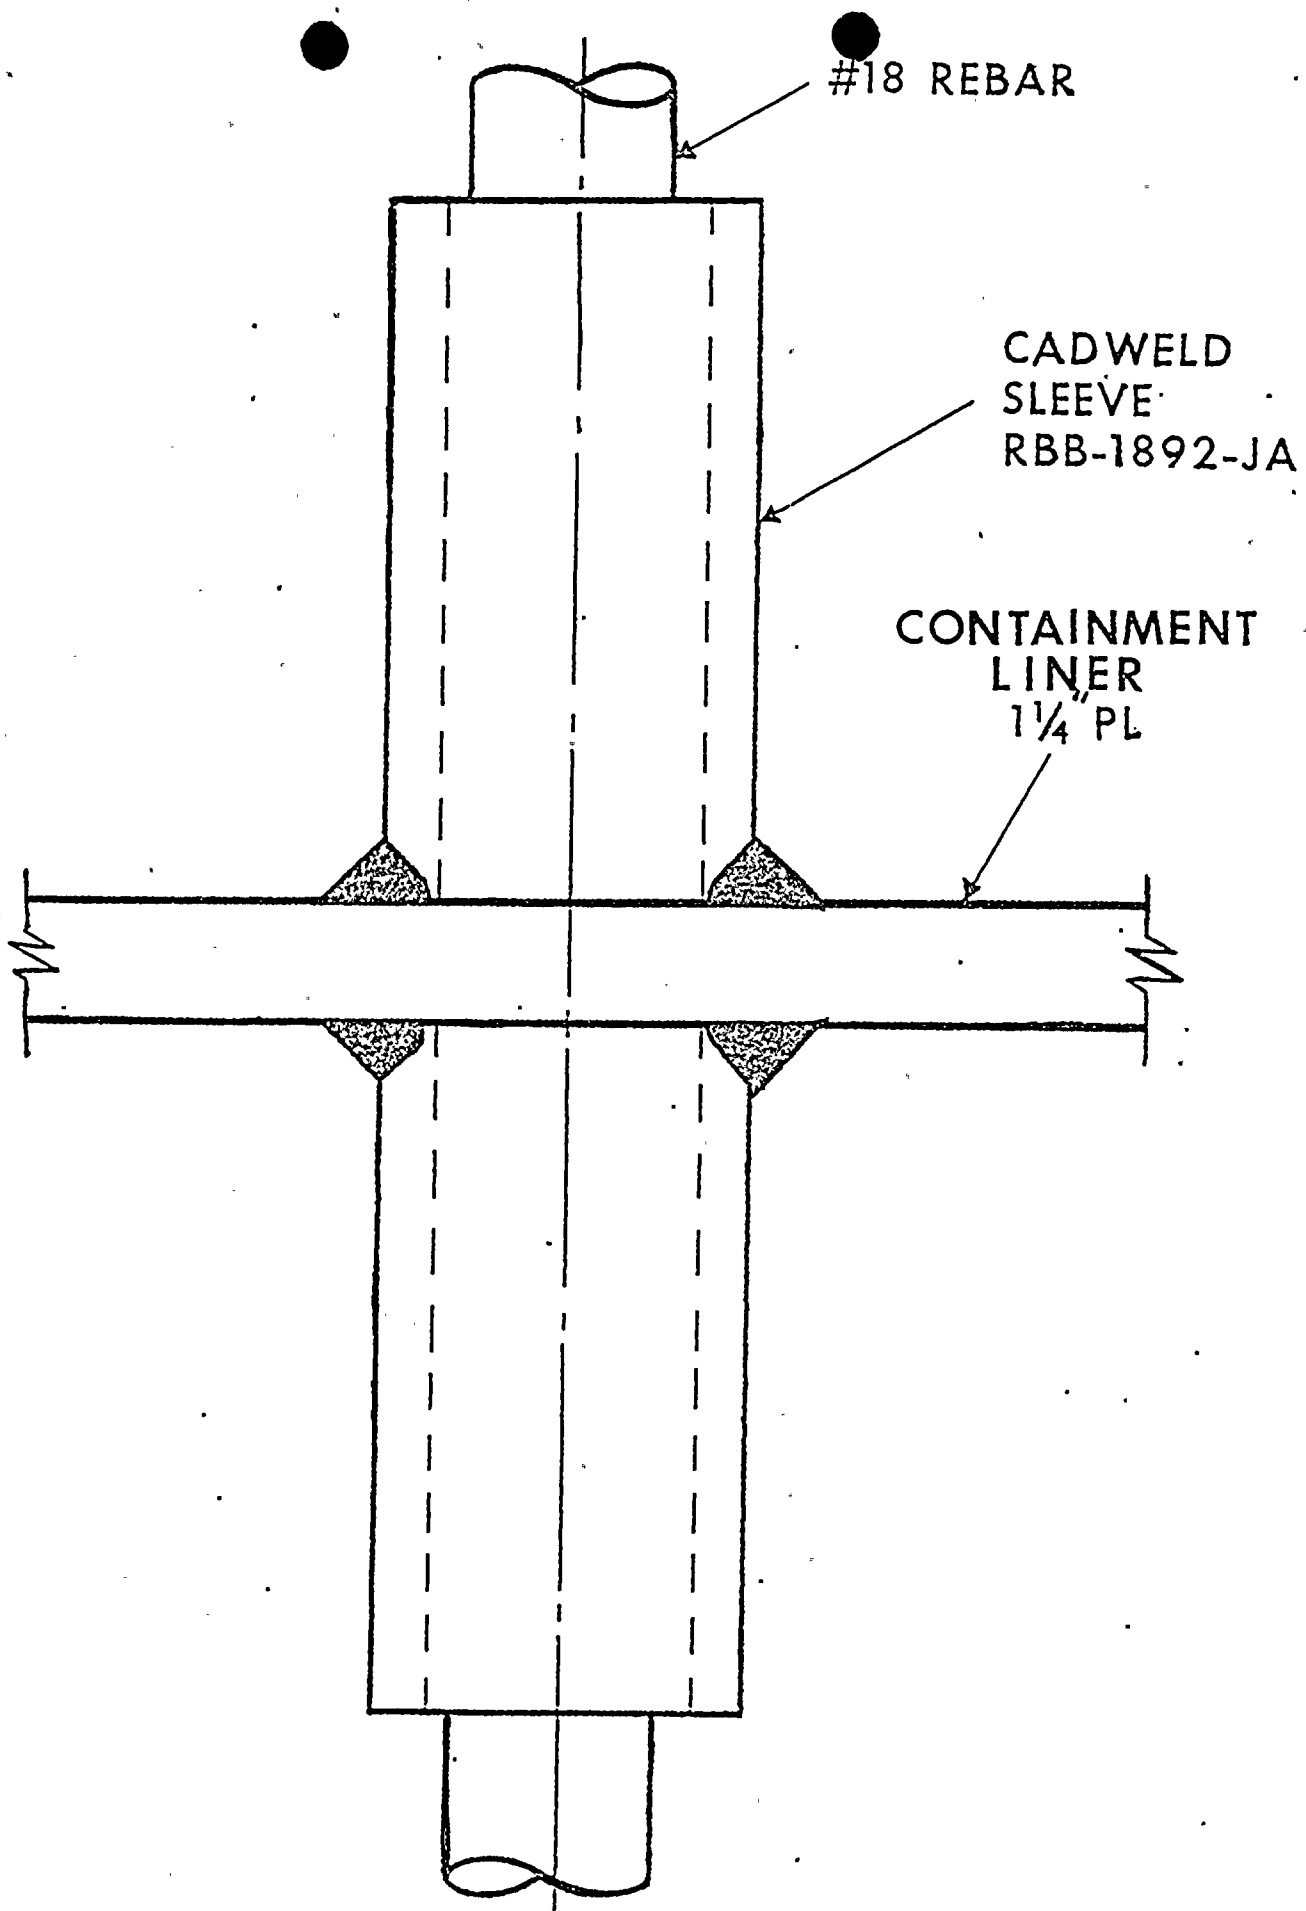
CONTAINMENT LINER CADWELD SLEEVE DESIGN FIG.1

Four cadweld sleeve assemblies representing the worst-case ultrasonic test results were removed from the liner and tensile tested after having rebar stubs cadwelded at each end (see Figure 1). In all cases, the rebar failed and not the weld. Subsequent cross-sectioning confirmed the ultrasonic test results as accurate. Photographs of the cross-sections are provided as Figures 3 and 4. Two additional onsite sleeve welds were ground in the J-bevel area and also confirmed the accuracy of the ultrasonic testing results.

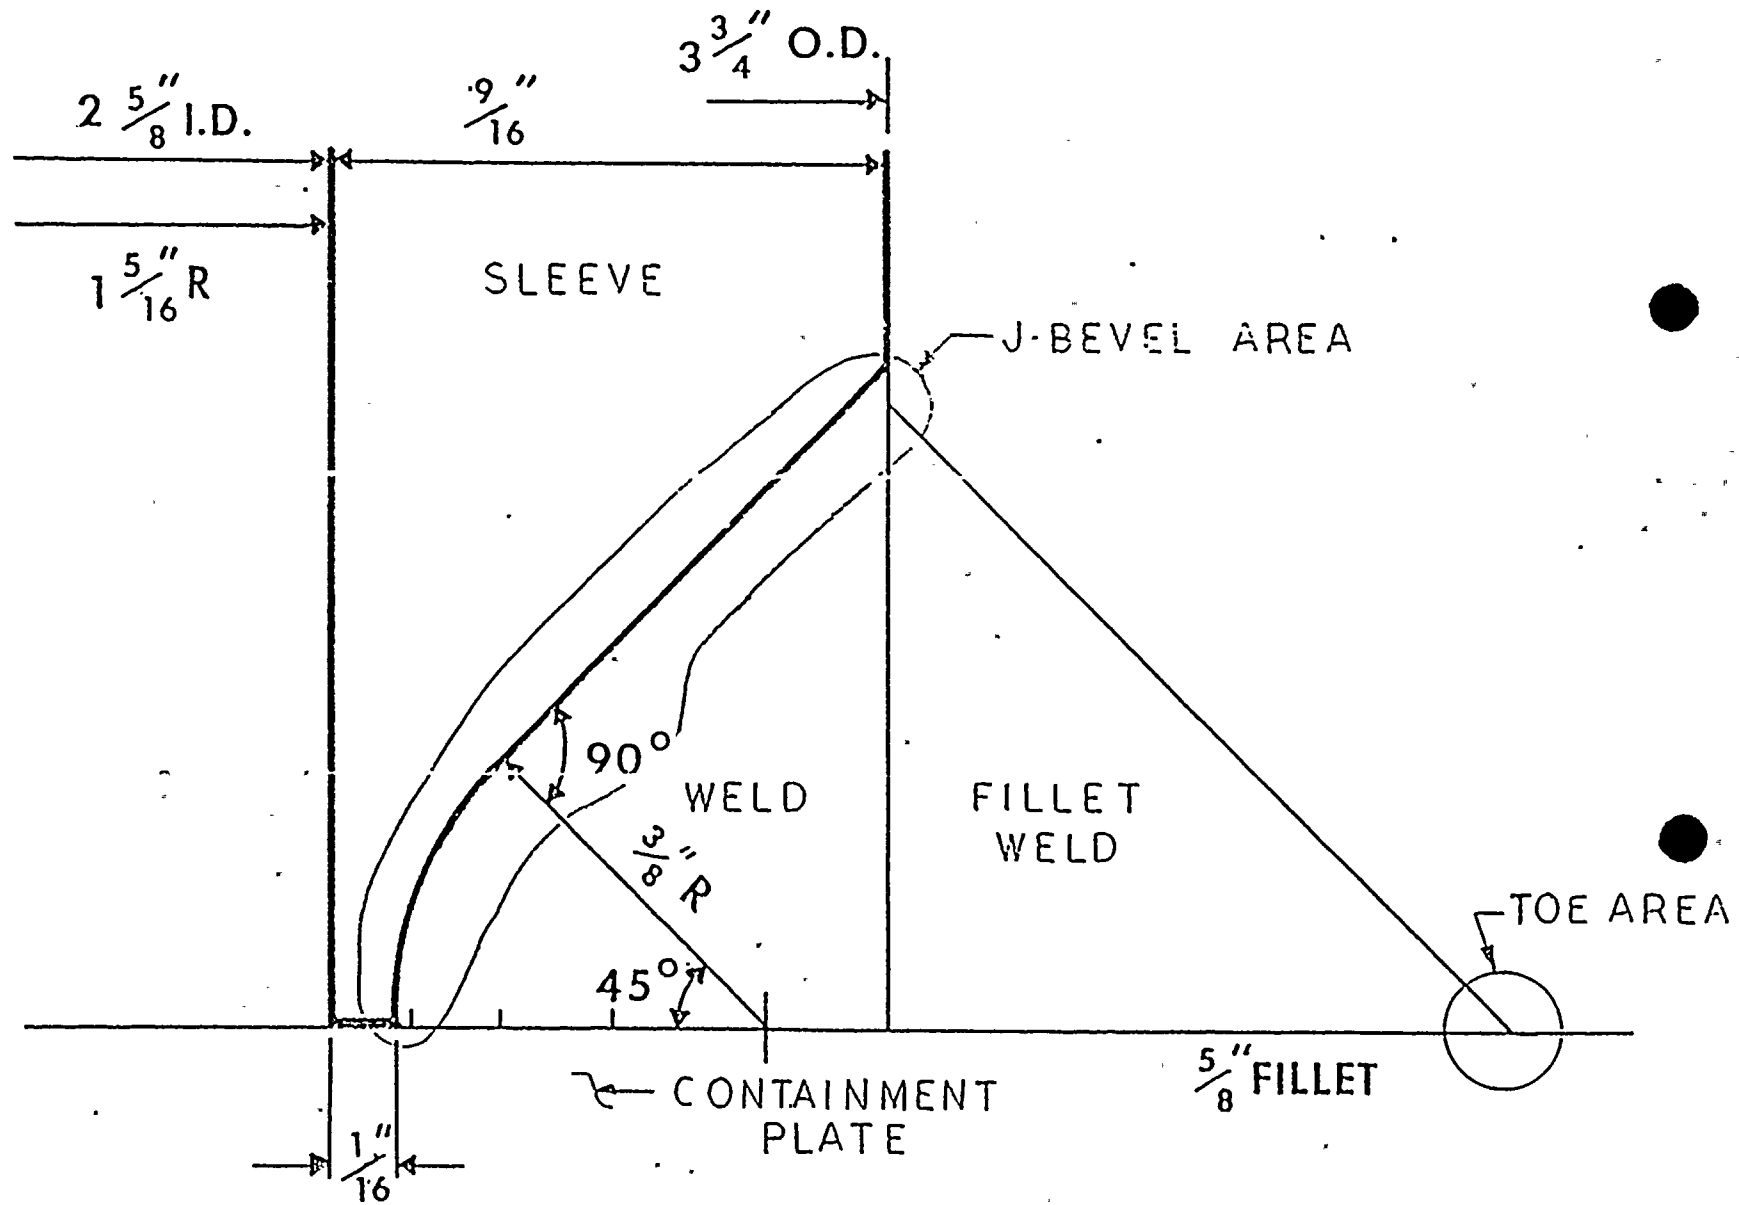
CADWELD JOINT DETAIL

During the subsequent ultrasonic testing investigation into these magnetic particle indications, a second potential reportable deficiency was discovered. This deficiency was characterized by entrapped slag and lack of fusion along the J-bevel area of some of the cadweld sleeves (see Figure 2). This condition was reported to the Nuclear Regulatory Commission in accordance with 10CFR50.55(e) on November 22, 1978. Extensive analyses and tests were performed to determine the extent of this welding deficiency.

The ultrasonic test investigation of the toe area magnetic particle defects revealed the second potential reportable deficiency. This was a lack of fusion along the J-bevel area of the cadweld sleeve (see Figure 2). Eighteen of the 255 welds with magnetic particle indications and 24 of the remaining welds without magnetic particle indications were selected randomly for investigation. Eleven of the 18 and six of the 24 revealed linear indications 1/4 inch and greater in the J-bevel area for circumferential lengths up to 360 degrees.

A total of 1,824 cadwelds (less eight removed for testing) currently on the containment knuckle area will be removed, and new cadweld sleeves will be welded to the containment liner knuckle plate using a manual process.

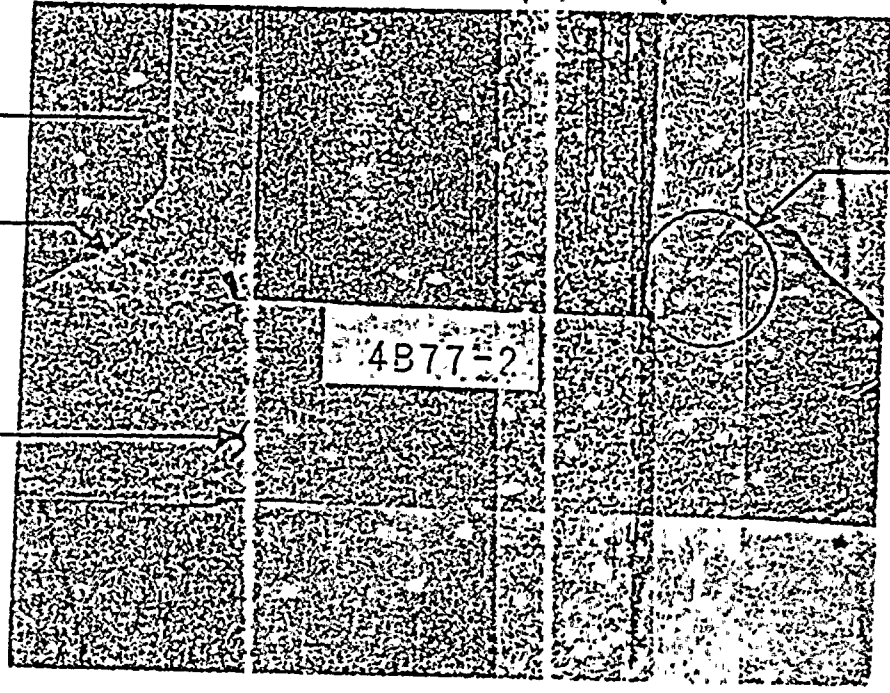
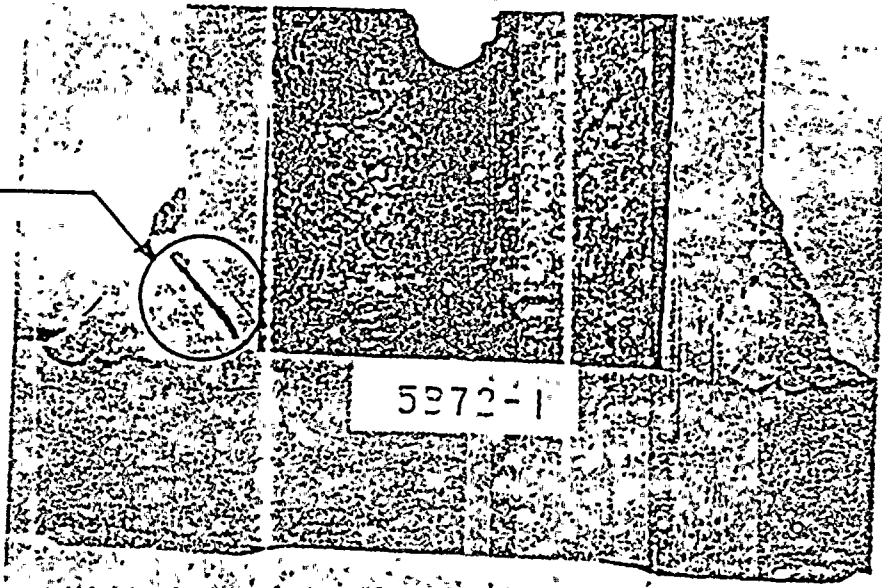
CROSS SECTION OF LINER CADWELD SLEEVE WELDS.

The second reported deficiency, the slag and lack of fusion along the cadweld sleeve J-bevel area in the containment liner knuckle plate is a departure from the specified technical requirements. This would be considered a potential safety hazard if it were to remain uncorrected. The design requirements for allowable stress in these welds and the containment liner plate could be exceeded with the type of J-bevel defects disclosed.

J BEVEL LACK OF FUSION

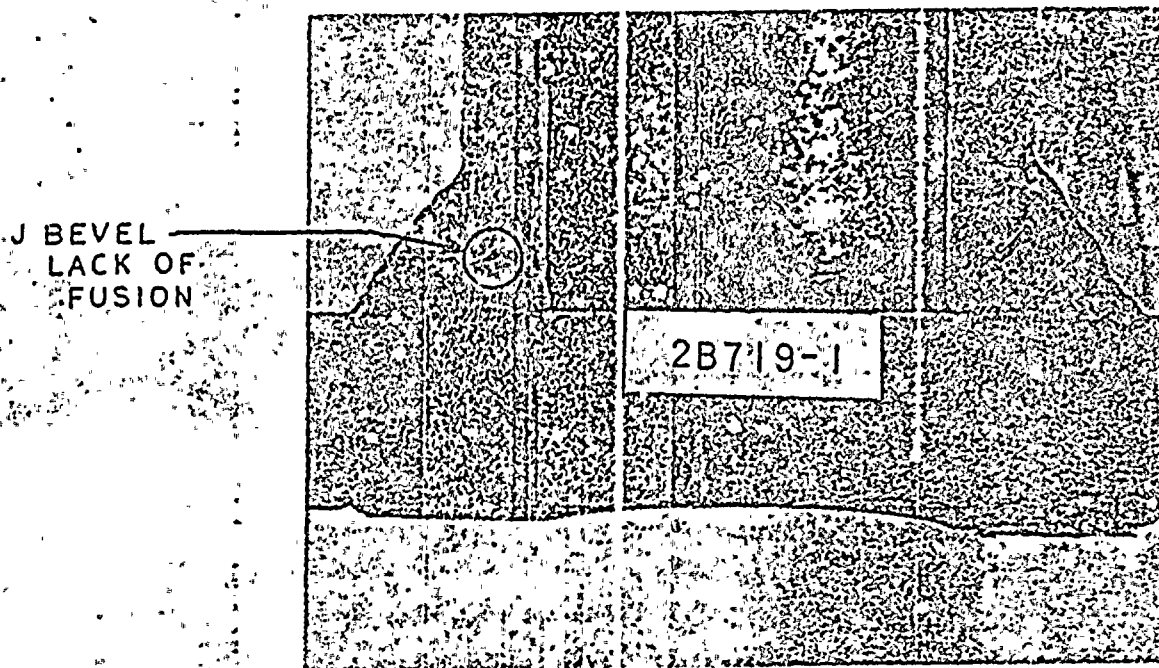
FIG. 4

CROSS SECTION OF LINER CADWELD SLEEVE WELDS

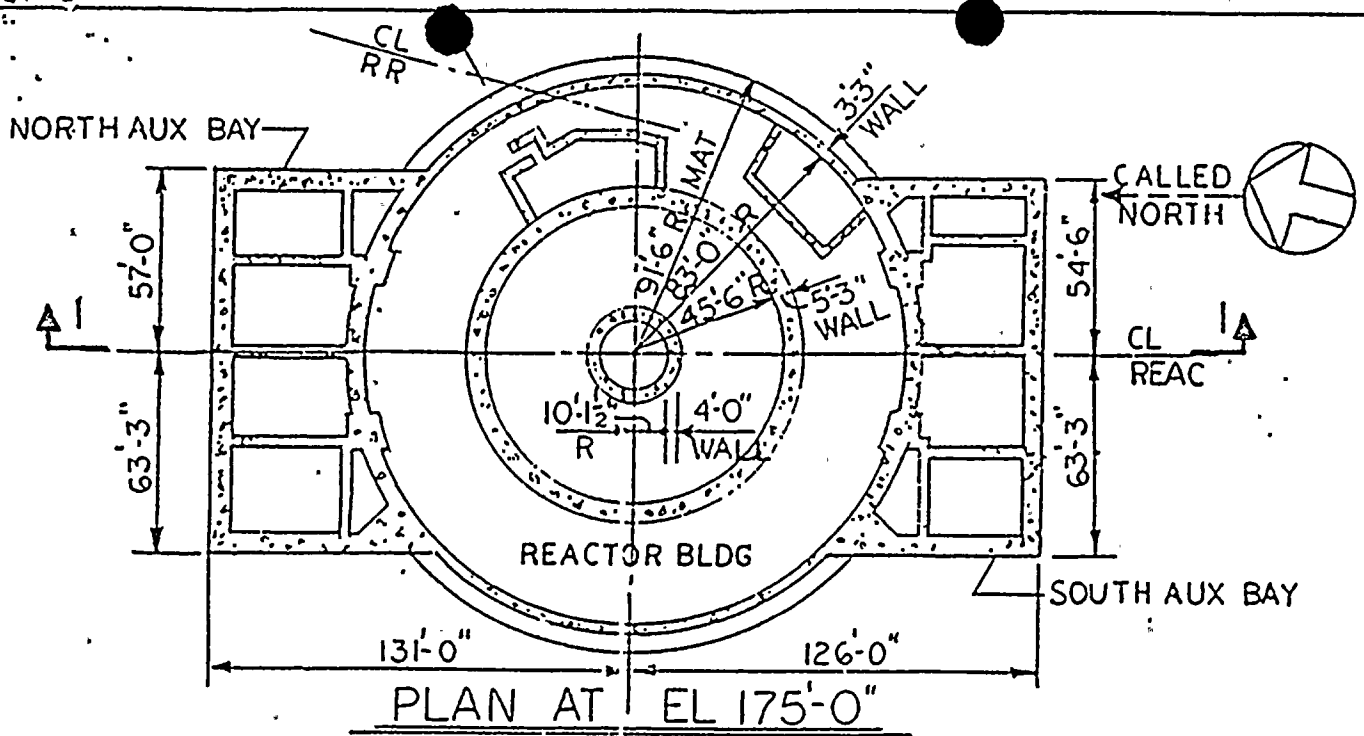
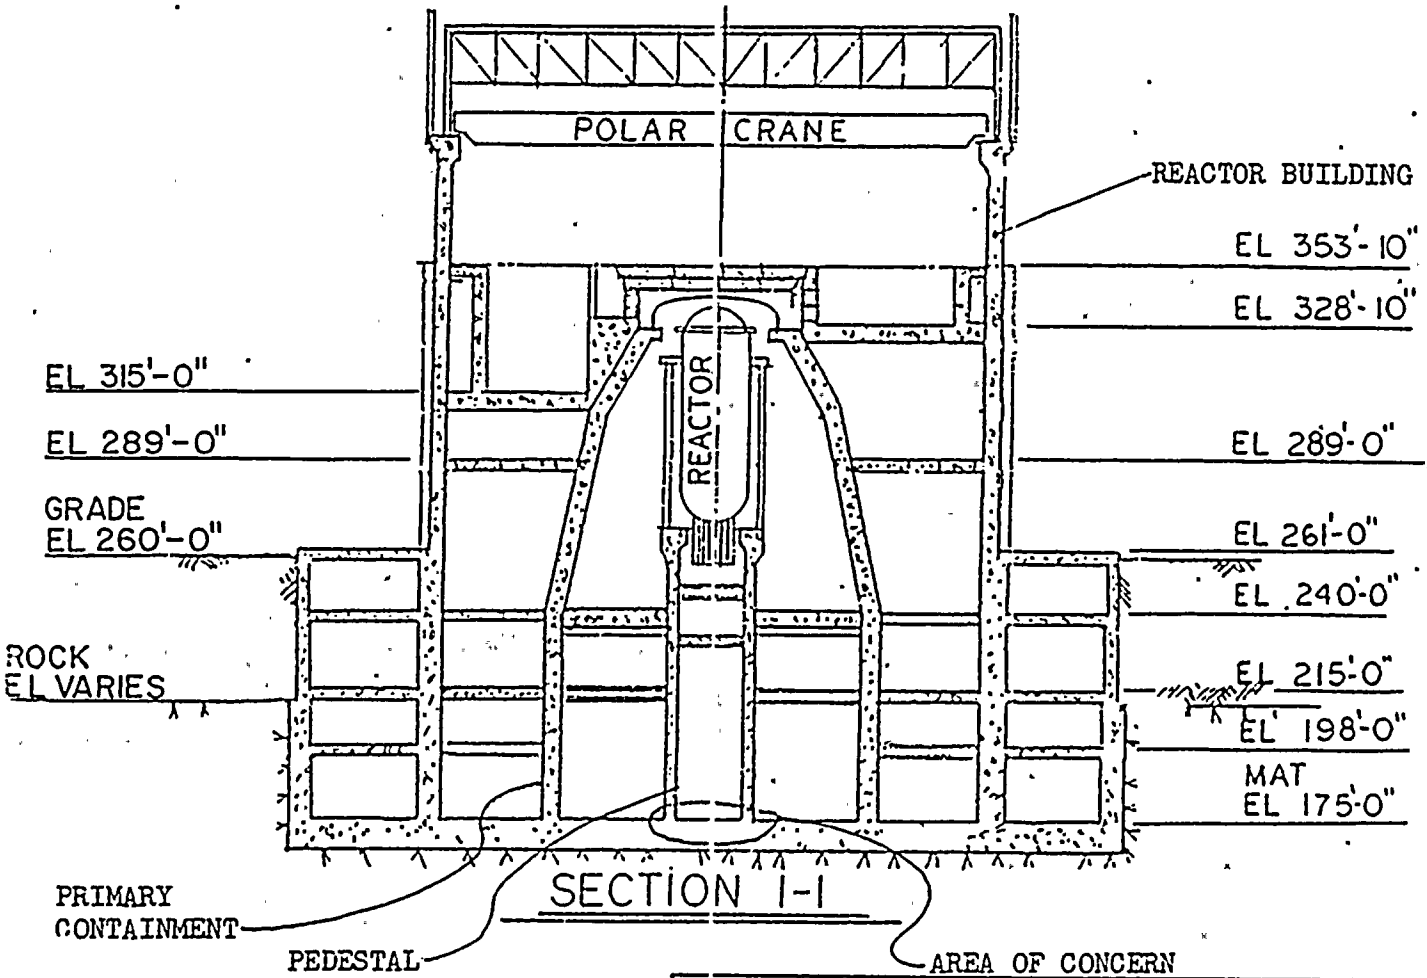
FIGURE 5
 PLAN AND SECTION, REACTOR
 BUILDING AND AUXILLIARY BAYS
 NINE MILE POINT NUCLEAR STATION, UNIT 2
 NIAGARA MOHAWK POWER CORPORATION

Due to the problem identified in the containment liner knuckle plate, further investigations were conducted relative to the cadweld sleeve to base plate welds at the junction of the reactor pedestal and the mat. Figure 5 shows the location of these welds. All 680 cadweld sleeve welds in this location had previously passed magnetic particle inspection. Of these, 625 cadweld sleeve welds were performed using a manual stick welding method, and tensile tests were conducted on equivalent test assemblies. All the test assemblies failed in the number 18 rebar at loads higher than 125 percent of the minimum rebar yield strength, and no failure occurred in the welds. The remaining 55 welds in this location were performed by the same welding method and procedure as the liner knuckle welds. The exact location of these 55 welds is not known except that 10 are in one 90-degree sector and 45 are in another 90-degree section of the pedestal-to-mat junction (see Figure 6).

The 55 suspect welds in the junction of the base plate and reactor pedestal have no safety implications and require no corrective action as discussed in Section III above.

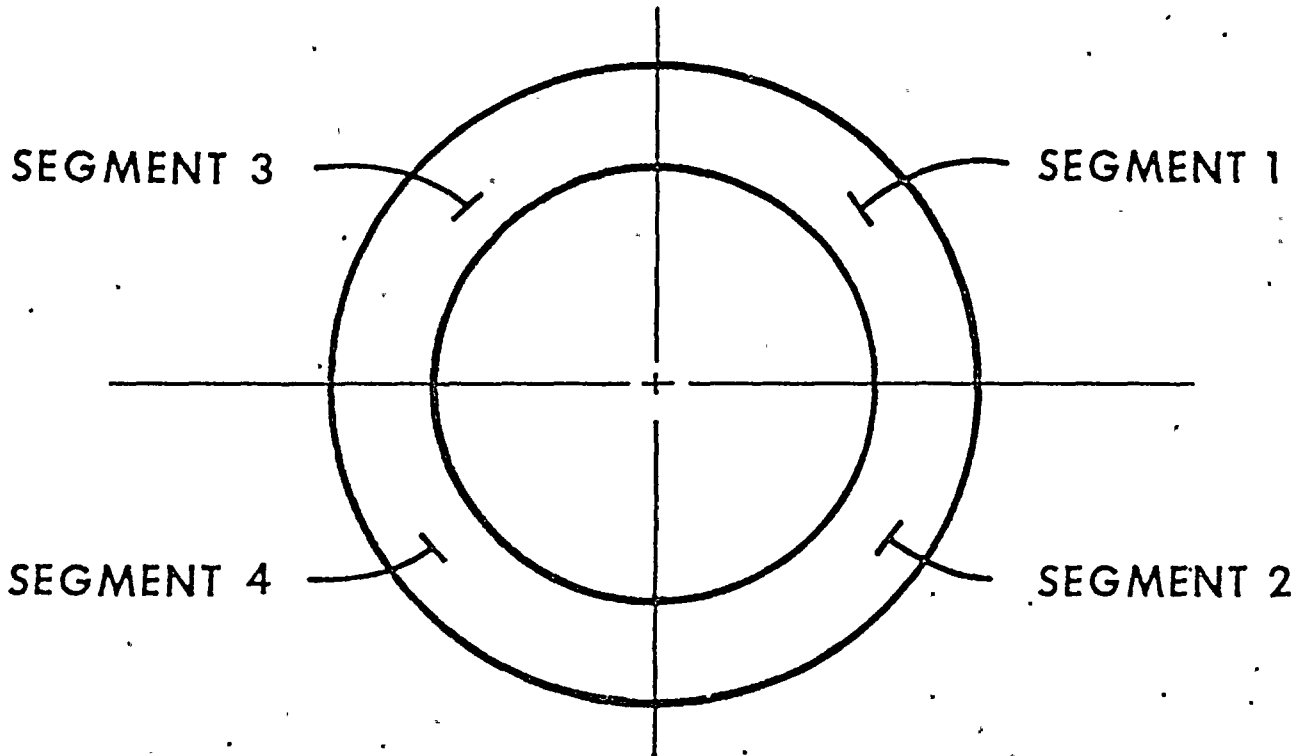
FIGURE-6

of this design change, forces in the rebar at the base of the reactor pedestal are greatly reduced. Since the pedestal to mat reinforcing design details were not changed from the original, the re-inforcing is conservatively designed for the existing forces. Although there is no evidence that the cadweld sleeve to base plate welds at the pedestal base are unable to withstand required rebar forces, an analysis with conservative assumptions was performed. It was concluded that even if 55 welds are assumed to be in the worst possible location with no load carrying capability, the remaining rebar will not be overstressed and the overall stability and integrity of the structure is maintained.

Based on this analysis, there are no safety implications as a result of potentially deficient cadweld sleeve to base plate welds at the junction of the reactor pedestal and the mat.

SEGMENT 1 - SUSPECT 45 - B-SERIES CADWELD SLEEVES
WERE WELDED USING SEMI-AUTOMATIC
WELDING PROCEDURE

SEGMENT 3 - SUSPECT 10 - B-SERIES CADWELD SLEEVES
WERE WELDED USING SEMI-AUTOMATIC
WELDING PROCEDURE
