REPORT OF INVESTIGATION INTO SIGNIFICANT
DEFICIENCY CONCERNING INADEQUATE NONDESTRUCTIVE
EXAMINATIONS PERFORMED ON THE
NINE MILE POINT UNIT 2 CONTAINMENT LINER WELDS

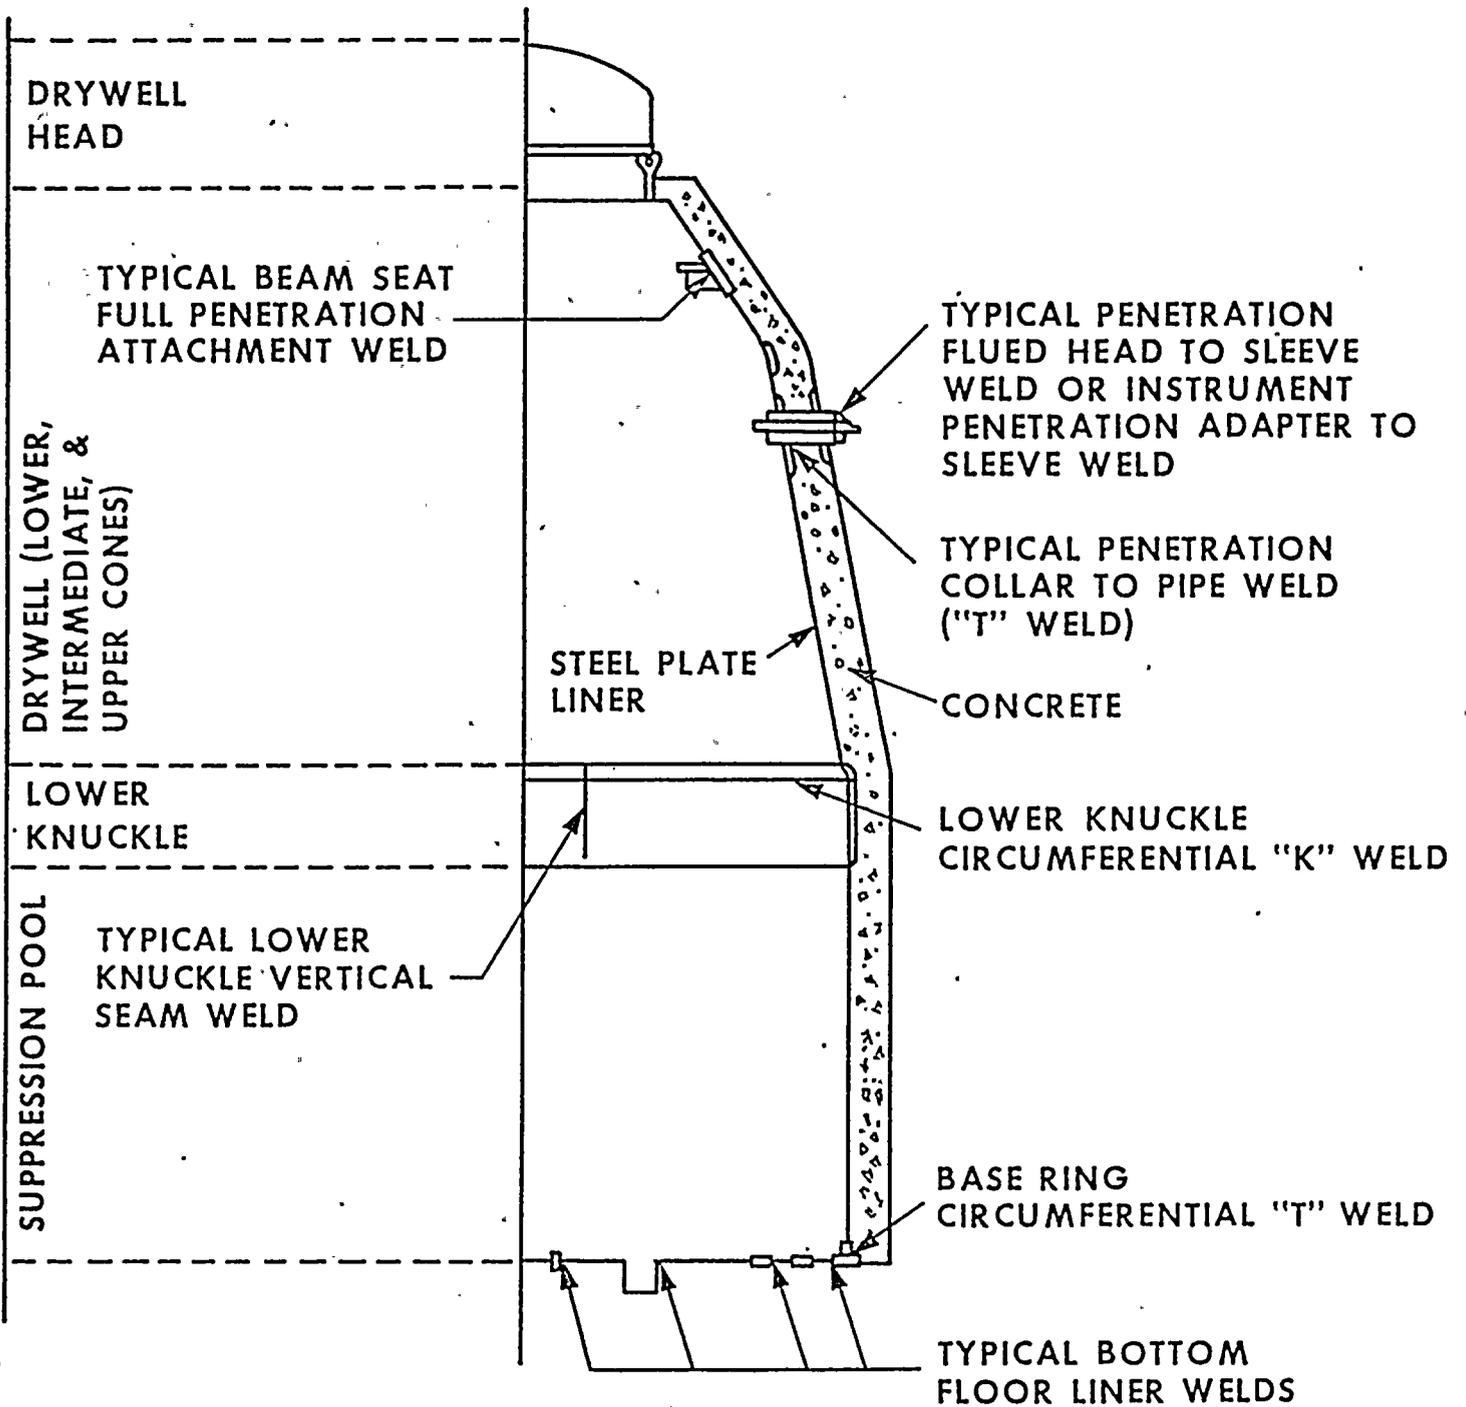
FIGURE 1

NMP2 PRIMARY CONTAINMENT LINER
