UNITED STATES
NUCLEAR REGULATORY COMMISSION
OFFICE OF INSPECTION AND ENFORCEMENT
WASHINGTON, D.C. 20555

October 17, 1979
IE Bulletin No. 79-13
Revision 2
Page 1 of 5

CRACKING IN FEEDWATER SYSTEM PIPING

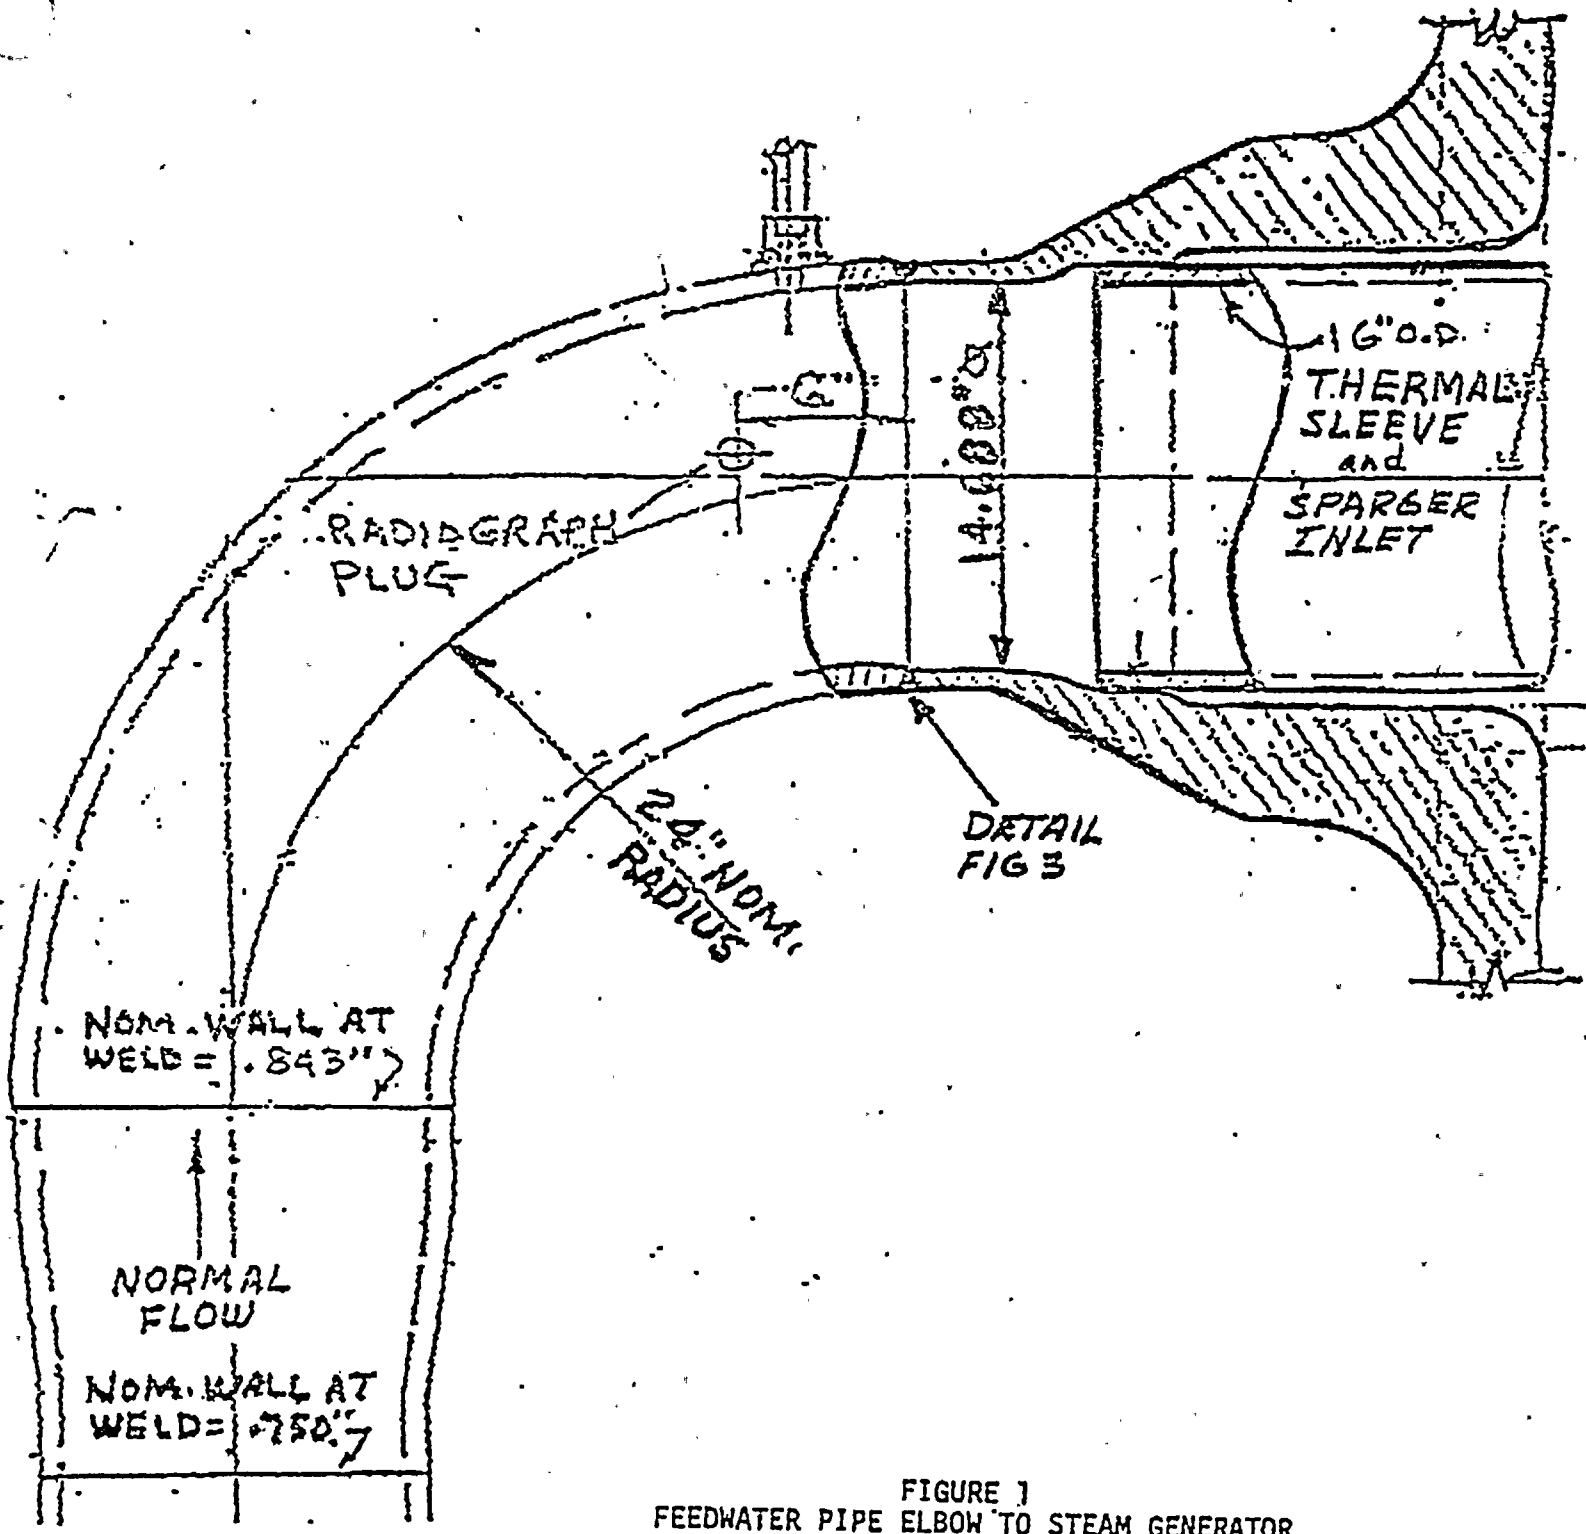
FIGURE 1
FEEDWATER PIPE ELBOW TO STEAM GENERATOR
NOZZLE INSTALLATION (DC COOK)

The feedwater nozzle-to-pipe configurations for D. C. Cook and for San Onofre are shown on the attached figures 1 and 2. A typical feedwater nozzle-to-pipe weld joint detail showing the principal crack locations for D. C. Cook and San Onofre are shown on the attached figure 3.

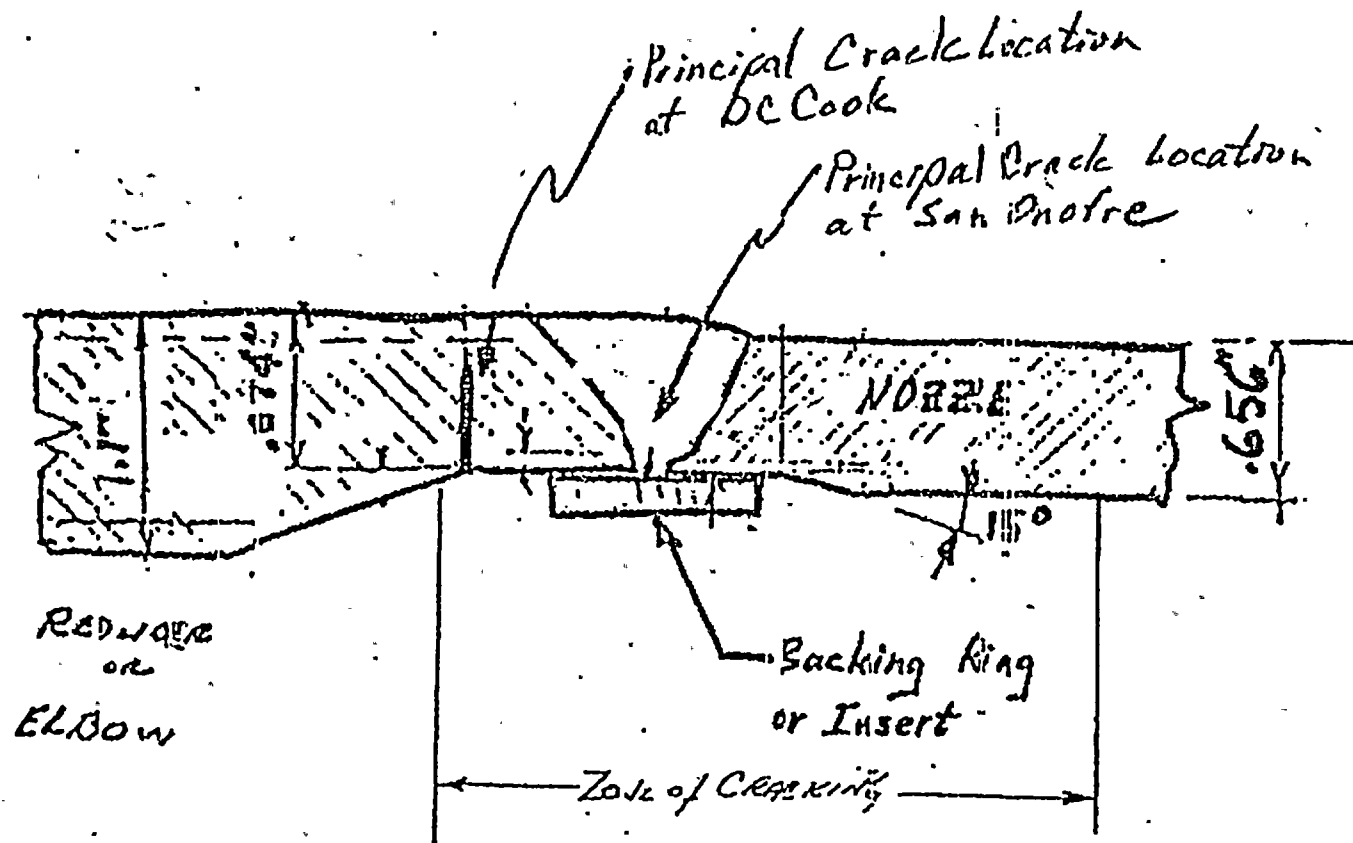
FIGURE 3
 TYPICAL FEEDWATER PIPE TO NOZZLE
 WELDED JOINT DETAIL
 (1 CE)

An extensive metallurgical investigation has been conducted by Westinghouse on a substantial number of cracked weldments removed from the above plants. Results of the metallurgical analysis lead to the conclusion that a corrosion fatigue phenomenon is the probable failure mechanism, except for the San Onofre piping which has been characterized as stress assisted corrosion.
